Stream Morphology and Water Quality Based Restoration Plan for the Paradise Creek Watershed

Phase I Technical Report for the Paradise Creek Watershed Assessment

Prepared by Robert Limbeck, Watershed Scientist Delaware River Basin Commission, West Trenton, NJ For the Brodhead Watershed Association, Henryville, PA

February 2005

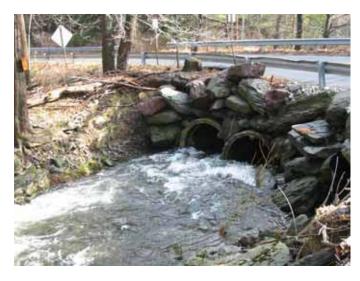
Cranberry Creek at Browns Hill Road crossing – multiple culverts, blockages, undersized.
 Cranberry Ck at Cranberry Creek Road crossing – culvert effects.
 Cranberry Ck UNT7 (R) at Route 191 crossing – culvert effects.

Figure 7 - Cranberry Creek at Browns Hill Road: culvert is undersized, threatens road. Culvert should be replaced and sized sufficiently to provide additional cross sectional area and improve fish passage.

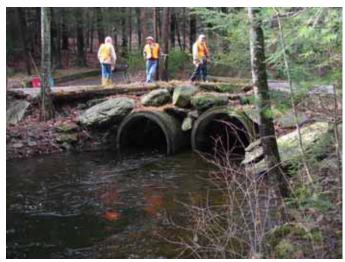
Figure 8 - Cranberry Creek at Cranberry Creek Road crossing. Culvert undersized, road frequently floods. Stream receives a large amount of road runoff. Non-point source pollution management recommended here.

Road crossing is being renovated (proposed project as of January 2005) Crossing frequently floods, culvert undersized. Road runoff is potential problem. Possible project. Road runoff should be captured and treated.

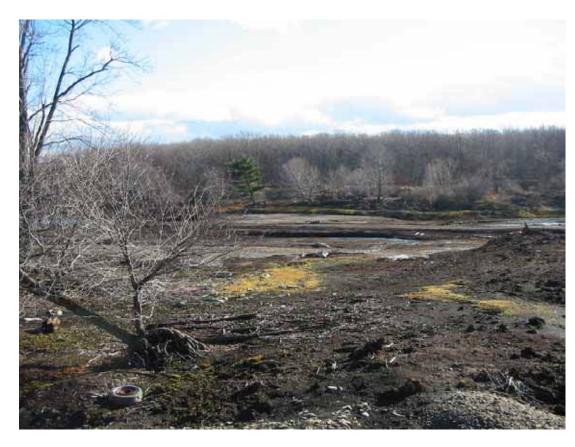
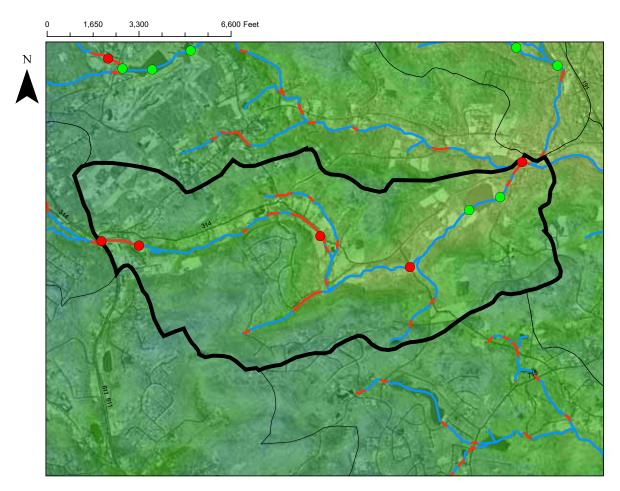
4. Cranberry Ck (L) through parcel 8534 peat mining operation, extreme channelization.

Figure 10 (left) and Figure 11 (below): headwaters of Cranberry Creek watershed at active peat mining operation. Upon conclusion of peat mining operations, this site will require extensive restoration. Little is presently done to manage water quality impacts at this site.

See 8534 Aerial Photo. Extensive disturbance of stream channel, mitigation necessary once mining operation is completed.

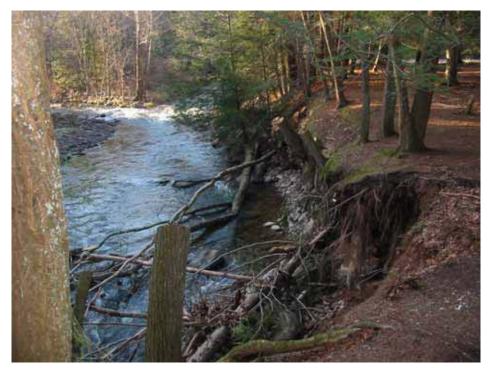
1. Swiftwater Creek at Parcel 0299 residential – bank gets brunt of erosion effects from sharp turn in creek.

Figure 13: Lower Swiftwater Project 1: Left bank erosion at confluence of Forest Hills Run and Swiftwater Creek. Landowner has received emergency stabilization funding, but poststabilization habitat improvements and perhaps upstream channel realignment would improve instream conditions. This site was previously channelized, creating a 90-degree confluence of the streams and producing these erosion effects.

Landowner received disaster recovery funds for bank stabilization. Habitat improvements needed. Large restoration project – up to 2 miles of stream affected by backwater flooding & erosion. Stabilization and habitat improvement recommended (large project). Examine storm water runoff management at site, potential future projects with Aventis (small project). Manage highway runoff (small project).

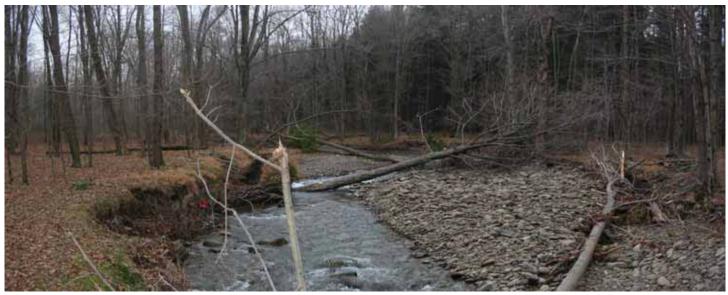
2. Swiftwater Creek at Route 314 crossing - bridge effects.

Figure 14 - Lower Swiftwater Project #2: Swiftwater Creek upstream of Route 314 crossing – up to 2 miles of severe erosion.

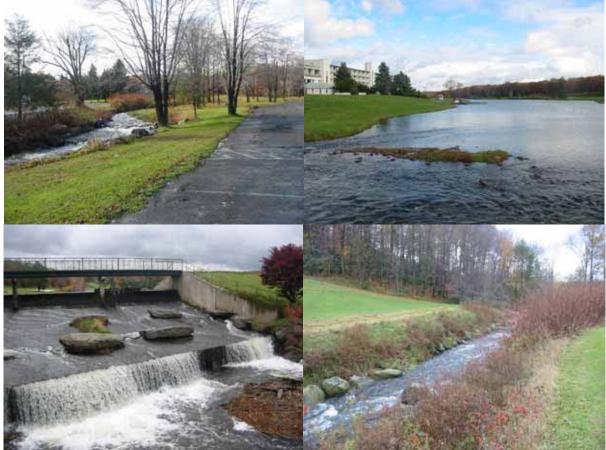
Figure 17 – Forest Hills Run Projects 2,3,4,5: Mount Airy Lodge site, where improvements can be made to the riparian buffer, storm water management for water quality, stream channelization repair, invasive species removal, and Canada Goose management.

- Photo 1 Parking lot upstream of Woodland Road by Forest Hills Run
- Photo 2 Forest Hills Run enters Lake, see sediment deposit, extensive lawn and no buffer.
- Photo 3 Dam and Spillway of Lake, fish passage blocked.
- Photo 4 Downstream of Lake at golf course fairway channelized, invasive species, poor buffer.

Manage runoff quality; establish riparian areas.

Establish riparian zone; reduce water quality effects of turfgrass & fertilizers; reduce Canada Goose impacts; prepare storm water plan for site.

Establish riparian zone as environmentally sensitive area on golf course; remove invasive plants; reconstruct meanders if necessary (detailed survey to determine erosive energy of stream, create restoration plan).

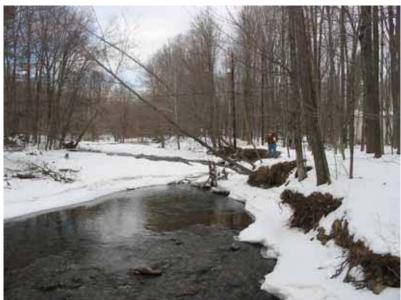
1. Paradise Creek upstream to downstream of Red Rock Rd crossing – channel migration, incision, widening.

Figure 19 – Upper Paradise Project 1: Paradise Creek from the vicinity of Red Rock Road to Lake Crawford. Previously channelized, this reach is now widening, forming meanders, and threatening private property. Note the telephone pole in background, once about 15 feet from the stream, is now about to be undermined. A more detailed assessment and restoration is recommended from Red Rock Road to Lake Crawford.

Large project - protect private property and stabilize up to 1 mile of stream. Long channelized reach produces high energy downstream. Improve habitat, reduce energy, restore channel upstream of breached dam, create stormwater management plan, install BMPs. Address road runoff and runoff effects of stable.

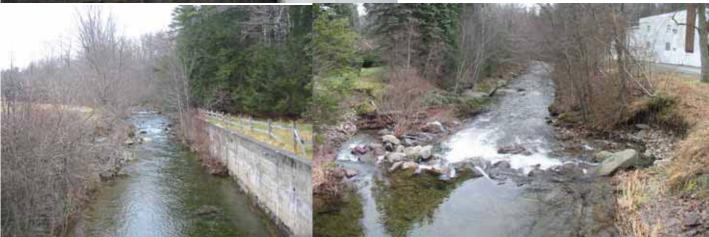
2. Paradise Creek in vicinity of abandoned Pocono Gardens Resort – runoff, channelized, breached dam, road crossings.

Figure 20 – Upper Paradise Project 2: Pocono Gardens Resort Site – upstream view of channelized section (above) and downstream view past breached dam (right).

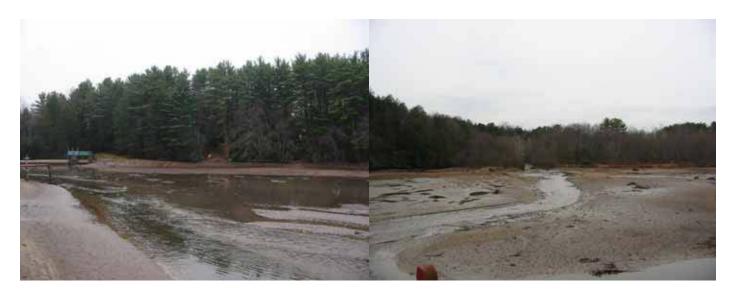
Figure 21 - Crawford Lake dredging, December 2004: Once the lake is dredged, a sediment forebay could be created for future sediment capture and maintenance, and approximately ½ mile of upstream stabilization of Paradise Creek. Installation of a fish passage structure and additional habitat improvements are recommended. Left – Downstream view toward dam. Right – Upstream view of Paradise Creek entering Lake Crawford. Below – panoramic view of dredging project taken February 2005.

Install fish passage structure. Implement lake management recommendations. Install sediment capture forebay, maintain regularly. Possible large restoration project to ½ mile upstream of lake.

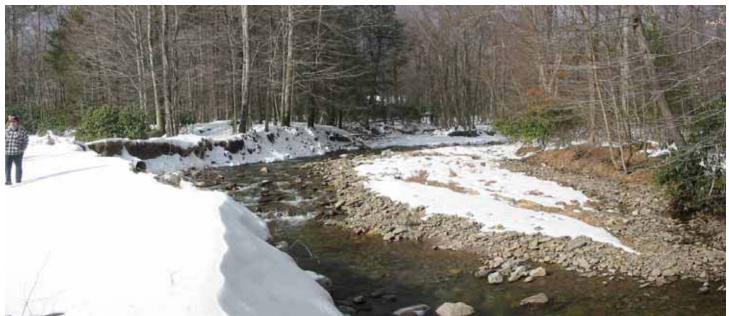
Other (1 green) Observation 1. Devils Hole Creek at Paradise Stream resort – incision, bank erosion, property threat, sediment in pond.

Figure 23 - Devils Hole Creek at upstream end of Ceasar's Paradise Stream Resort. The stream has widened, eroding the stream bank and creating a large bar. The erosion threatens part of the resort property. Emergency stabilization is necessary at this location. Between this location and the dam downstream (see photos below), it is believed that the stream was channelized at some time past. This part of the stream is located in the transition area between high-gradient mountainous terrain and the low-gradient, wide valley of the Paradise Creek.

Major restoration and stabilization project. Recommend dam removal at lower end of reach.

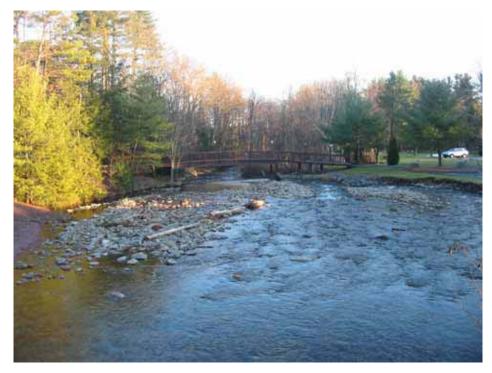
Figure 24 - Downstream view of sediment-filled small impoundment on Devils Hole Creek. The dam is just upstream of the footbridge in the background, and is located about 100 yards upstream of the confluence of Devils Hole Creek and Paradise Creek. Bank erosion to the right threatens a driveway and building. Dam removal is recommended at this location. Unless such impoundments are maintained frequently, installation of dams in highenergy stream environments is discouraged.
