Fatality Assessment & Control Evaluation Project

FACE 01-NJ-108

August 29, 2002

Worker Killed in Compressed Air Explosion at a Tire Retread Plant

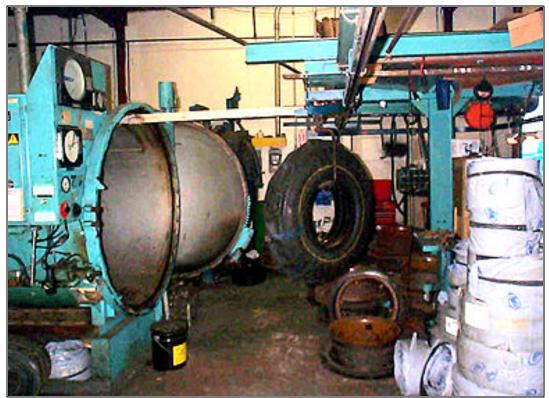
Photo 3 Tire in envelope hanging in front of curing chamber
