# Study of Stormwater Basins in the Barnegat Bay Watershed

**SUMMARY OF  
TECHNICAL ANALYSIS  
AS MANDATED BY P.L. 2010, CHAPTER 114**

NEW JERSEY DEPARTMENT OF TRANSPORTATION

June 2014

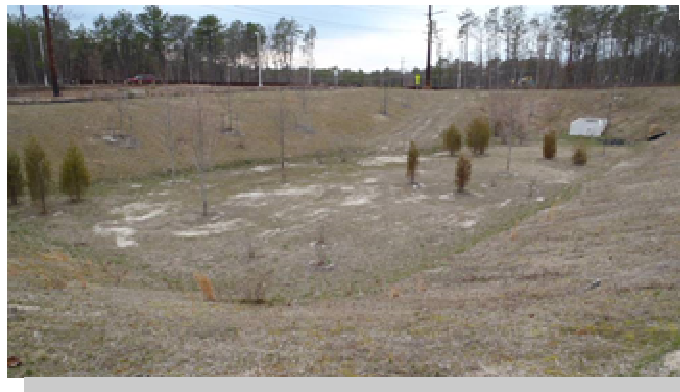
**One of the stormwater basins evaluated**

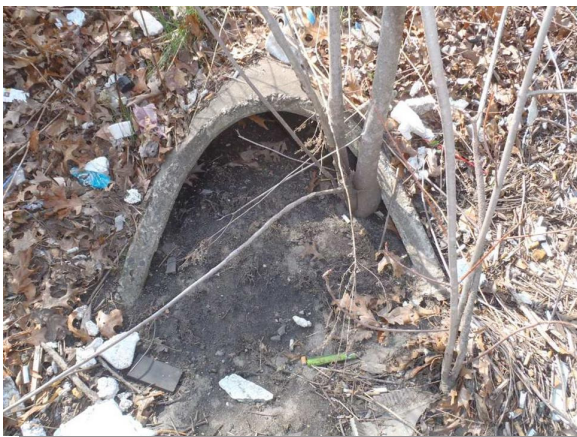
**Clogged inlet pipe in urgent need of maintenance**

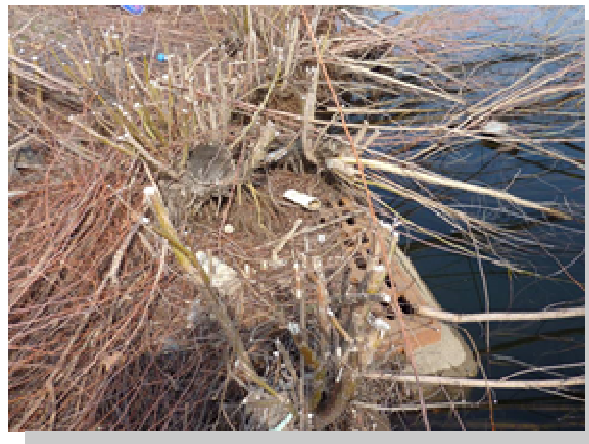
**Overgrown vegetation interfering with wet pond outlet**
