UNDERWATER BRIDGE EVALUATION SURVEY REPORT

STRUCTURE NO.: 0802-151

**ROUTE NJ 41 OVER
SOUTH BRANCH TIMBER CREEK
TOWNSHIP OF DEPTFORD
GLOUCESTER COUNTY**

September 27, 2007

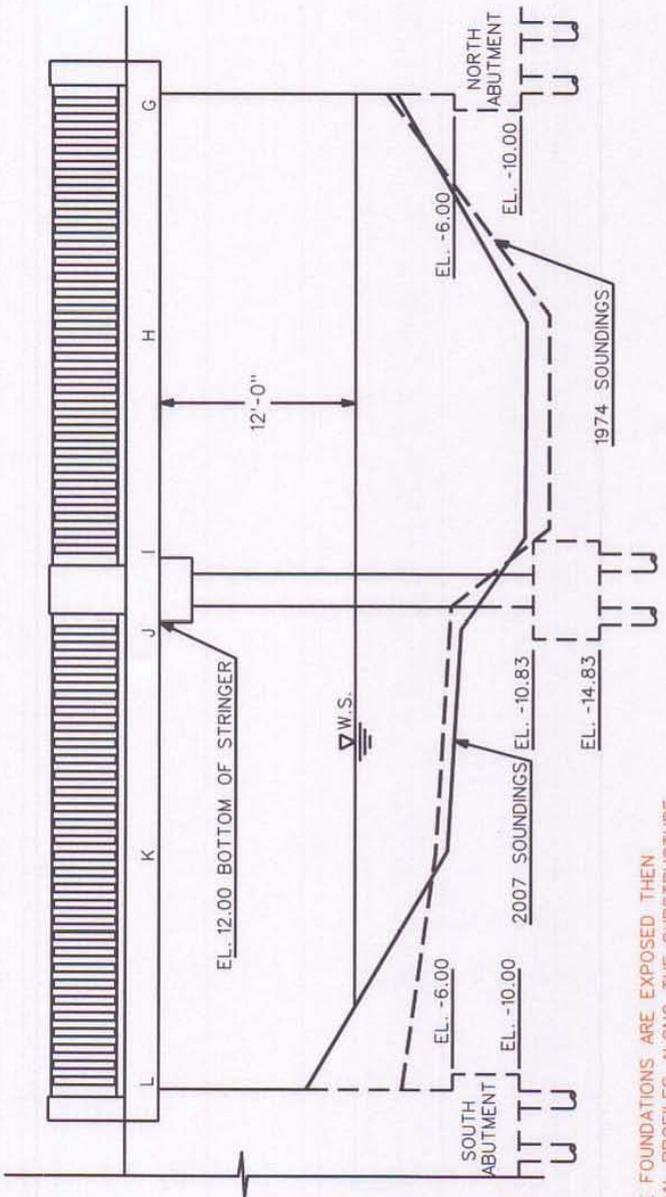
EAST ELEVATION

Based upon our probing of the channel bottom material adjacent to the substructure and our review of prior reports and plans, the bridge appears to have minor potential scour problem at this time. There is minor local scour at the east end of the pier approximately 1' deep along the north side.

POINT	LOCATION	UPSTREAM	
		1974	2007
G	NORTH ABUTMENT	WATER CLEAR DIM. 13.9'	WATER CLEAR DIM. 14.5'
H	MID SPAN 2	23.9'	10.5'
I	N. FACE PIER	23.9'	11.0'
J	S. FACE PIER	17.9'	6.5'
K	MID SPAN 1	16.9'	5.5'
L	SOUTH ABUTMENT	14.9'	0.0'

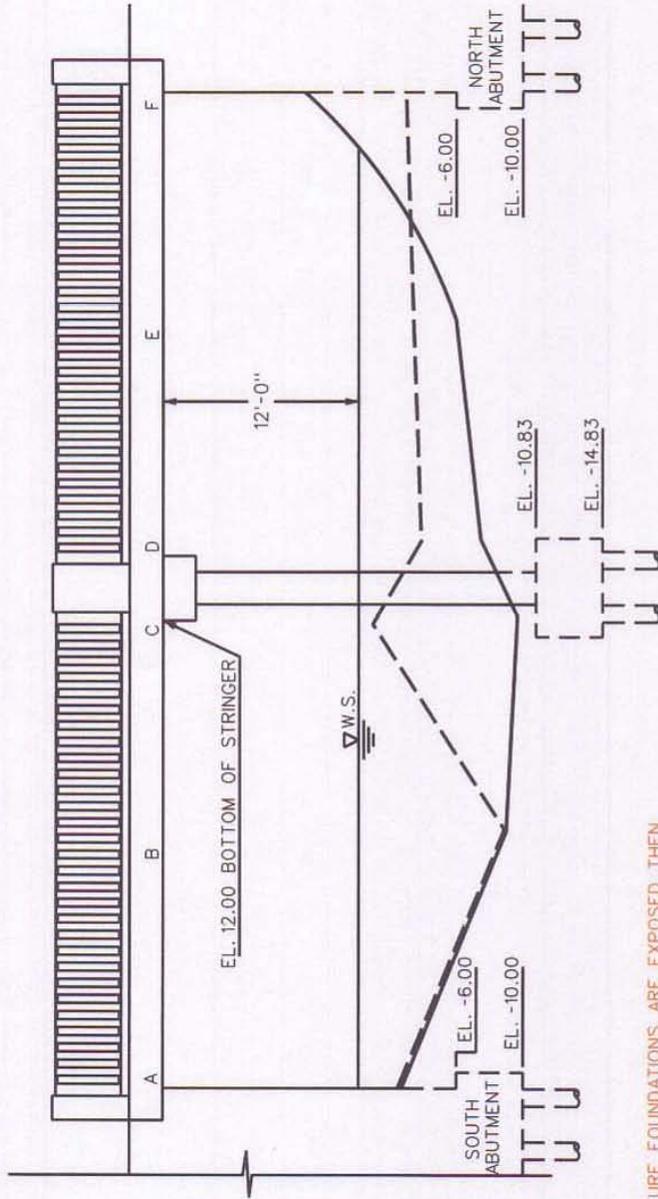
WEST ELEVATION

POINT	LOCATION	DOWNSTREAM	
		1974	2007
A	NORTH ABUTMENT	WATER DEPTH * 14.4'	CLEAR DIM. 14.5'
B	MID SPAN 2	WATER DEPTH * 20.9'	CLEAR DIM. 21.0'
C	N. FACE PIER	WATER DEPTH * 12.9'	CLEAR DIM. 10.0'
D	S. FACE PIER	WATER DEPTH * 15.9'	CLEAR DIM. 7.5'
E	MID SPAN 1	WATER DEPTH * 15.4'	CLEAR DIM. 6.0'
F	SOUTH ABUTMENT	WATER DEPTH * 14.9'	CLEAR DIM. 0.0'

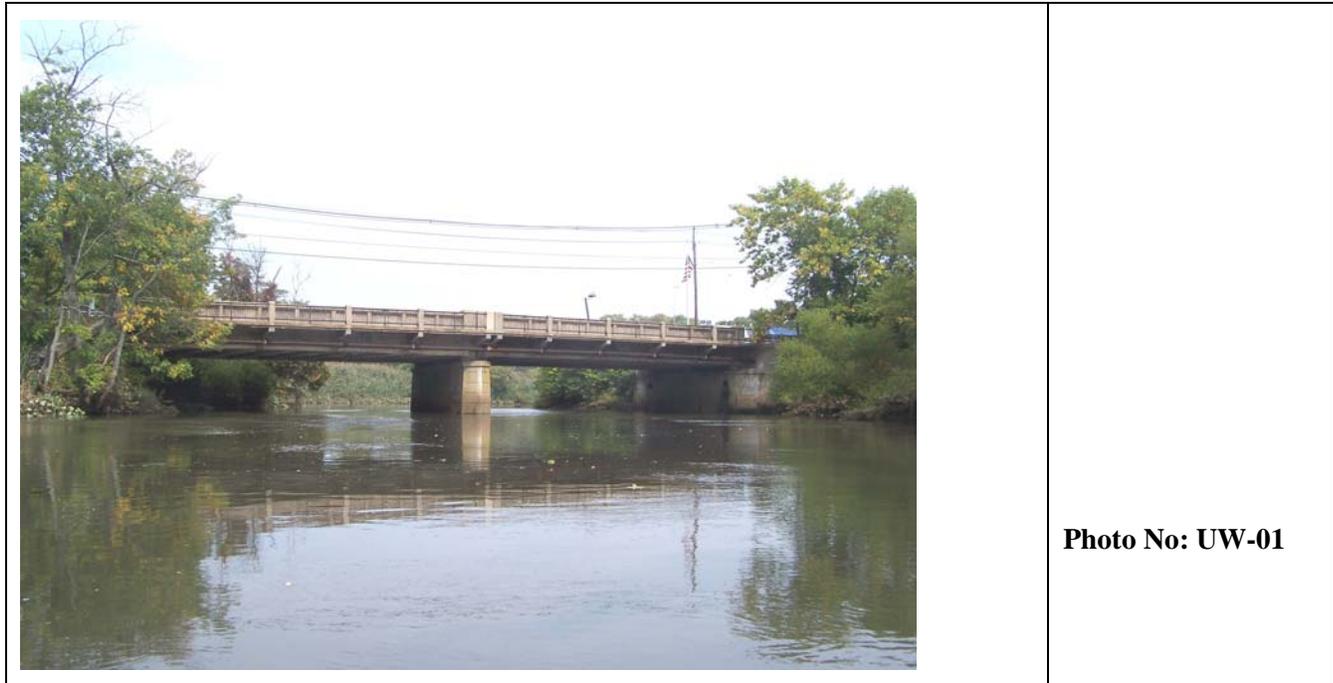
Photo No: UW-01

Location:	East elevation, looking west
Description:	General view.

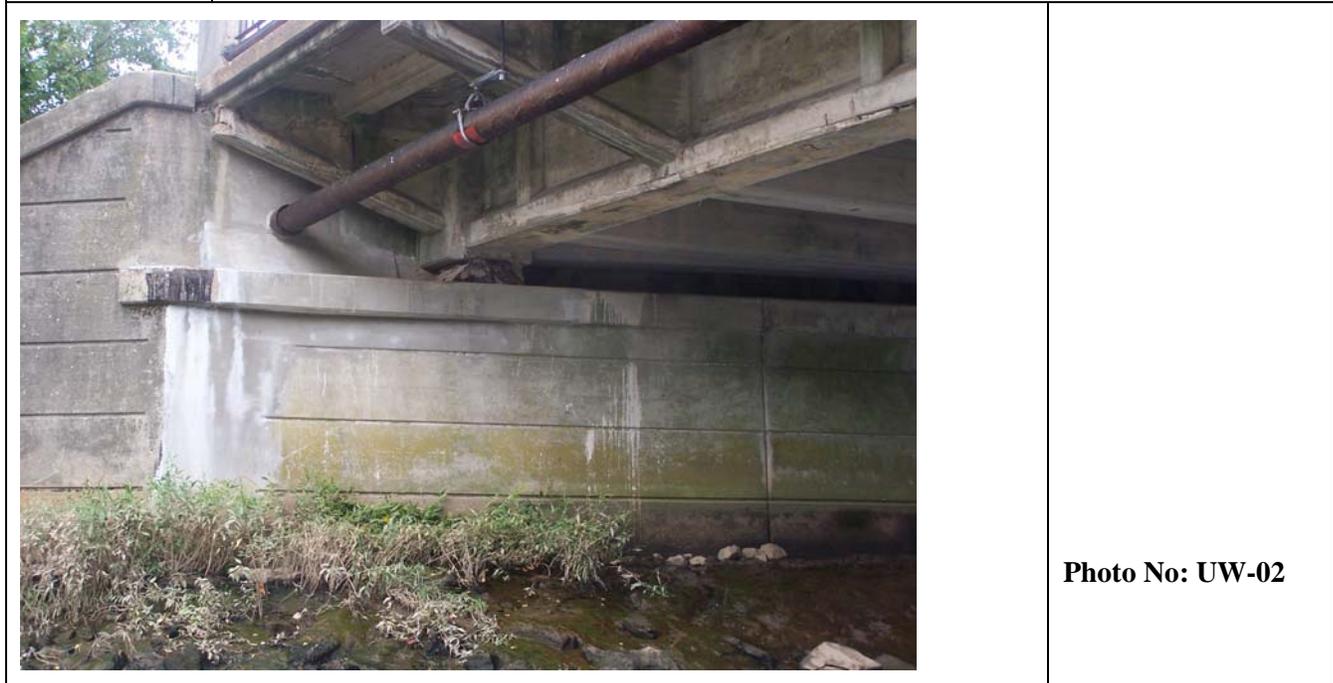
Photo No: UW-02

WORK DONE: Several spalls along both abutments have been repaired (Photo No.UW-02).

Location:	South abutment, east side, looking south.
Description:	Work done: Concrete patched areas; typical at both abutments.
