**ENGINEERING INVESTIGATION & ANALYSIS  
GEOTECHNICAL & STRUCTURAL  
ASSESSMENT REPORT**

**10 SYLVAN ROAD  
FAIRFIELD, NEW JERSEY 07004**

Matrix No. 20-1052

October 2021

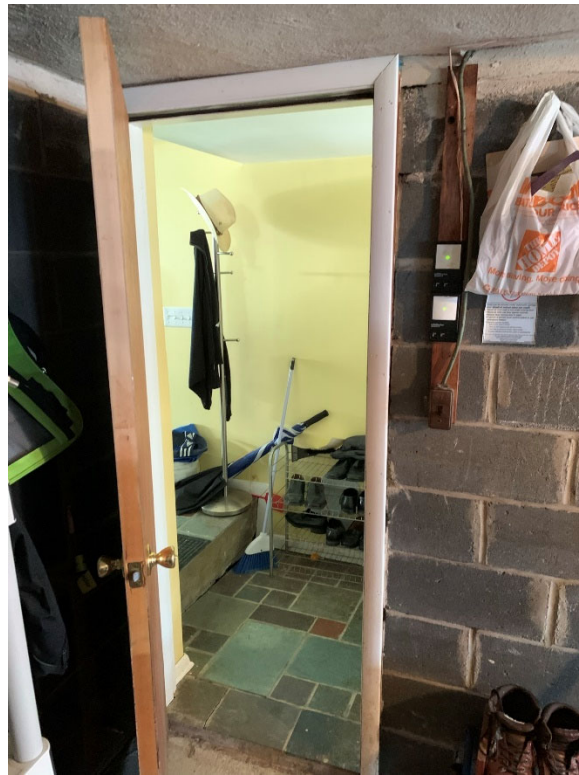
The garage area of the building, measuring 25'-2" long x 20'-8" wide, encompasses the east portion of the ground level. The garage contains CMU (8x8x18 block) foundation walls around the full perimeter of the area, typically ranging between 82" and 84" in height from floor to top of wall. In the front wall of the garage, the CMU blocks have been removed above a glass window and have been replaced with timber framing. Two garage doors are located along the east wall of the garage, both measuring 8'-3" wide. The framing of the second floor above could not be observed, due to the presence of a stucco-covered sheetrock ceiling throughout the space. A girder was visible beneath the ceiling, spanning the garage from east to west (side to side of house), but this structural member was also covered in a stucco coating. The girder

**Photo 3. Garage Entrance Door & CMU Foundation Walls (Looking North)**

The garage doors located along the east wall of the house will need to be removed prior to raising the house, then replaced at the ground level once the house is elevated and the new first floor is constructed. The existing CMU exhaust chimney located within the interior of the house will also require extending during raising of the house to keep the top of the chimney above the roof level. Additionally, the rear timber deck

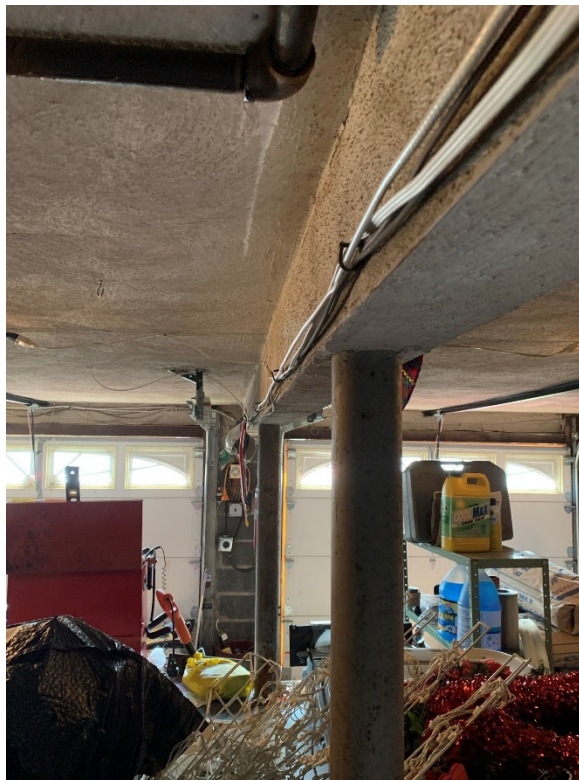
measured 6" wide x 9.25" deep, suggesting a composition of (3) connected nominal 2x10 timber members. The girder is supported throughout its span, between the edge foundation walls, by (2) 4" diameter steel post columns that extend into the ground below the concrete floor slab. The longest clear span of the girder measured 7'-3" at each end between the steel post column and the CMU walls. The concrete floor of the garage was not evenly graded, as the distance from floor to ceiling varied in this area between 7'-1" and 7'-2".

**Photo 4. Garage Girder & Steel Post Columns (Looking East)**

The existing steel post columns intermittently supporting the building's girders must be removed and replaced by new steel, concrete, or masonry block columns. These new columns will need to include a spread footing beneath to sufficiently support the building loads.

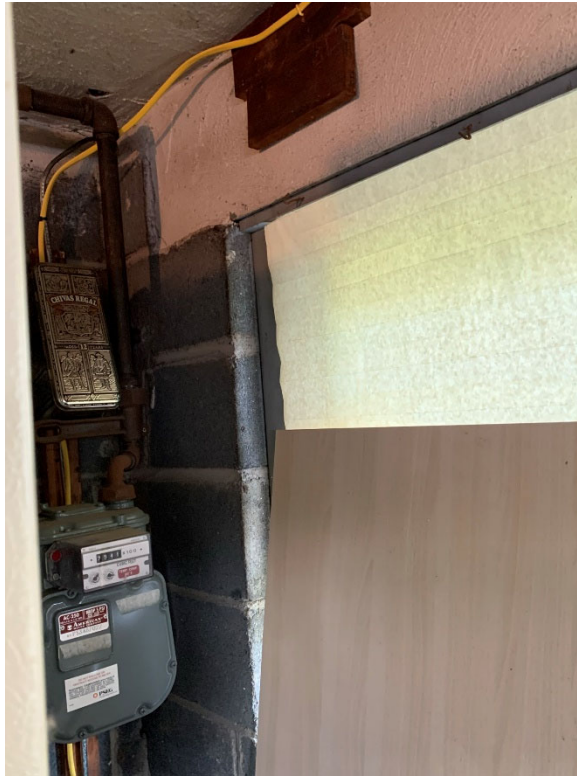
**Photo 5. CMU Wall Along Front Wall of Garage, Timber Frame Wall Above Window**

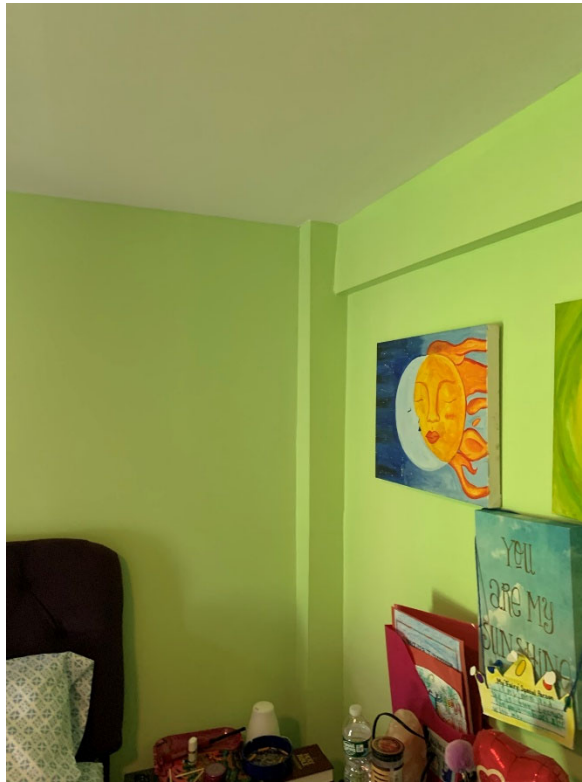
The remainder of the ground level, located west of the entrance vestibule and approximately 18" below the vestibule floor, consists of furnished living space. This space contains timber-framed partition walls that separate the area into a bathroom, bedroom, living room, and laundry room. Similar to the garage, this area contains CMU perimeter foundation walls that appear to extend to the full height of the floor up to the ceiling (CMU blocks are likely removed above windows, similar to the garage). The concrete slab on grade in this area is covered with tile throughout, and measured approximately 7'-7" to the painted sheetrock ceiling. Beneath the stairs leading to the second floor of the house, a boiler room was observed that did not contain a sheetrock ceiling. From this room, the subfloor of the second floor was observed to consist of nominal 2x8 timber members, spaced 16" on center, running from front to rear of the house. These joists are supported by a girder that appeared to consist of (3) nominal 2x10 timber members spanning the full width of the ground-level living space from the west wall of the garage to the west exterior wall of the building. Though they could not be observed behind the finished sheetrock walls of the ground level, column supports are expected to be in place along the length of the girder to provide the necessary support for the building's loads.

**Photo 8. Ground Level Living Space with Girder & Column (Looking Northwest)**

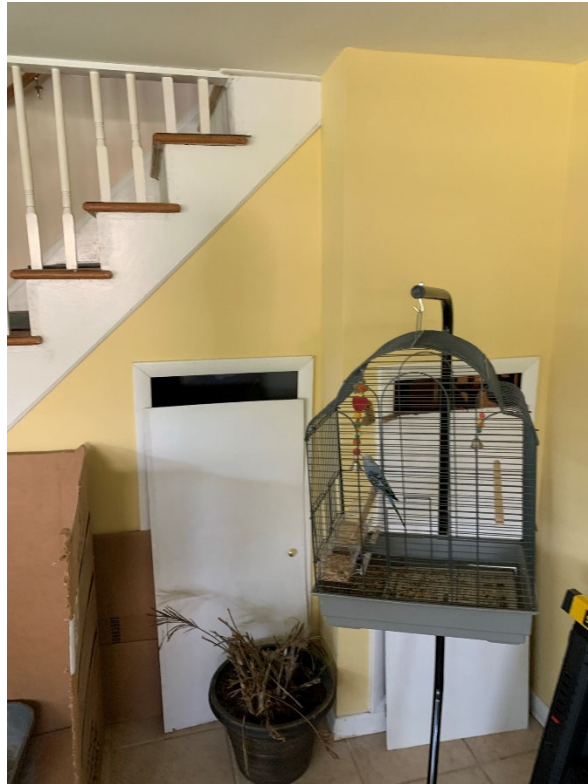
In the boiler room, located under the stairs to the second floor, a boiler and hot water heater were observed. The boiler was raised 7" above the concrete floor with brick and stone blocks, while the hot water heater was raised 4" above the floor on concrete blocks/pavers. Next to the hot water heater, a water filter tank was observed on the floor surface. Also in the boiler room, a CMU exhaust chimney connects to the exhaust pipelines of the hot water heater and boiler, extending up through the roof of the house. Outside the boiler room, in the laundry room of the ground-level living space, separate washer and dryer units were observed situated on the floor surface.

**Photo 9. Boiler Room Beneath Stairs to Second Floor (Looking Southeast)**

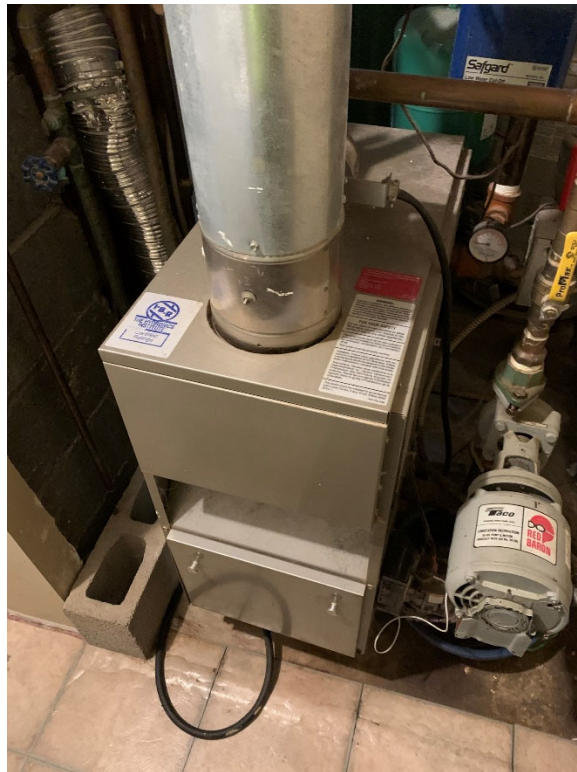
**Photo 10. Boiler in Boiler Room (Looking North)**

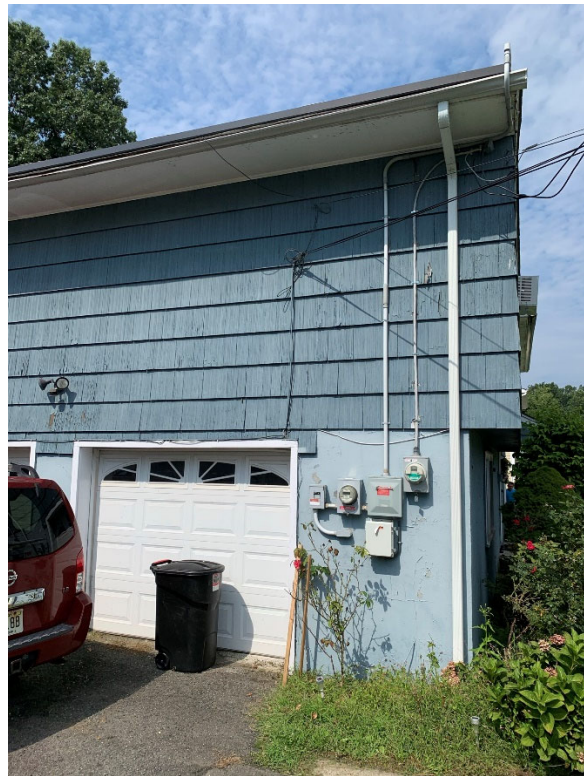
Outside the building, on the roof, multiple solar panels cover much of the south and east areas of the roof surface. The roof panels connect to an inverter/electrical box mounted to the east exterior wall of the house (north of the garage doors). All air conditioning for the house appears to come from window units installed along the second floor.

**Photo 12. Solar Panel Equipment on East Exterior Wall of House**

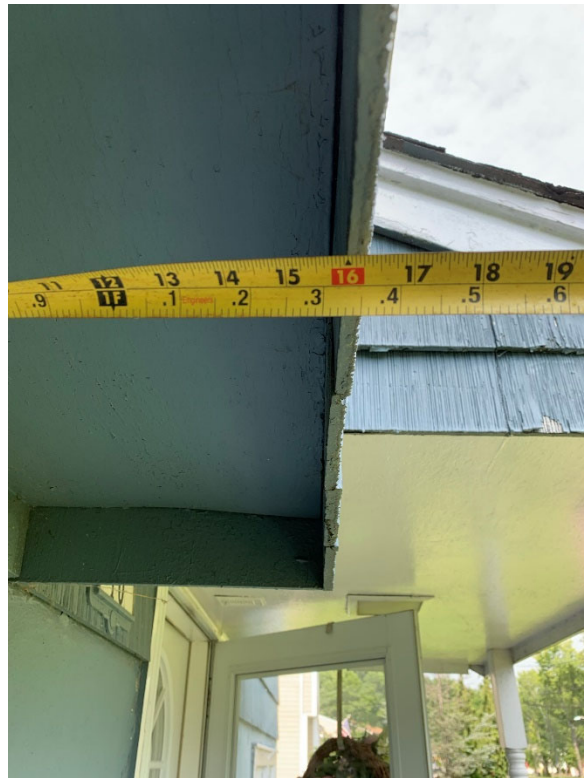
An approximately 16” overhang was observed on the second floor in the front of the house, above the ground-level garage area only. This is a cantilever overhang, as there is no additional support for the overhanging area of the second-floor joists.

**Photo 13. Second-Floor Overhang Over Garage Front Wall**

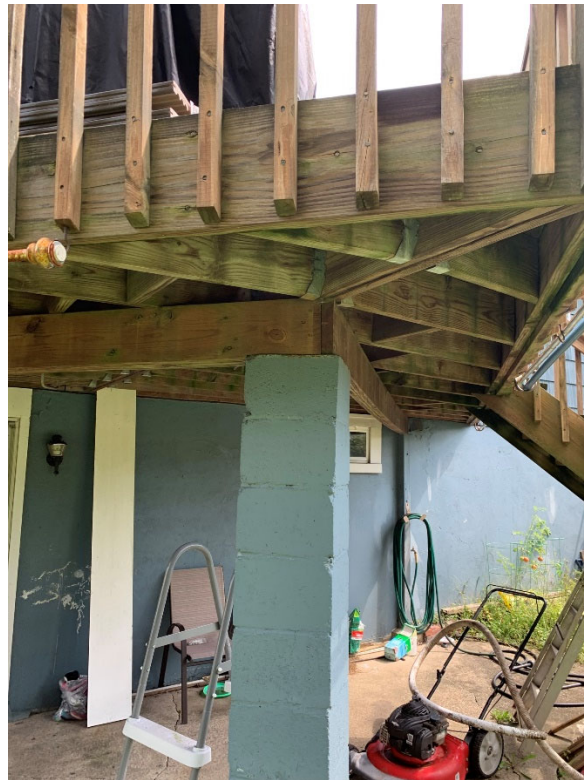
**Photo 14. Rear Timber Deck Frame & Columns**

is anticipated to require raising to match the new ingress/egress at heights of the main structure. This would require replacement or extension of the timber support posts and CMU column.

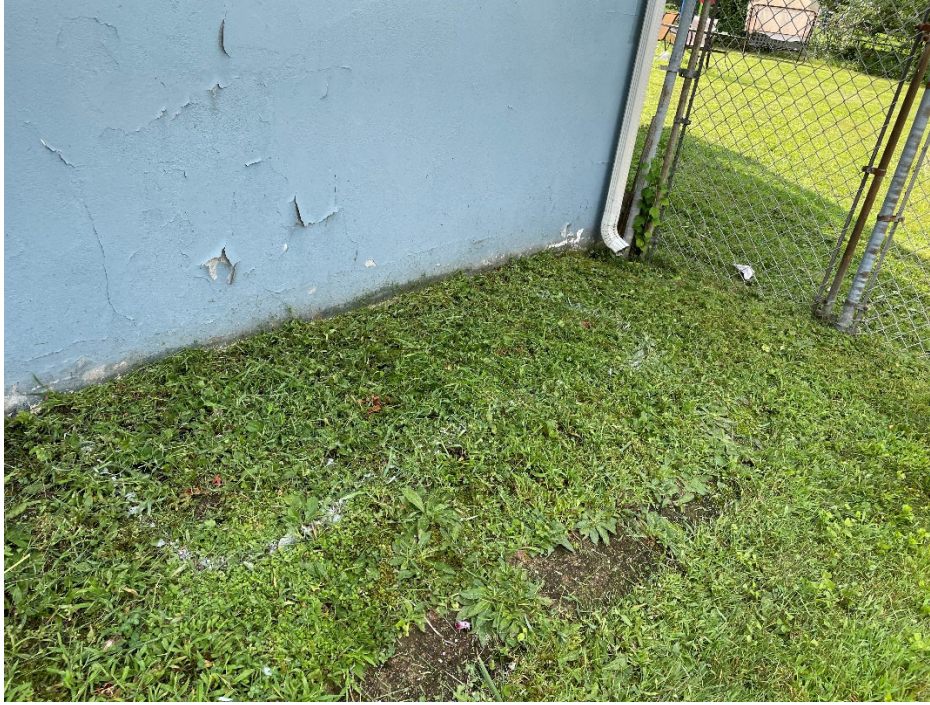
The test pit completed along the west wall of the building was prematurely terminated at 14” below the ground surface (bgs), due to the presence of groundwater. Using a metal rod, the top of concrete was encountered at 44 inches bgs. The high groundwater table within the test pit prevented measurement of the foundation wall footing dimensions.

**Photo 15. Test Pit TP-1 Location (Southwest Corner of Building – Ground Level Living Space)**

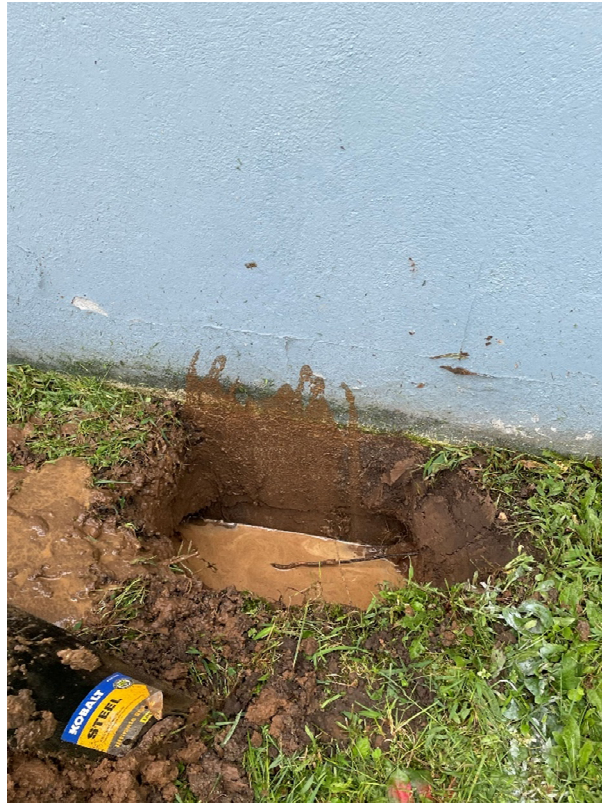
A test pit excavation conducted along the west wall of the building was prematurely terminated at 14" bgs due to the presence of the groundwater table at that depth. Using a metal rod, the top of the concrete footing was encountered at 44" bgs, but due to groundwater obstructions the footing dimensions could not be measured. Based on our findings within the test pit and from conventional foundation construction, Matrix utilized a 16" wide footing as a minimum value for analysis, but believes the actual footings for the building to likely range from 16" to 24" in width. Prior to raising the house, Matrix recommends that the contractor confirm the foundation size and bearing adequacy with multiple test pits around the building perimeter.

**Photo 16. Test Pit TP-1 Conditions**
