Beaver Brook - FIBI047

SUMMARY OF RESULTS – FIBI047

FIBI047
BEAVER BROOK
SAREPTA ROAD (CR 618)
WHITE TWP., WARREN COUNTY

HABITAT ASSESSMENT FOR HIGH GRADIENT STREAMS Beaver Brook (FIBI047) – 9/13/07

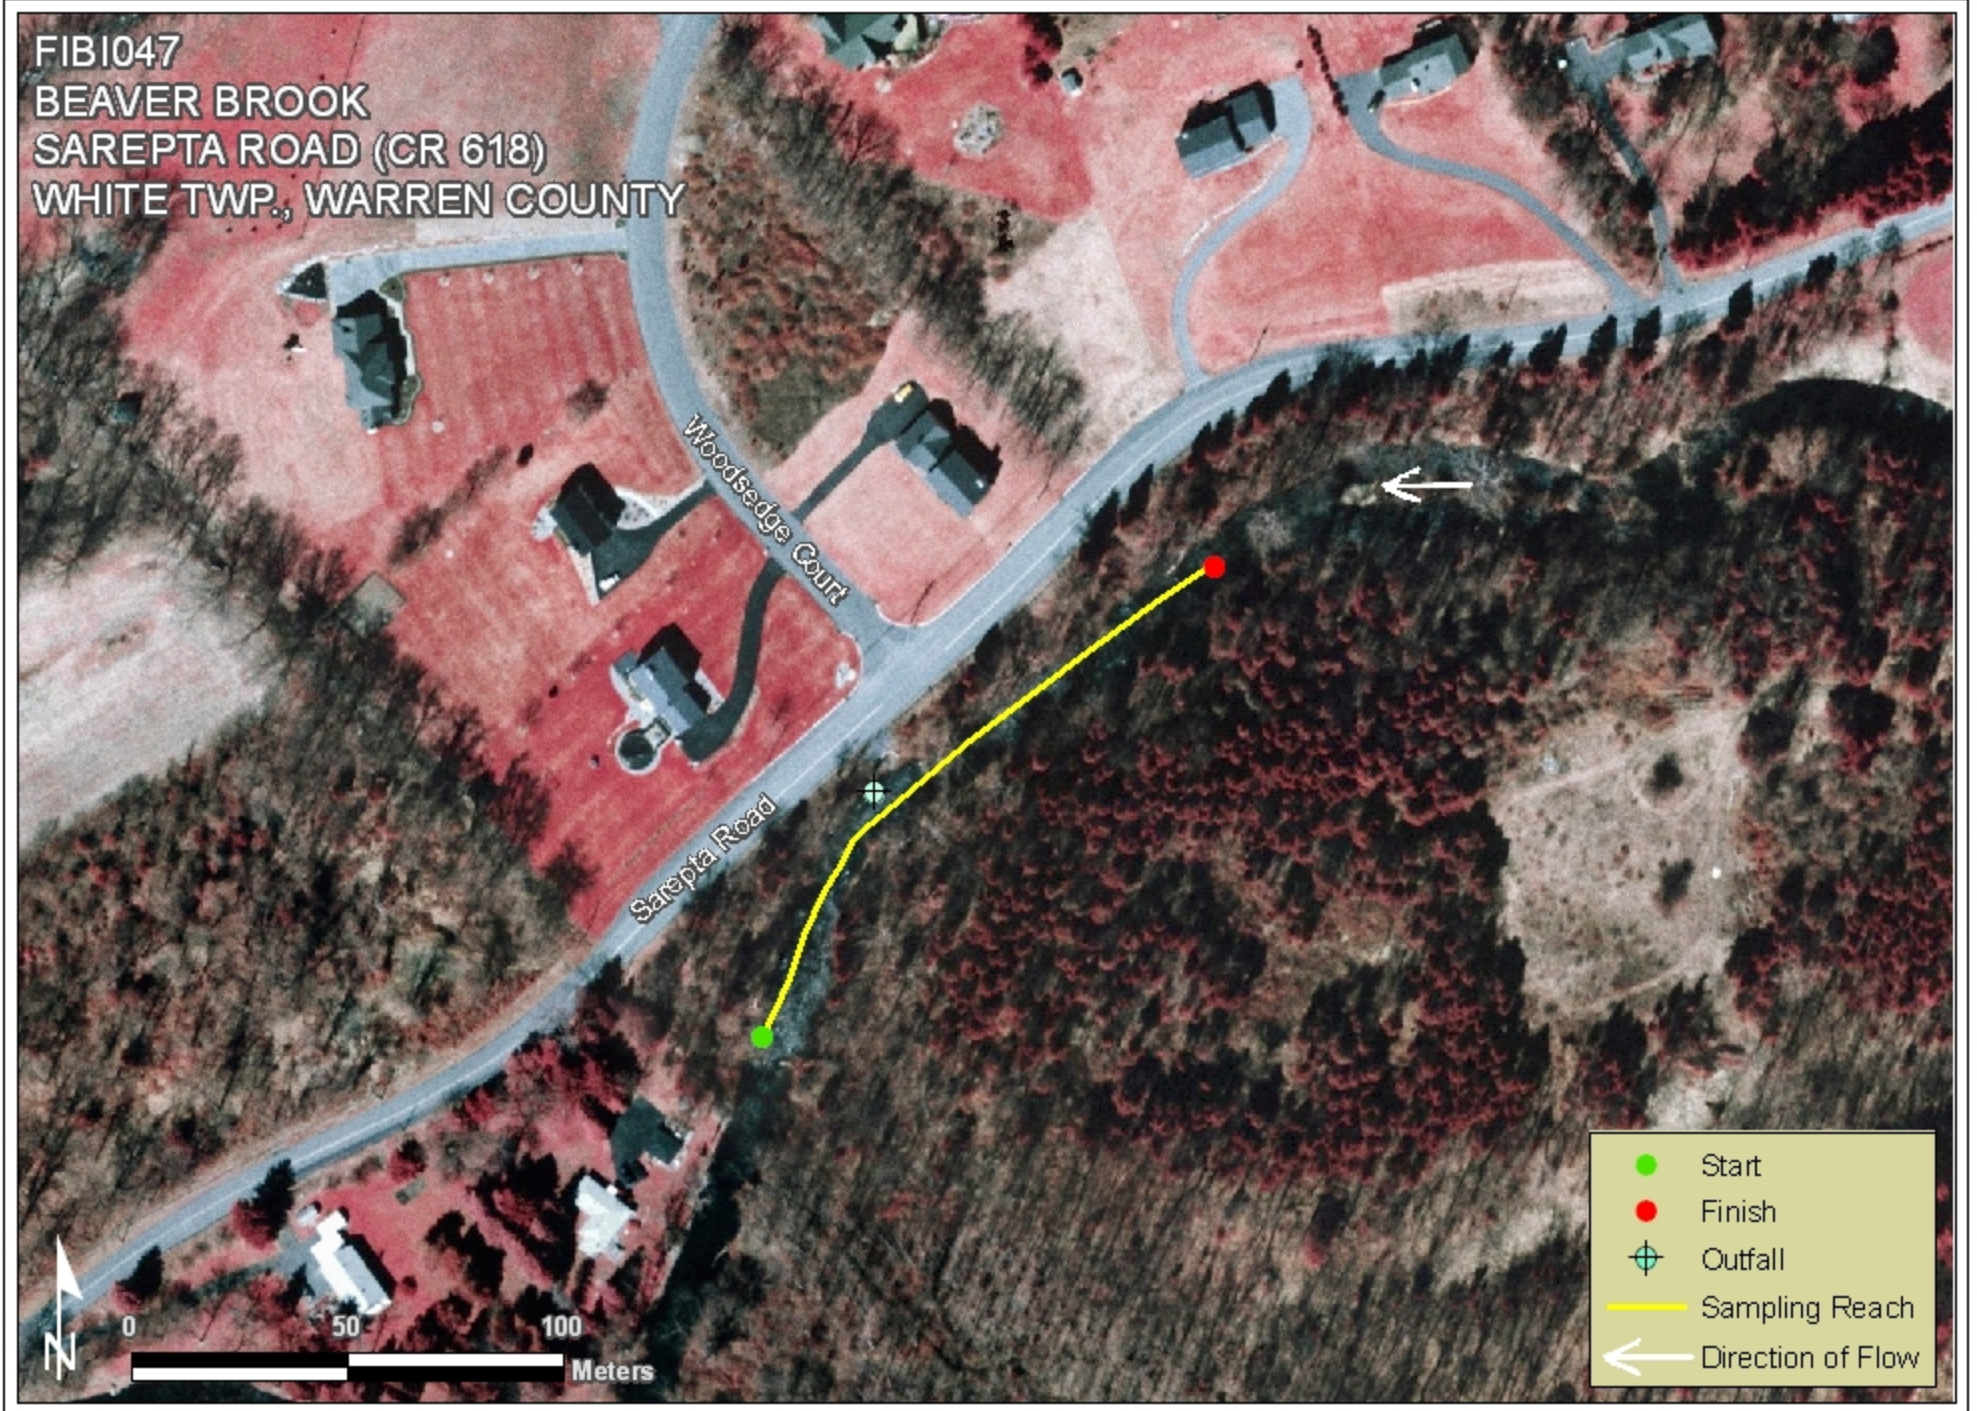
26. Number of Fish With Anomalies:	6
27. Other Observations:	Bridge construction just upstream of sample location.
