2021 ANNUAL HYDROLOGIC CONDITIONS REPORT

Technical Report No. 2022-2

Managing, Protecting and Improving
the Water Resources of the
Delaware River Basin since 1961

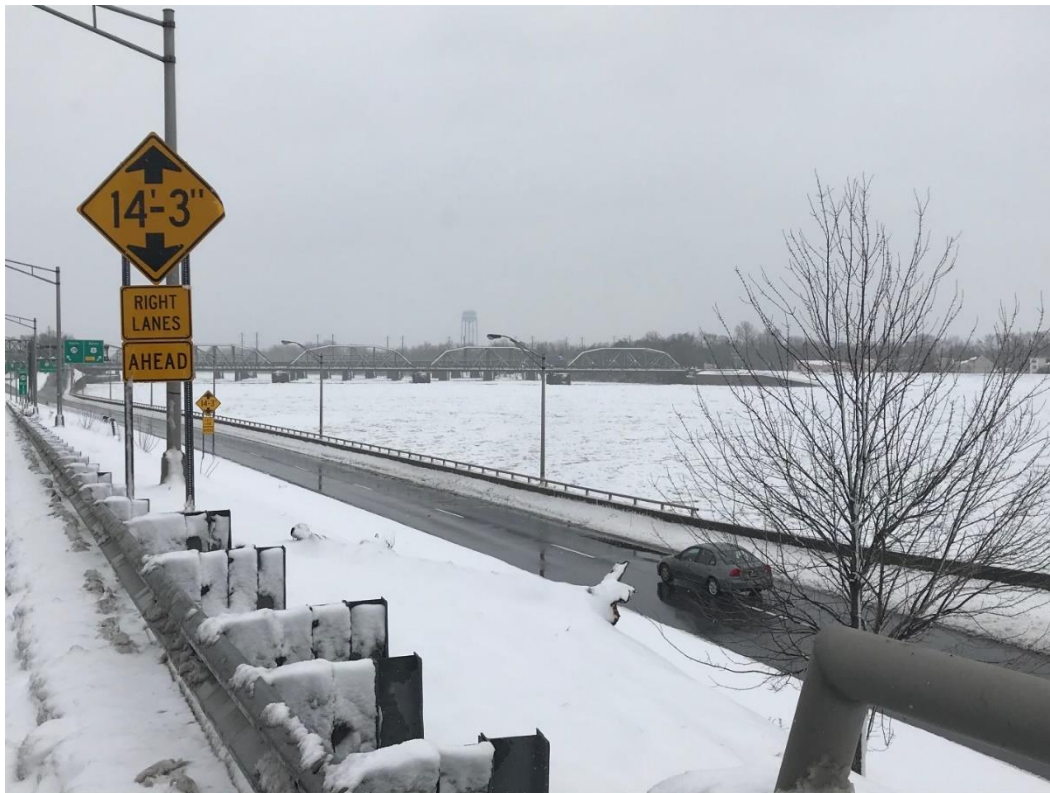
Figure 1: Snowfall in the DRB and surrounding areas during a multi-day snow event at the end of January and beginning of February. Totals from the 3-day period ranged from less than 1 inch in the lower basin to over 35 inches in Northeast Pennsylvania.

The first winter storm of the year occurred on January 31. Snow amounts were highest in northeast Pennsylvania, where some areas received more than 30 inches of snow over the three-day period. Figure 1 shows the map of snowfall totals in the DRB. Areas north of Trenton, N.J. received over 12 inches of snow. The combined snow and ice in the river led to minor ice build-up at several locations along the river. The time-series of the water level at Trenton, N.J. on January 30, presented in Figure 2, shows a rapid increase in elevation from near 9 feet to 15 feet in approximately 24 hours. A picture of the ice in the Delaware River at Trenton, N.J. is included below. The photo was taken off of Route 29 in New Jersey looking south towards the “Trenton Makes the World Takes” bridge. The ice cleared by February 2. A second period of ice

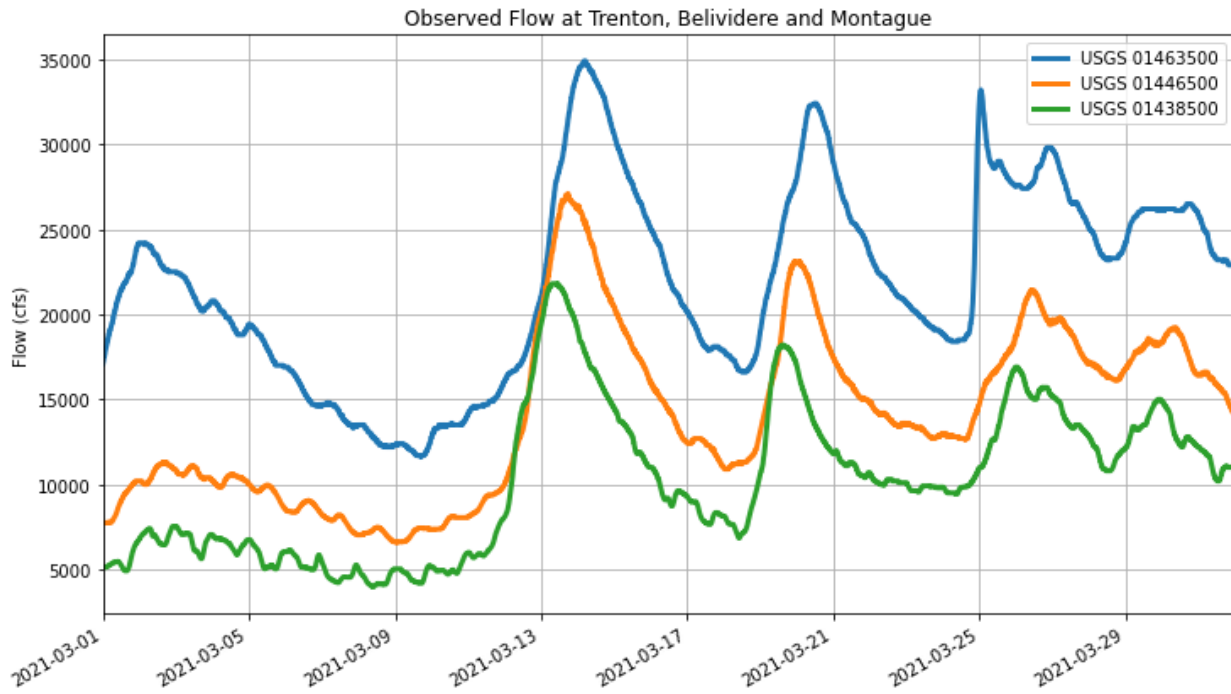
Figure 4: Streamflow with snowmelt at three USGS gages in the mainstem Delaware River. Trenton, N.J. (blue, 01463500); Belvidere, N.J. (orange, 01446500); and Montague, N.J. (green, 01438500).

The seasonal snowfall for the winter of 2020-2021 is shown in Figure 3. Areas north of Trenton, N.J. received more than 35 inches of snow. Some areas in the upper basin received more than 80 inches. Near the estuary, some areas received no measurable snow and other locations received up to 15 inches. Warmer temperatures resulted in snow melt occurring in late February and early March. Snowmelt did not lead to river flooding. Three peaks in flow were observed in March along the mainstem, as shown in Figure 4. The first and third peak in the mainstem were caused by snowmelt runoff only, and the middle peak was a combination of rain and snowmelt. Each event led to increases in flow in the mainstem to approximately 35,000 cfs at Trenton, N.J.

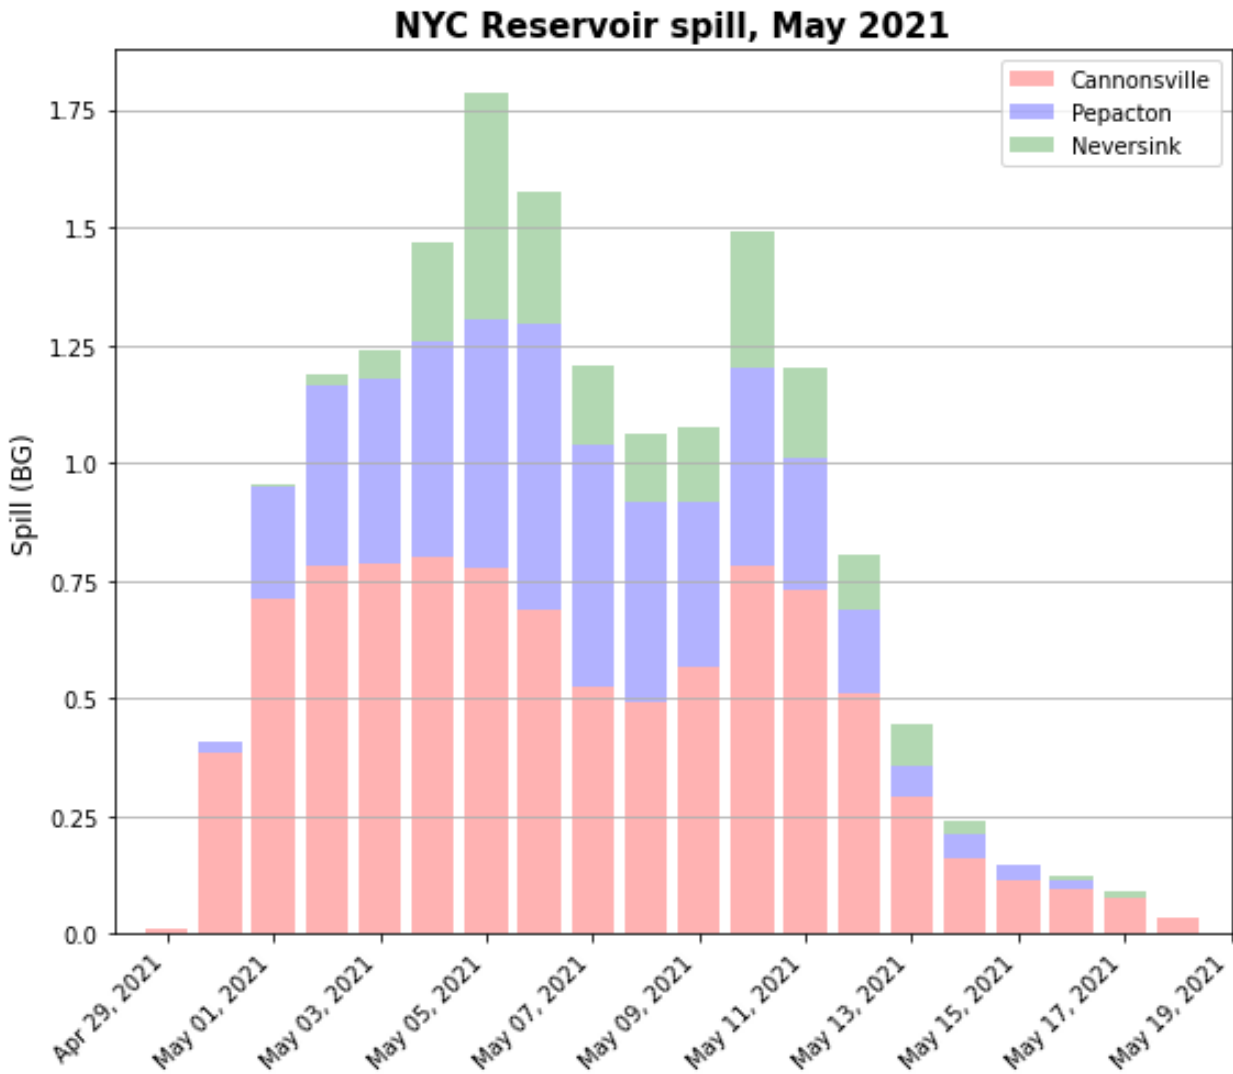
Figure 5: Volume of Spill (BG) from Cannonsville, Pepacton, and Neversink Reservoirs from April 29 – May 18, 2021.

The three New York City (NYC) reservoirs were full, 267.4 billion gallons (BG), at the beginning of May as shown in Figure 22, a normal occurrence. Two rain events (1.0-1.5 inches on April 29, and 1.1-2.7 inches from May 3 to May 5) resulted in spills from each. Cannonsville Reservoir spilled approximately 9.3 BG from April 29 – May 15. Pepacton reservoir spilled approximately 5.0 BG from April 30 – May 16. Neversink reservoir spilled approximately 2.3 BG from May 1 – May 17. The daily amount of spilled water from each reservoir from April 29 – May 18 is shown in Figure 5.

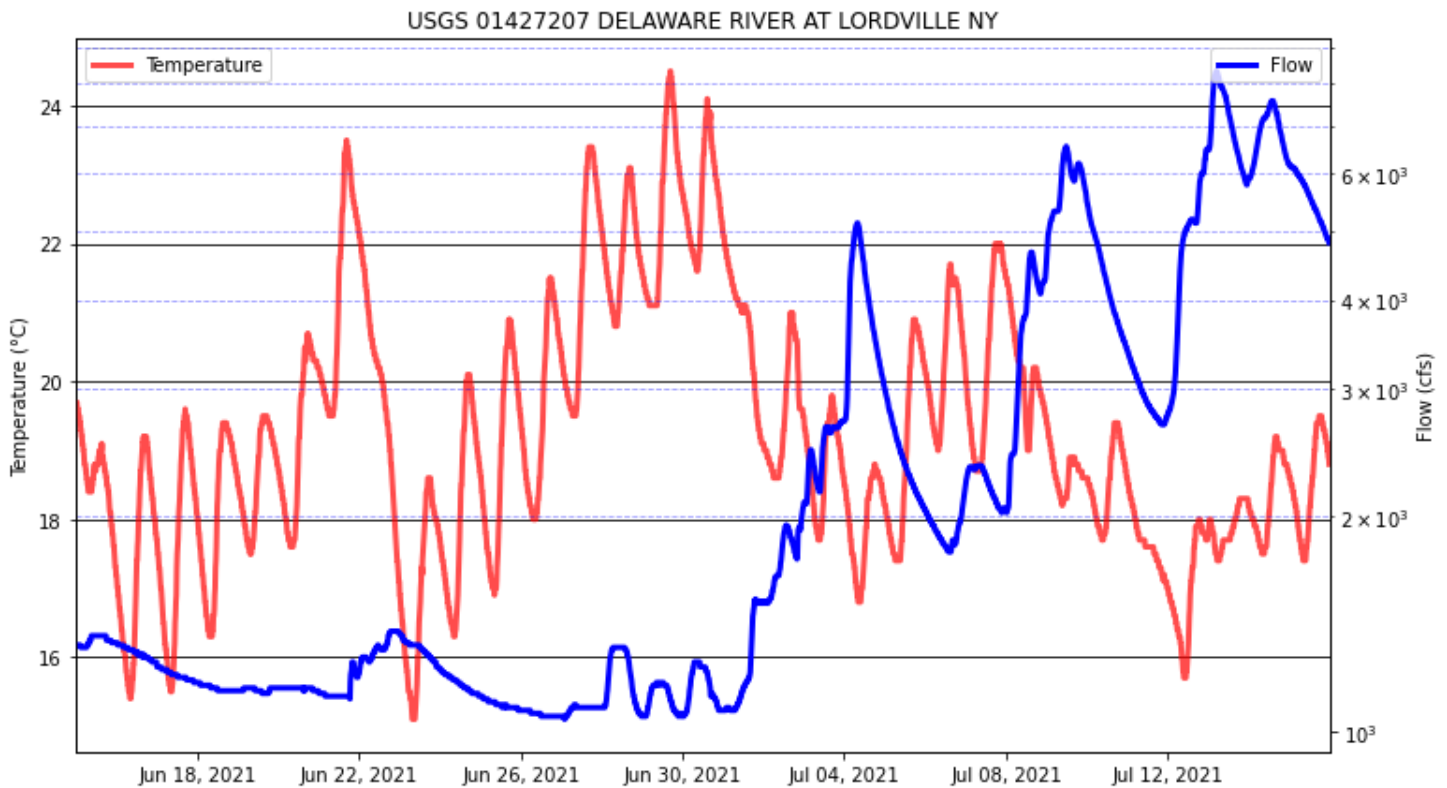
Figure 6: Temperature (red) and flow (blue) at USGS gage 01427207 (Delaware River at Lordville, N.Y.). During a stretch of warm water temperatures in late June, the maximum temperature surpassed 24°C on two days. An increase in the flow in July led to a decrease in the water temperatures at Lordville.

In late June, high air temperatures in the upper basin resulted in the need for thermal mitigation releases from Cannonsville to reduce water temperatures downstream at Lordville, N.Y., the indicator location. The time-series of water temperature and flow in 15-minute intervals at the USGS gage in Lordville, N.Y. is shown in Figure 6. The three peaks in flow between June 26 and 30 are indicative of the thermal release pulses made overnight. The water used for thermal mitigation over the five-day period was 524 cfs-days for 339 million gallons (MG). The pulses were successful, except for June 30, when the maximum water temperature at the USGS gage at Lordville, N.Y. was 24.1 degrees Celsius (approximately 75.4 degrees F). Thermal releases were terminated after an increase in flow which reduced water temperature. Thermal releases were also needed in August for three days as shown in Figure 7.

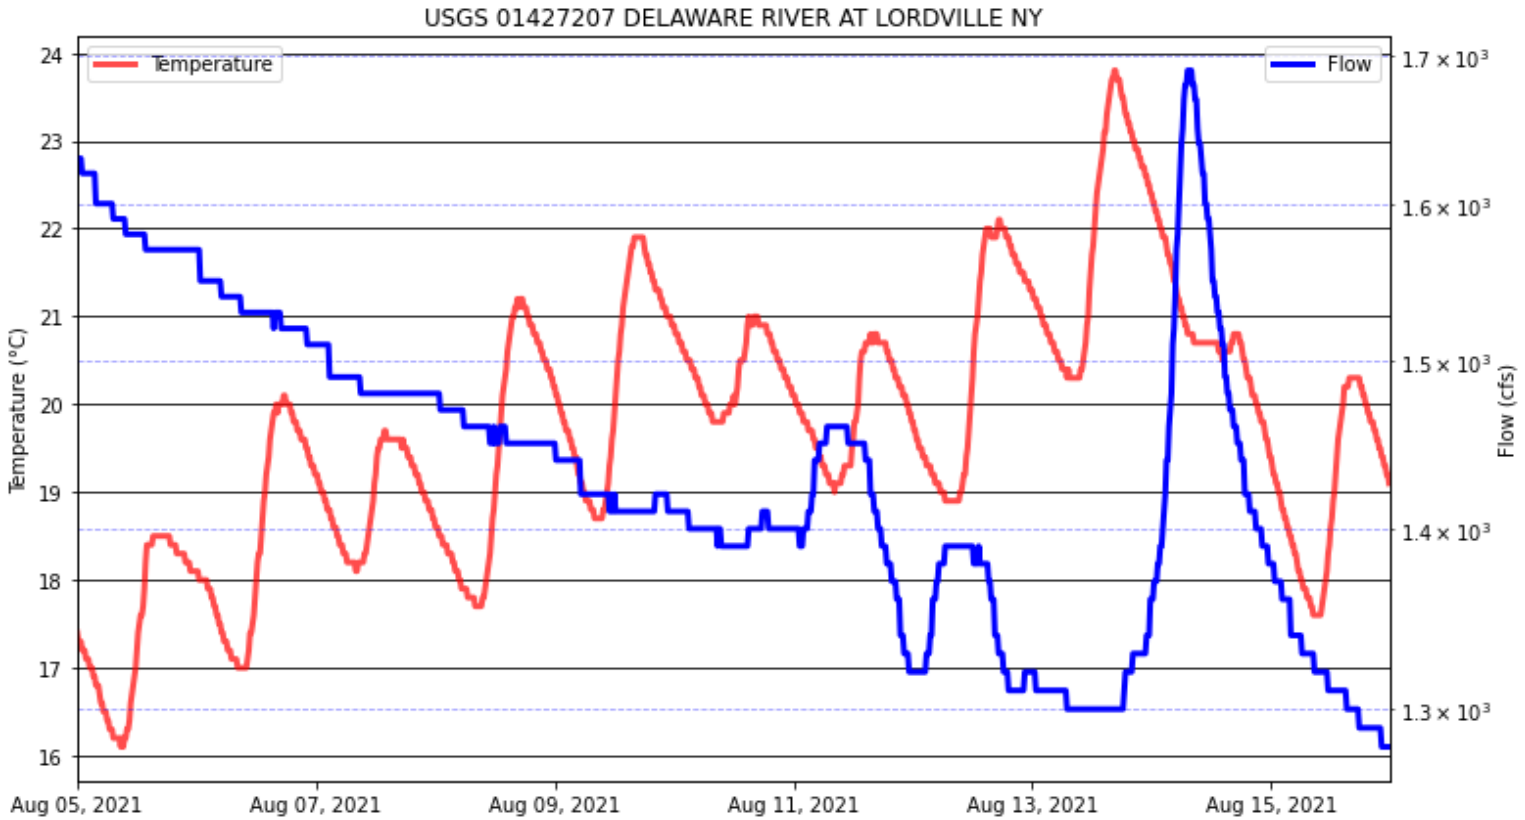
Figure 7: Temperature (red) and flow (blue) at USGS gage 01427207 (Delaware River at Lordville, N.Y.). During a stretch of warm water temperatures in mid-August, the maximum temperature did not surpass 24°C.

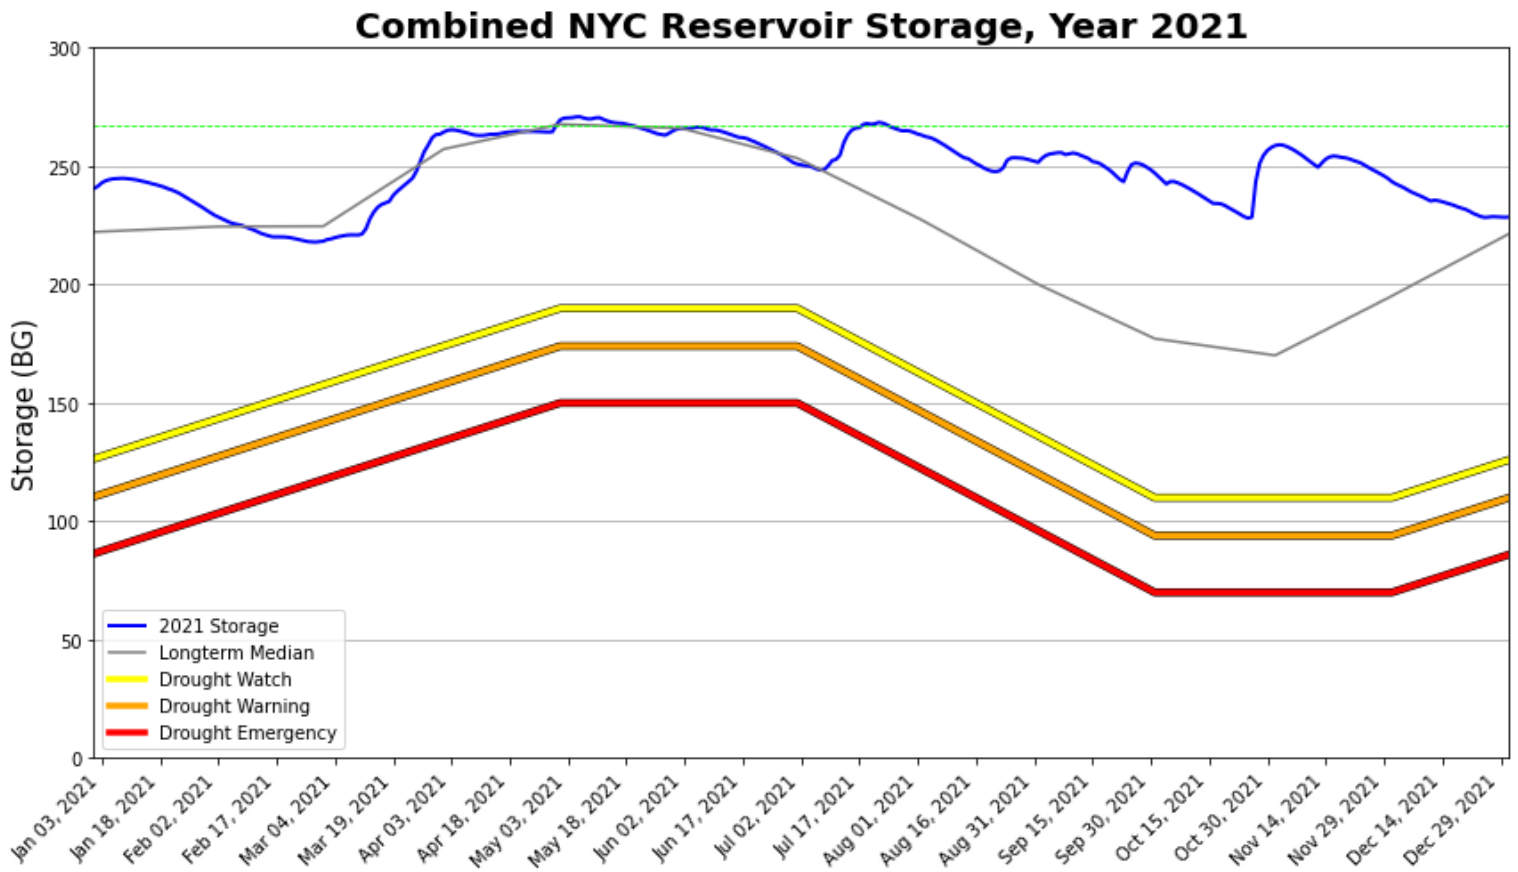
Figure 22: New York City combined reservoir storage.

The combined storage decreased, with a few temporary increases from the tropical storm events, through October. A strong storm at the end of the month caused the combined storage to increase from 228.1 BG to 259.1 BG, approximately 31 BG in one week. During this period, Neversink Reservoir spilled an additional 1.7 BG. Through November and December, the combined storage decreased. At the end of the calendar year, the combined storage was approximately 228.5 BG (85.4 percent).

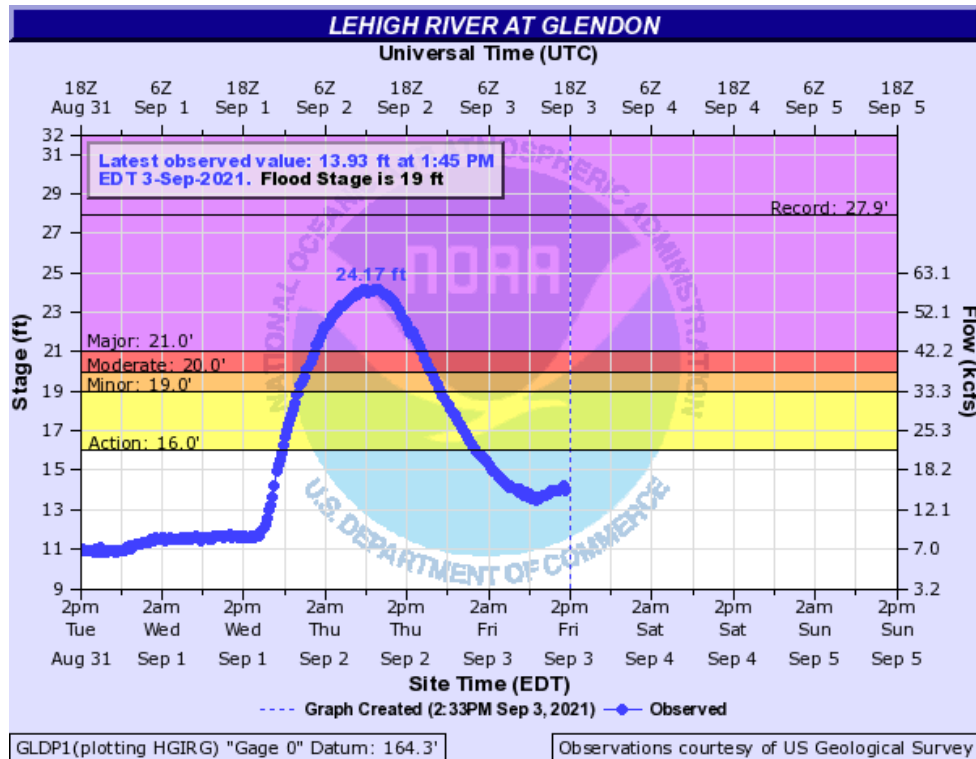
Lehigh River at Glendon, Major Flood Stage, Peak 24.17 feet.

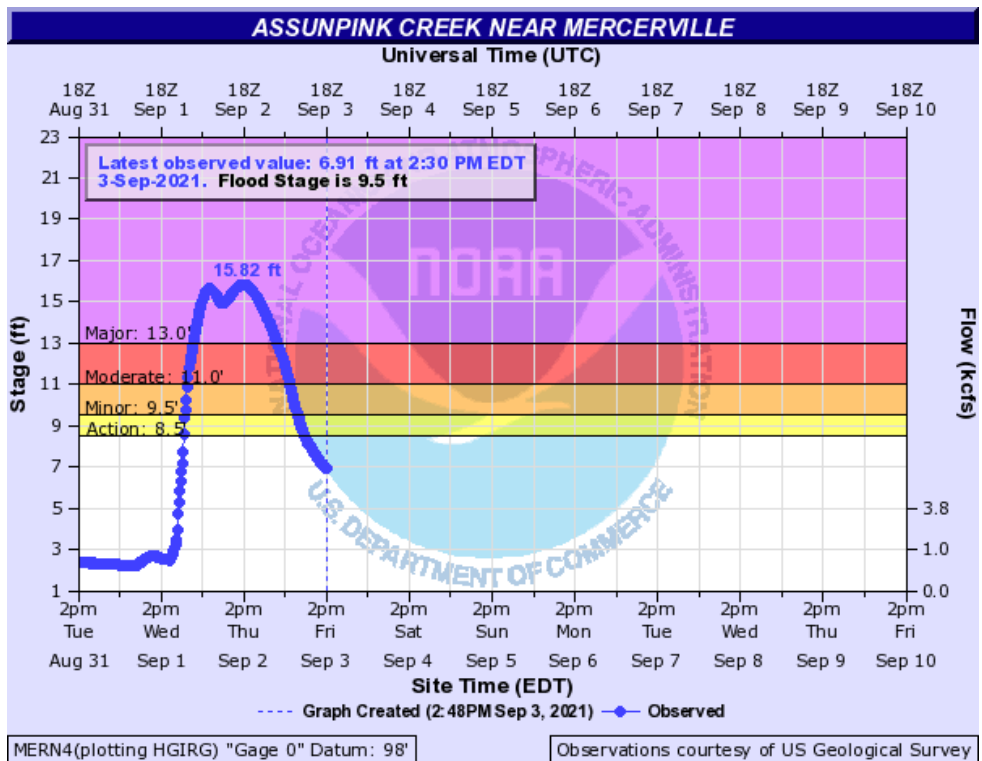
Assunpink Creek near Mercerville, Major Flood Stage, Peak 15.82 feet.

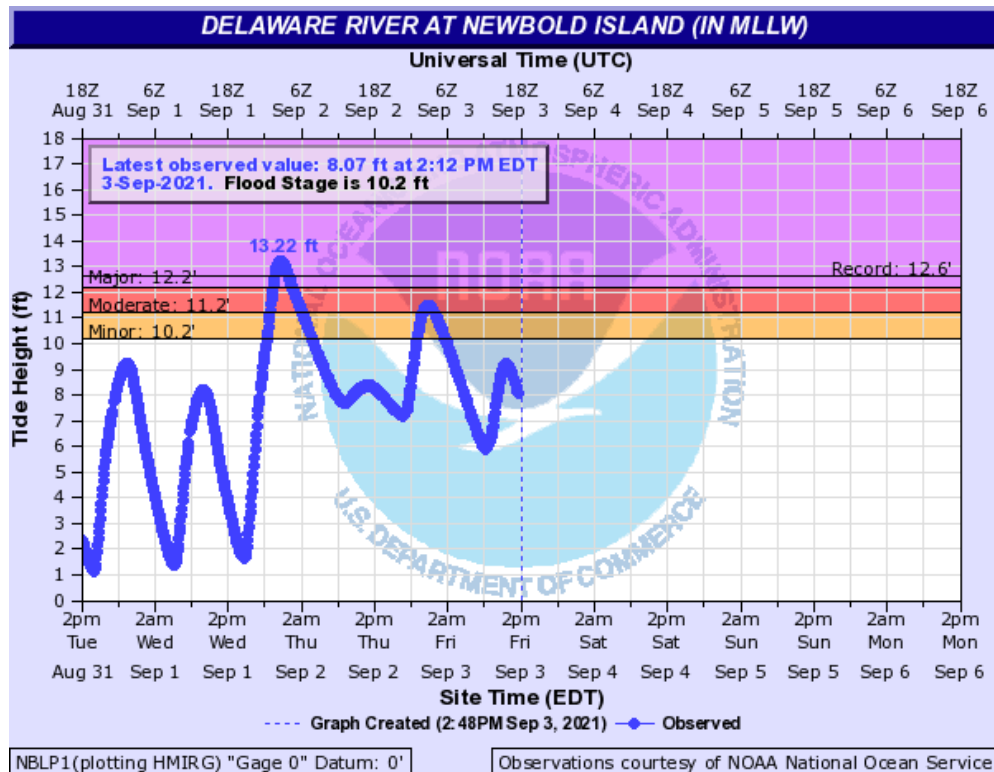
Delaware River at Newbold Island, Major Flood Stage, Peak 13.22 feet.
