Coastal Hazard Analysis and Mapping - Delaware River and Bay

Delaware River Basin Commission Flood Advisory Committee September 2012 Meeting

Risk Assessment, Mapping, and Planning
Partners (**RAMPP**)

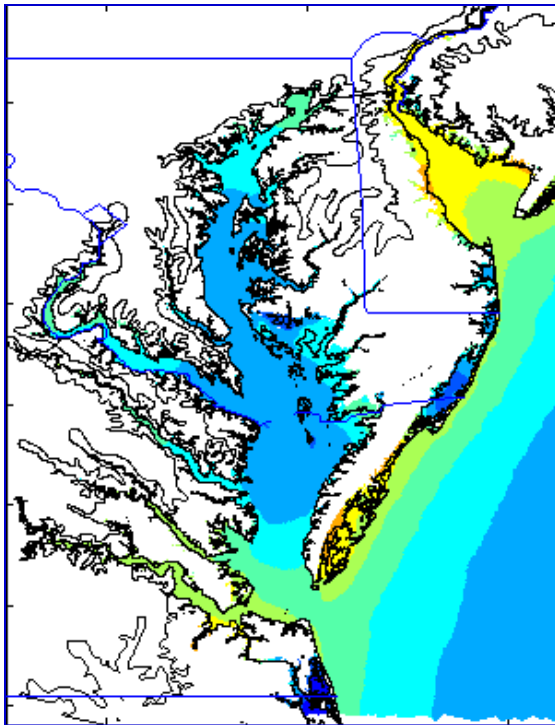
Hurricanes

Updated 1%-annual-chance water levels

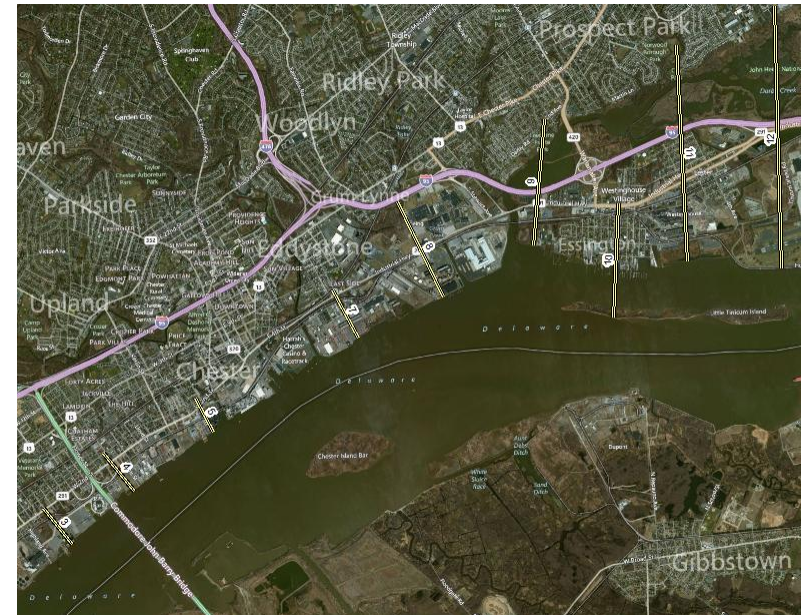
**Proposed Transect Layout for area
in Delaware, PA**

Transect Placement

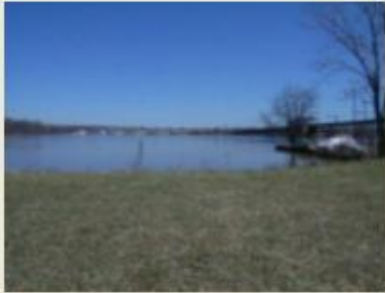
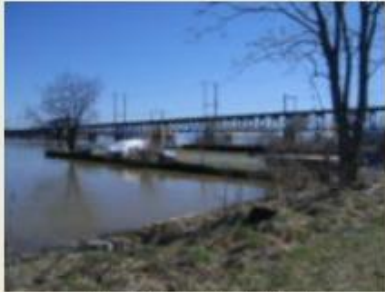
Location Havre de Grace, 600 block of water street, at transect location.

Coast Description Low-lying plateau, extending back towards road, where terrain begins rising. Open space at transect location, cluster of buildings: boat yard to

Structure Type seawall **Structure Material** concrete

Structure Description Concrete block seawall, approx 2 ft above water level, transitions to wooden bulkhead to S where shoreline orientation changes to NE. Likely

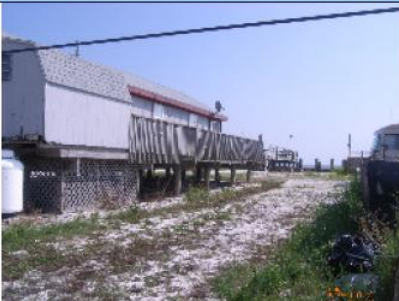
<p>Description: Residential houses by the coast Latitude, Longitude: N39.19376, W-75.01999 Direction: 180.9 degrees #0425</p>

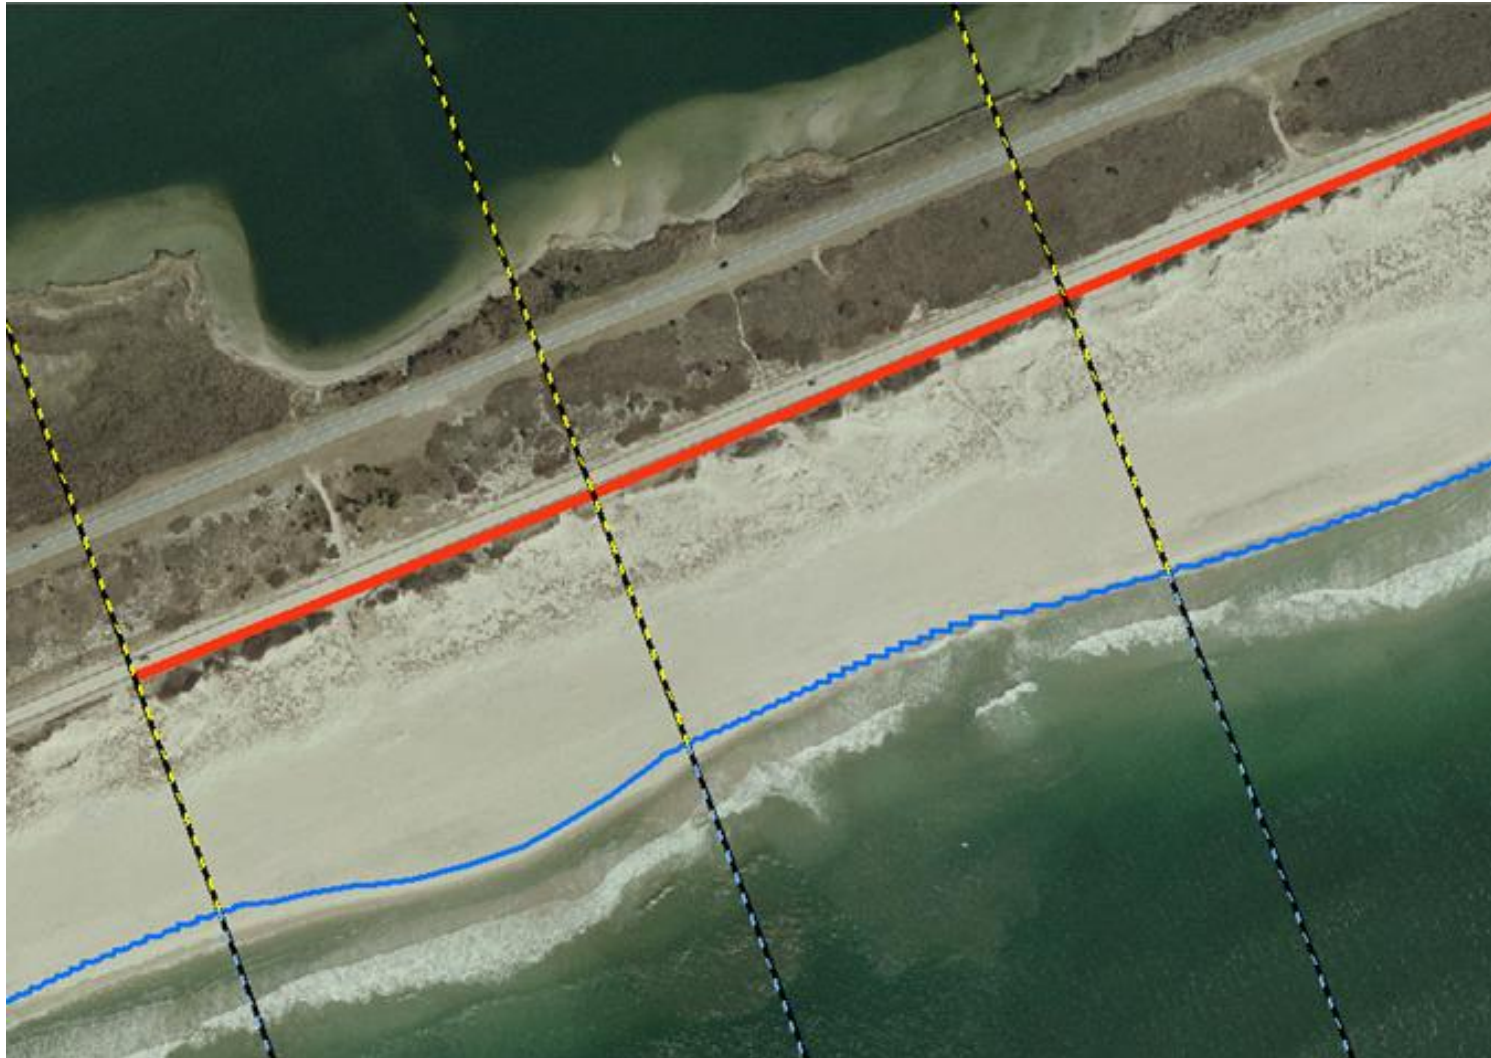
Primary Frontal Dune Line Drawn Based on Aerial Images, Topography and Information Obtained from Field Reconnaissance

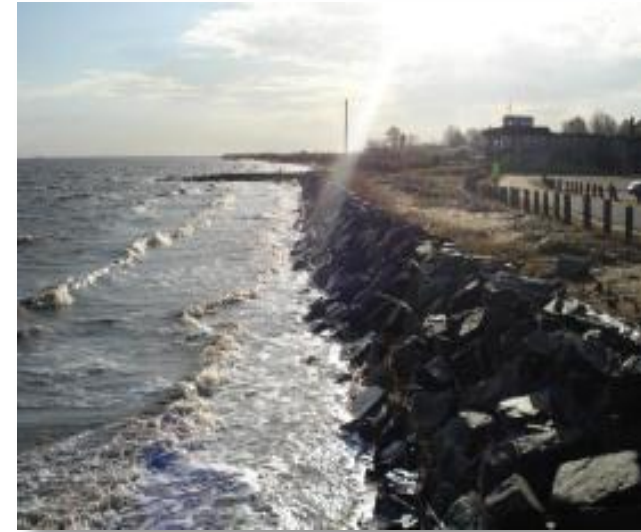
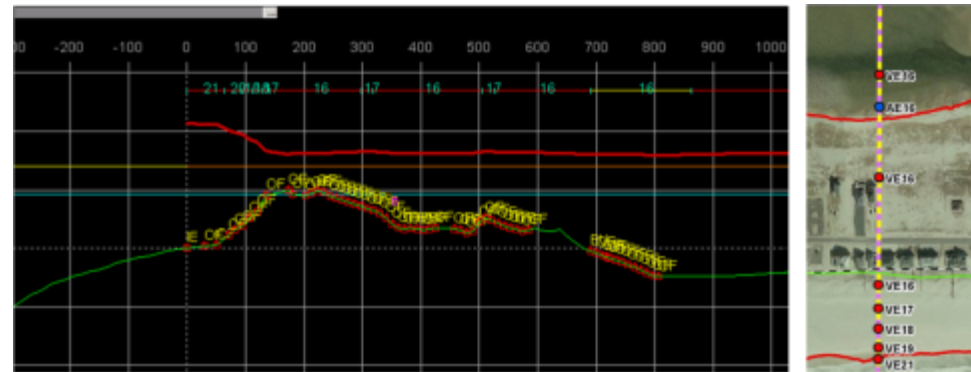
Overland Wave Height and Runup Analysis

- **Storm-induced erosion**
 - Primary dunes, bluffs
 - Shoreline protection structures
- **WHAFIS modeling**
 - Wave height above storm surge (stillwater) elevation
- **Wave runup analysis**
 - Sloped beaches, dunes, bluffs and cliffs
 - Runup 2.0, TAW, CSHORE
- **FEMA 2007 Guidelines and Specifications**

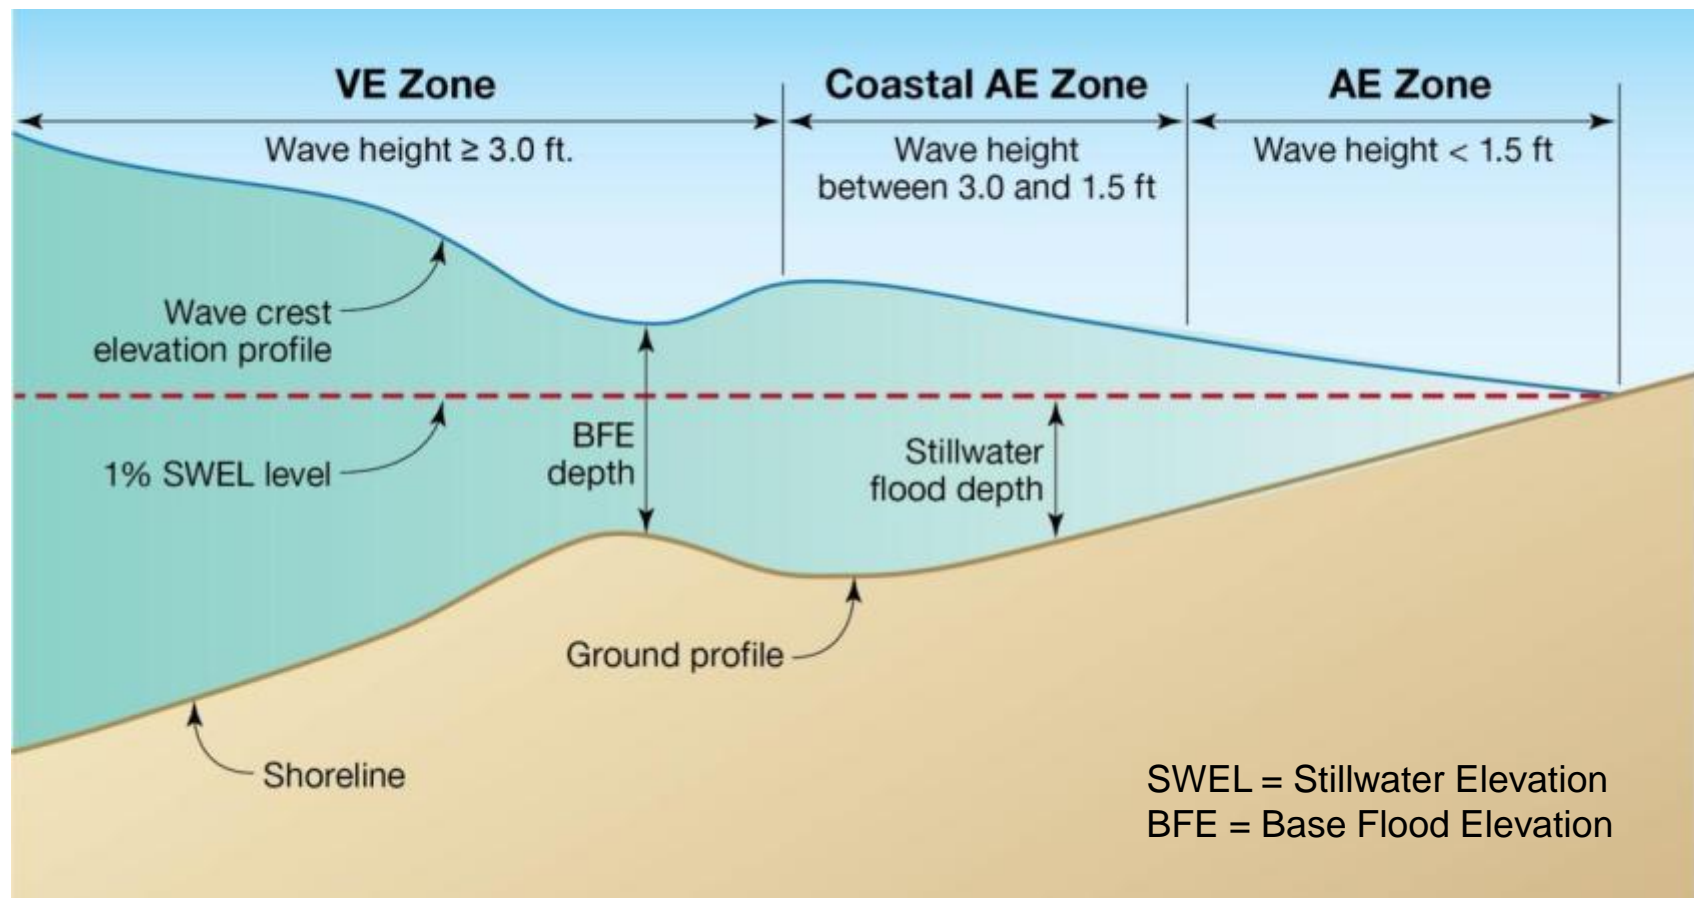
Limit of Moderate Wave Action (LiMWA)

- Defined by the area subject to wave action with waves greater than 1.5 feet in height
