NJ FACE INVESTIGATION REPORT

FACE 01-NJ-027

Warehouseman Crushed Between Two Rolls of Coiled Steel

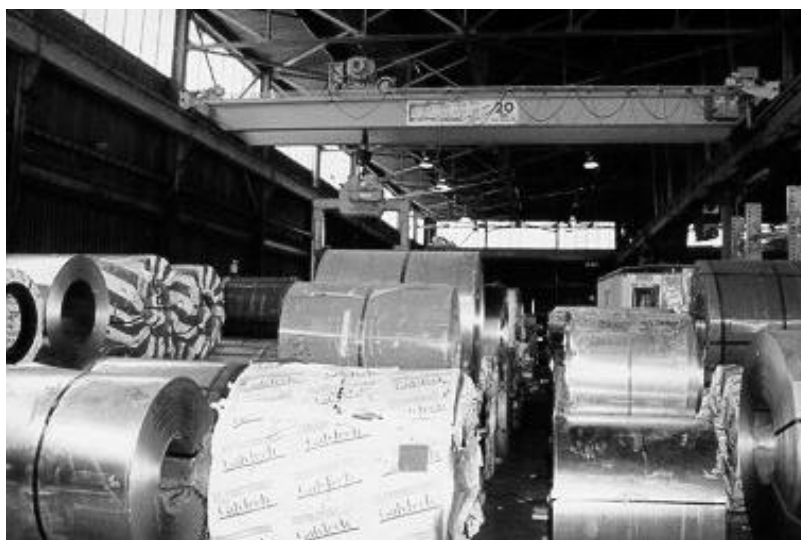
Photo 1

Production started with the delivery of coiled sheet steel that was trucked into the warehouse. Each coil varied in width, diameter, gauge, and weight, but all had a hole in the center to allow for the use of a lifting device to move the coil. Many of the coils were wrapped in plastic or coated with light oil to protect them from moisture. The coils were unloaded with a 20-ton capacity overhead hoist that traveled the length of the 28,000 square-foot warehouse. A worker operated the crane from the plant floor with a pendant controller and would walk with the crane as it moved across the warehouse. Once the crane was in position, the worker used a second pendant controller to operate a motorized two-sided coil lifter attached to the crane line. This lifter grabbed the coil from the sides using a device that hooked the coil horizontally through its center hole (see photo 1). All coils were handled and stored in the horizontal position. After unloading, the coils were placed in rows by the width of the coil. Each of the five 400 foot-long rows was stacked two to three high depending on the size of the coils, with each row separated by a narrow aisle measuring between 15 to 29 inches wide. To prevent the stacked coils from rolling apart, the two end coils in each row were chained together and chocked with 2-by-4 inch wood boards. When a coil was needed, a worker would bring the crane to the coil, lift it out of the row, and bring it down to the “level line” machine. This machine unrolled the coil, leveled out the residual bend of the coiled steel, and cut the steel into individual sheets. The sheets were stacked on pallets that were moved with the smaller two or six-ton capacity overhead cranes at the plant. The company cut seven to ten coils per day in two eight-hour shifts.

Interior of plant showing rows of coils and crane with coil lifting device

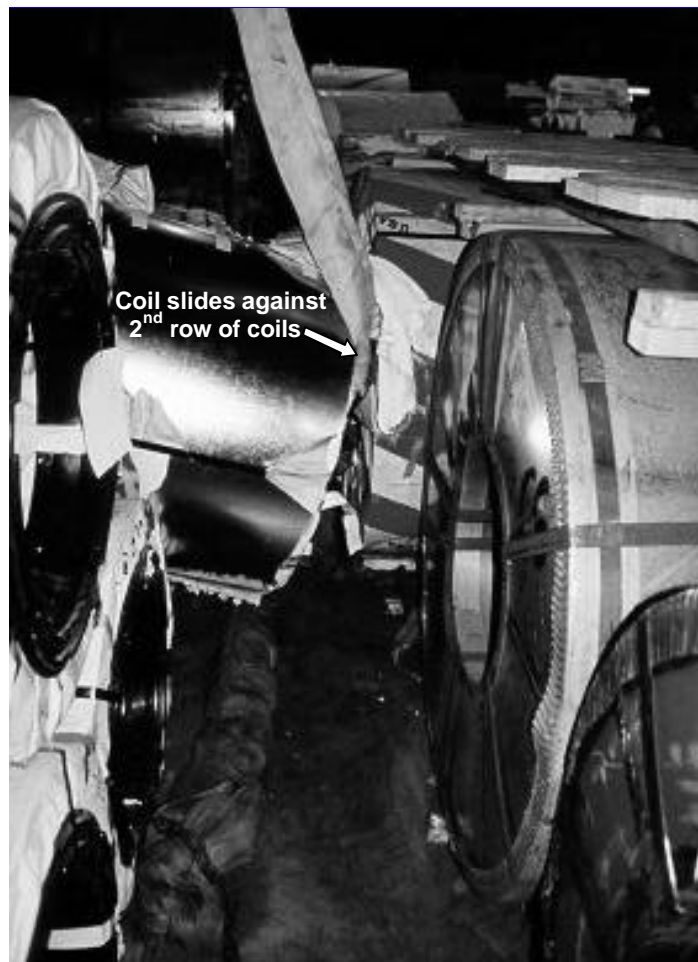
Photo 2

The incident occurred on the morning of Tuesday, March 20, 2001. On this day, the victim arrived for his usual work shift of 5:00 a.m. to 1:30 p.m. The early morning passed uneventfully as the victim “dug-out” coils and brought them to the level line machine. There were no witnesses to the incident. The victim was last seen shortly before 9:00 a.m. when he spoke briefly with a co-worker before returning to the crane. He was working in a 25-inch-wide aisle, facing a row of coils stacked three high and with his back to a row stacked two high. Circumstances suggest that he was operating the crane with the pendant controller to lift a coil from a row of coils that were wrapped in plastic. He had just lifted a coil when the neighboring stacked coils in the row shifted. A 10,150-pound coil apparently slipped into a space between the coils under it, causing it to slide off the row and against the victim who was standing in front of it. The coil struck him in the chest, crushing him against the row of coils behind him.

Position of coils following extrication of the victim

Discussion: It appears that the coil that crushed the victim slipped into a space between the two unchocked coils underneath it, causing it to slide off the row and against the victim. Witnesses state that this type of shifting occasionally occurred, especially with the more slippery plastic-covered coils. NJ FACE investigators recommend that the company develop a procedure for the safe storage of steel coils. The attached information sheet, *Safety Guidelines for the Stacking and Storage of Steel Coils*¹, gives basic instructions for safely storing and chocking coils. These recommendations include:

Recommendation #1: Employers should develop and implement a procedure for the stable storage of steel coils.

- Chocking each coil individually with wedge-shaped blocks,
- Arranging the bottom coils so there is no space between them,
- Never stacking larger, heavier coils on top of smaller coils.

The second attached publication from *SafetyLine Online*² gives a design for a steel "cradle" that supports the coil as it rests on the floor and allows a forklift to pick up and move the coil. It should be noted that the company and now uses similar wooden cradles and has adopted some of the Australian safety practices for handling steel coils.
