INVESTIGATION REPORT

Fatality Assessment & Control Evaluation Project

FACE 03-NJ-100

DPW Employee Dies After Falling Off The Trailer Hitch of a Leaf Vacuum

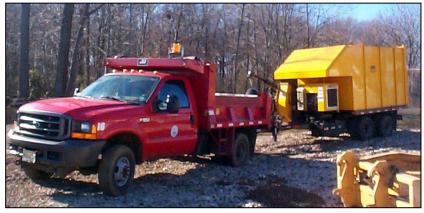
Photo 2
Identical leaf vacuum and pickup truck

The leaf vacuums were large, trailermounted machines that were towed by a
township dump truck. The vacuum
consisted of a large, box-like metal container
to hold the leaves, a diesel engine attached to
a vacuum impeller (rotor blade that creates
the vacuum), and a large rubber hose used to
vacuum the leaves. The model involved in

An 85-horsepower, water-cooled, diesel engine drove a six-blade, 32-inch diameter impeller that moved 22,000 cubic feet of air per minute. A 16-inch-diameter, 8.3-foot-long reinforced rubber suction hose was mounted on a swinging boom, which supported the weight of the hose to make it easier for the operator to position. The trailer was hitched to the tow vehicle with an approximately 8-foot-long towing hitch (tounge). A hydraulic lift at the base of the machine tipped the container backward for dumping.

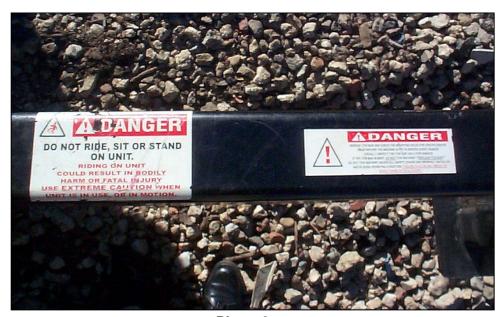
Photo 3
Warning labels on identical trailer

- The driver involved in the incident was driving with an expired license. (Police)
- The leaf vacuum was not registered with the NJ Department of Motor Vehicles. (Police)
- The leaf vacuum trailer had a number of maintenance defects, including inoperative brakes, an inoperative trailer break-away device (which activates the brakes if the trailer detaches), under-inflated and flat tires, and burned-out signal lights. (Police)
- An unauthorized retrofit was made by welding a piece of steel diamond-plate onto the trailer hitch as a seat. A manufacturer's warning label stating not to ride on the tongue had been removed. (NJDLWD)

<u>Leaf vacuum and trailer</u>: The report stated that the trailer that the victim fell from was improperly equipped with a diamond-plate "seat" and was lacking the required warning stickers. This was incorrect. The trailer that the victim was riding on was not equipped with a seat and did have the required warning stickers. The DPW's second leaf vacuum and trailer had these modifications. This error was due to confusion in reading the serial numbers that identified the two units.
