# NJ FACE INVESTIGATION REPORT

FACE 09-NJ-099

## Hispanic Construction Worker Wearing Fall Protection Dies after Falling 40 Feet from Roof

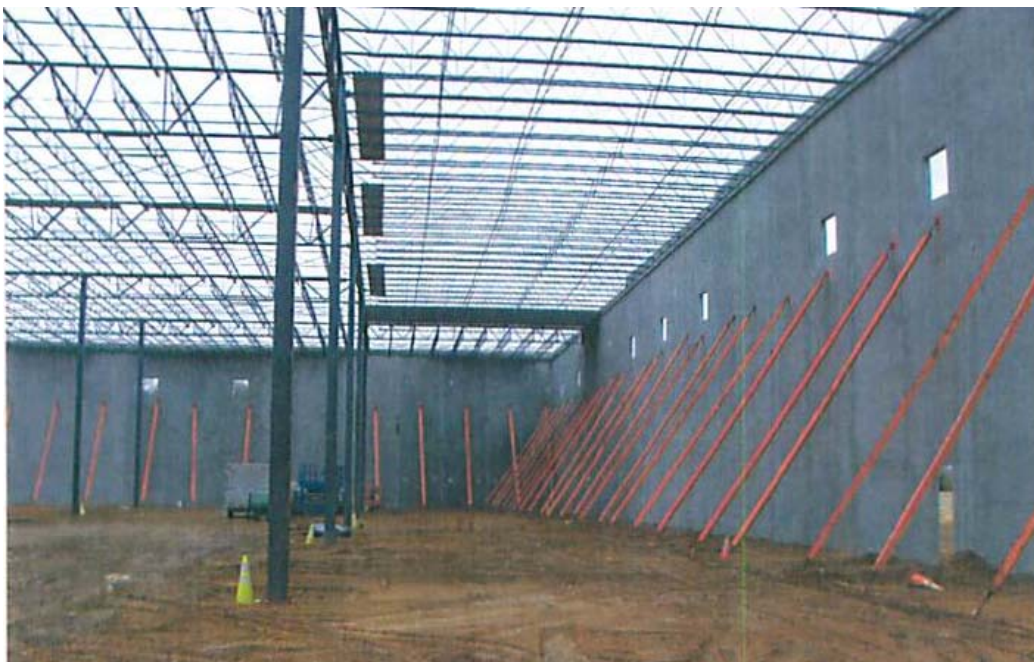
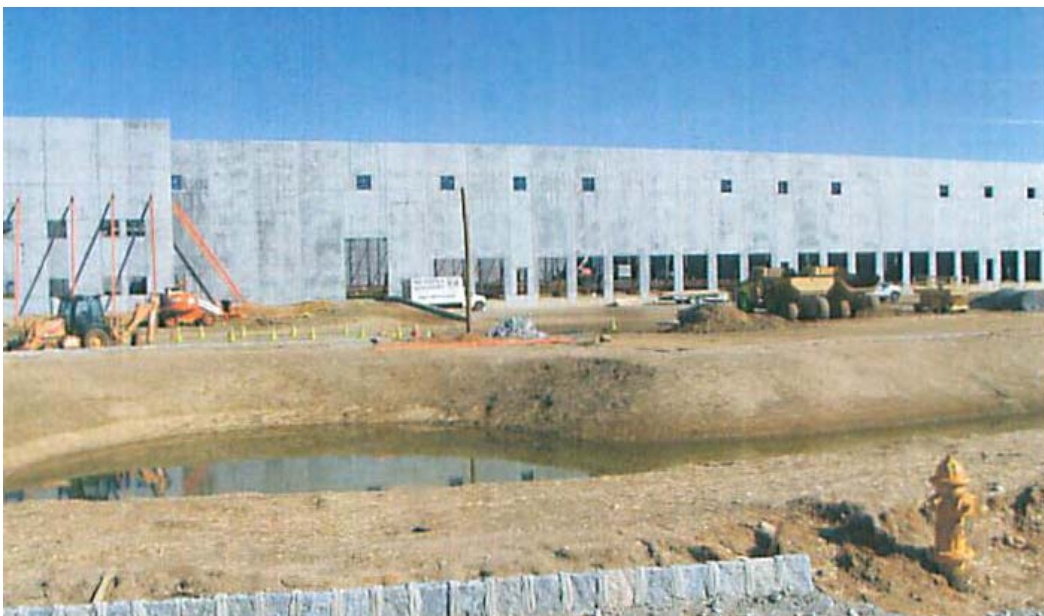
**FIGURE 1. Incident site; inside and outside views of construction site.**

The incident occurred on a clear, cold February day (approximately 32°F at the time of the incident). A light covering of snow remained on the ground from a snowstorm that occurred a few weeks prior; the average wind speed for the day was 5 mph (NW), with a maximum of 13 mph. The incident occurred at the construction site of a large distribution warehouse. The concrete walls and metal roof truss had been completed (see Figure 1). On the morning of the incident, the metal corrugated roof decking was being installed over the metal roof truss. Two workers were on the roof and were working in tandem to lay the roof decking.

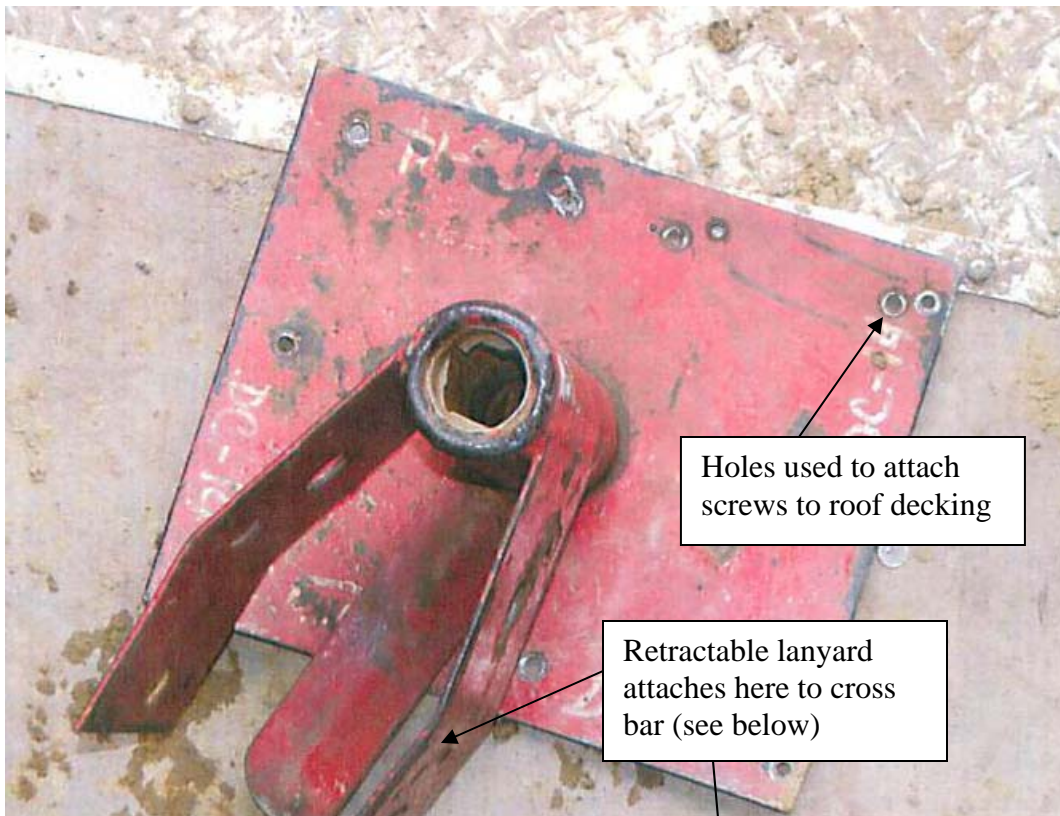
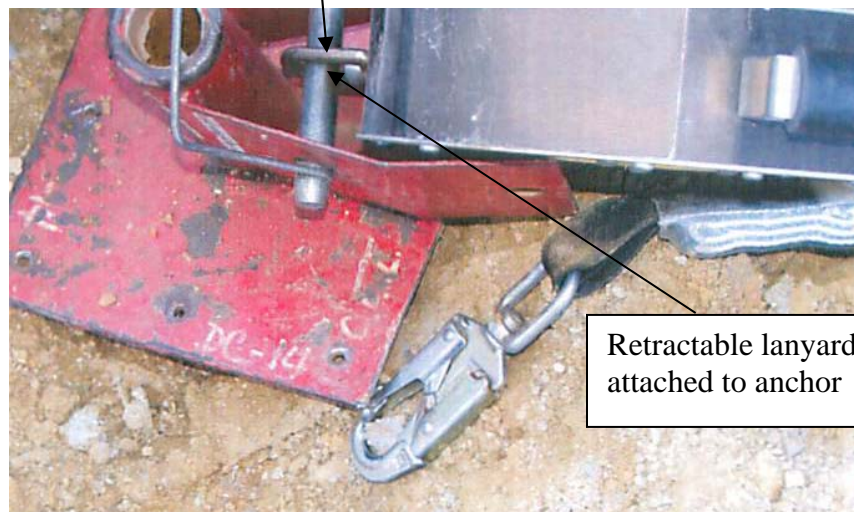
Worker # 1 (the deceased) was at the leading edge position and wore a retractable lanyard clipped into a 12" x 10" metal roof anchor device or anchor plate. The plate has 5" x 9.5" metal attachments that are affixed to an 8" stem in the plate (see Figure 2). At the end of the attachments is a crossbar, to which the retractable lanyard is clipped. It was noted that this clip and the clip point was undamaged and remained connected throughout the incident (i.e., the retractable lanyard device remained connected to the anchor). In addition, the folded fabric portion of retractable lanyard had its plastic covering and stitching still in-tact. The anchor plate was attached directly to the leading corrugated decking sheet, approximately 18" from the edge. A standard drill was used to attach the anchor plate with ¾" (thread length) screws. According to the manufacturer's instructions, installation of the plate requires 1" [hex washer self-drilling] screws. As determined by OSHA, the employer and employees were under the impression that the screws they used were appropriate because they were 1" in overall length. Worker #2 also wore a retractable lanyard, but his fall arrest system was attached to a beam clamp (Figure 3) and was not exposed to the leading edge hazard.

**FIGURE 2: Anchor device used by the victim.**

**Recommendation #1: Utilize the appropriate type of anchor plate when installing corrugated roof decking.**

According to the manufacturer, the type of anchor used in the incident was intended for use on flat metal roofs and would not adequately arrest a fall if attached to a corrugated roof. The employer was using the manufacturers' directions for a slightly different anchor plate, one that was smaller and meant for flat surfaces.

**Recommendation #2: Anchor plate screws should conform to manufacturer's specifications, including type and length of threading.**

The employee who installed the anchor plate confirmed that screws that were found at the scene were those that he had used during installation. The threaded portions of the screws were  $\frac{3}{4}$ " in length (with an overall length of 1"). However, the instructions specify that the screw thread should be 1" in length. According to an OSHA interview with the worker who installed the plate, he was under the impression that what they were using was correct since it was 1" in overall length. The extra threading allows for additional turns into the roof deck and truss and would have provided additional strength to the plate.

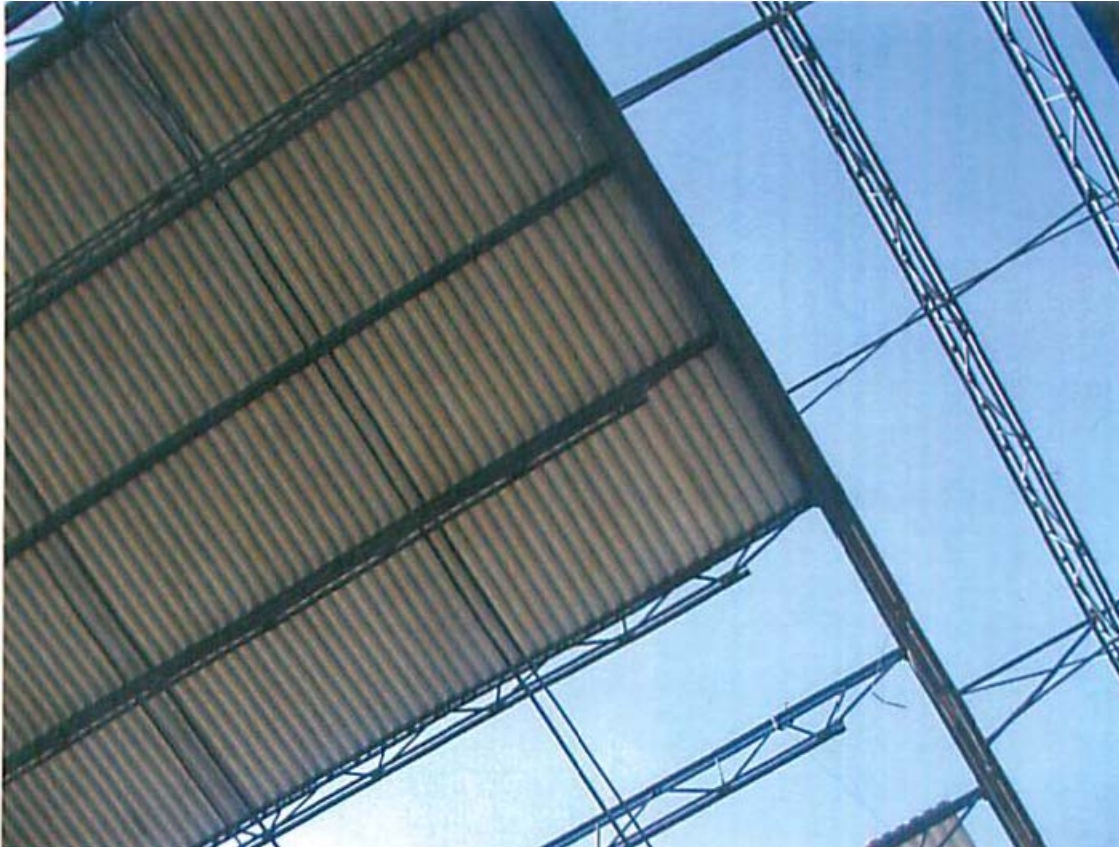
The employer's protocol for laying corrugated roofing materials requires that the leading edge of the decking not be secured until the next sheet was in place. Each metal sheet was fastened on the following end and anywhere else it was supported by a truss. The next sheet was then placed over the leading edge and attached with fasteners. This was continued until the roof was complete. On the day of the incident, for an unknown reason, the worker fell from the leading edge. When the worker fell and his retractable lanyard reached the end, the anchor plate was pulled completely out of the decking, allowing the worker to fall 40 feet to the ground.

**FIGURE 3. View from underneath the roof decking where the victim fell.**

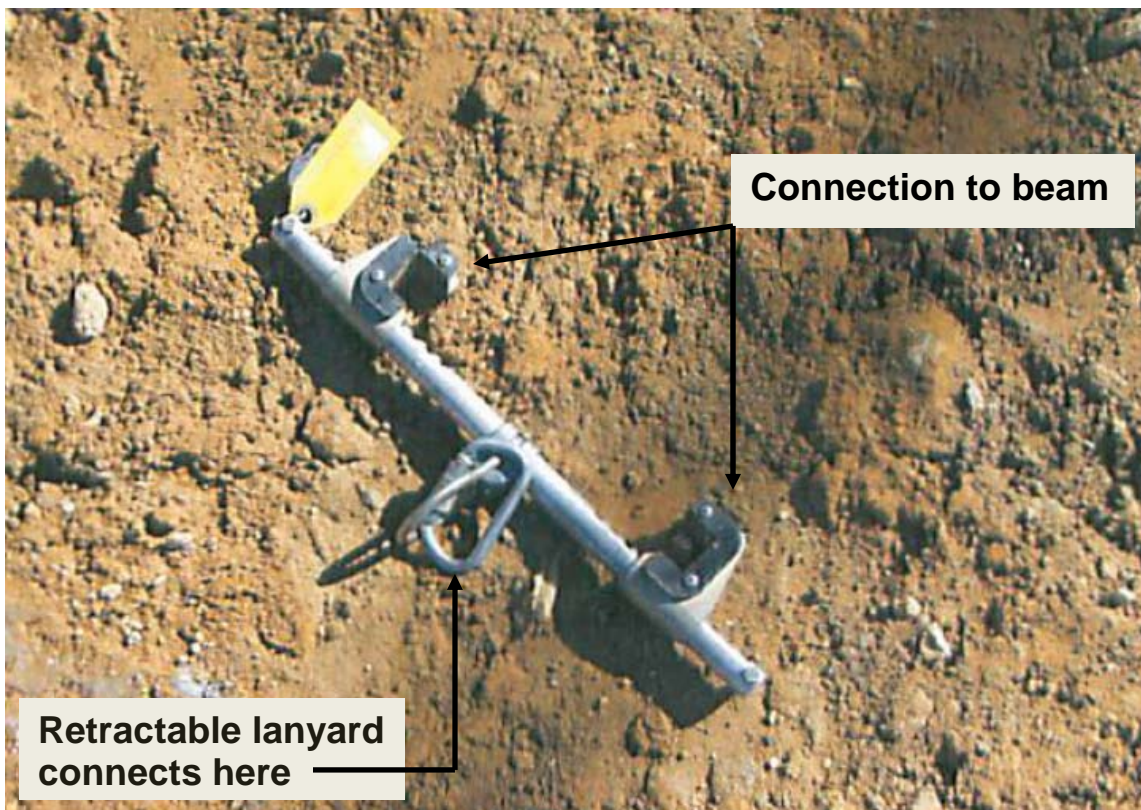
**FIGURE 3. Beam clamp to which Worker #2 was secured.**

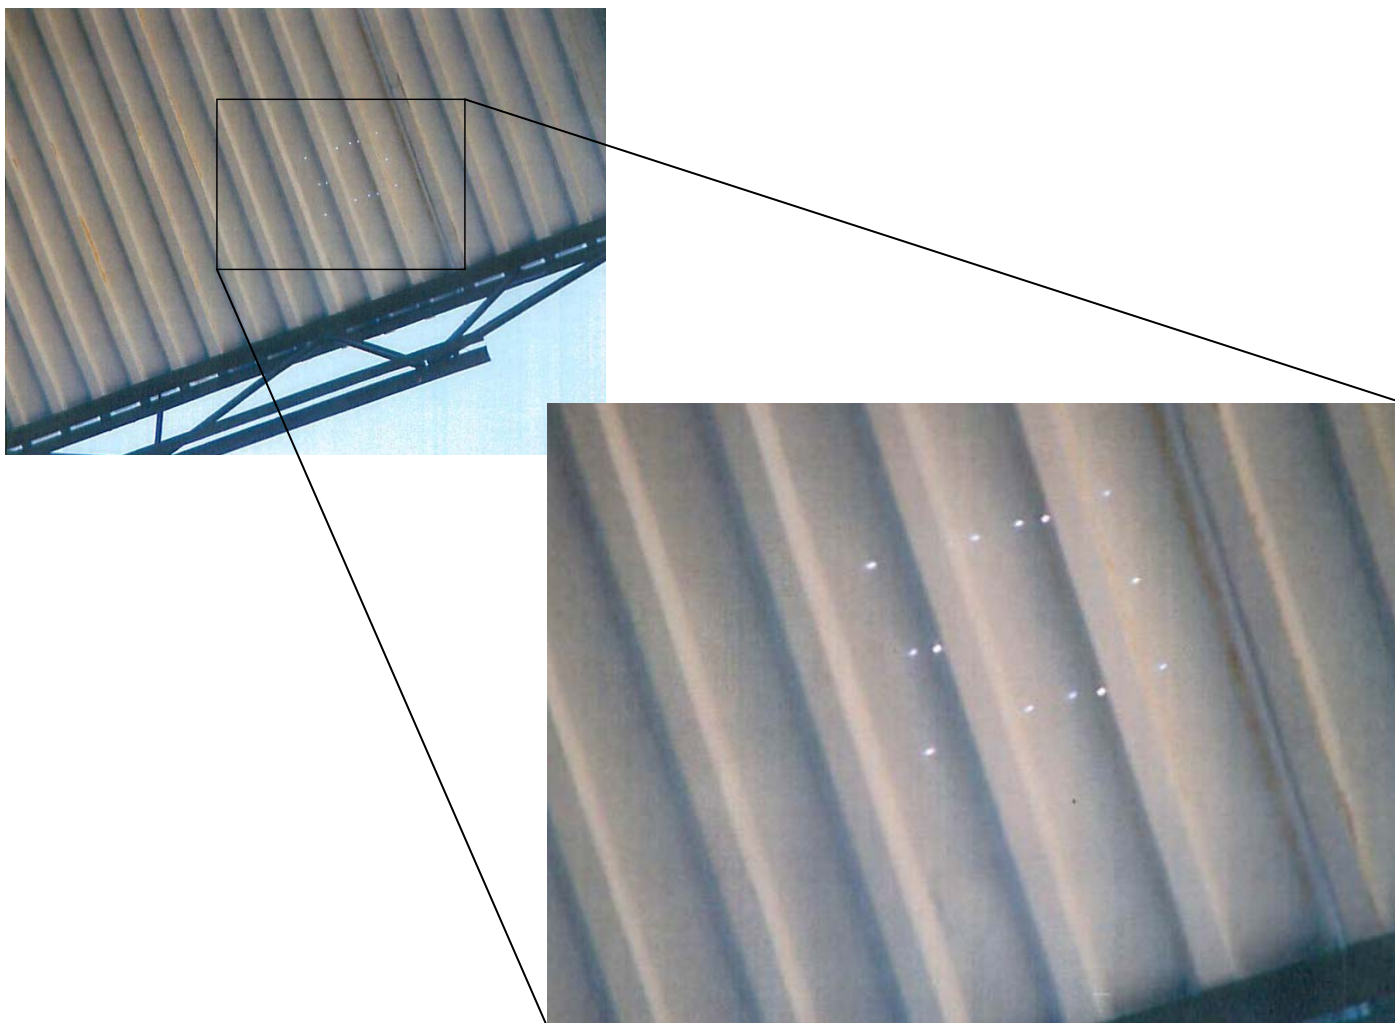
**FIGURE 4. Close up view of roof decking to show where anchor plate was installed.**

In this case, the anchor plate was located on the unsecured, leading edge of the roof installation. Therefore, when the worker fell from the edge that was not secured to the truss, an upward force was exerted on the anchor plate, forcing the screws out of the plate. NJ FACE recommends that all employees working near an unsecured piece of roofing near a roof edge should be anchored via beam clamp (see Figure 3). This type of personal fall-arrest system would conform with CFR 1926 502(d), which states that a fall protection device should be able to support up to 5,000 lbs.

**Recommendation #3: While installing roof decking, the anchor of the fall protection system should not be affixed to an unsecured leading edge.**
