Fatality Assessment & Control Evaluation Project

FACE 14-NJ-08

Plant Manager Crushed to Death Under Fallen Pile of Steel Beams

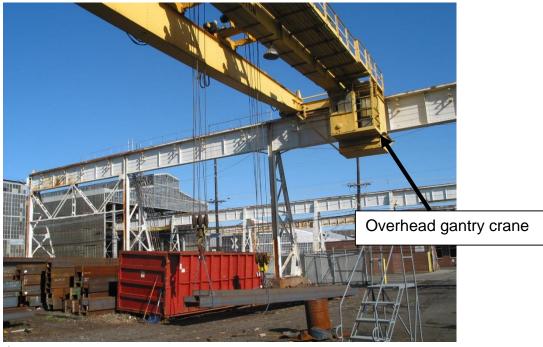
The incident occurred on a calm, dry, spring day (approximately 32° F at the time of the incident, wind speed up to seven mph), with no significant precipitation recorded. The incident site was located in the yard of the 1,000,000ft² processing and distribution warehouse (Figure 1).

FIGURE 1. Incident site, the yard of a steel beam warehousing facility: a) gantry crane; b) stacked beams.

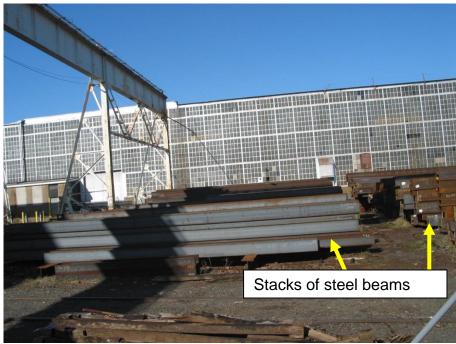
a)

b)

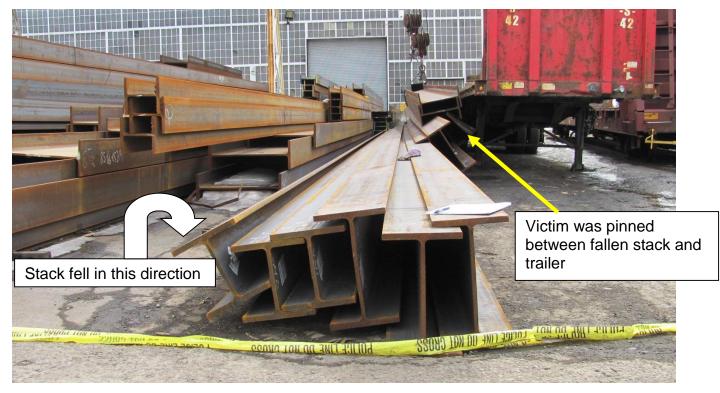
FIGURE 3. Scene of incident.

piled them on wooden dunnage (dunnage is used to prop up a pile in order to get chains on/off for connection to gantry crane). Figure 2 is a re-creation of this pile. As the victim was walking between the pile of steel beams and a tractor trailer flat bed, the pile toppled over, pinning him underneath (Figure 3). Paramedics were called and the victim was pronounced dead at the scene shortly afterwards.

- Unstable, unsecured stacking of beams
- Excessive amount of material stacked in yard instead of staging area

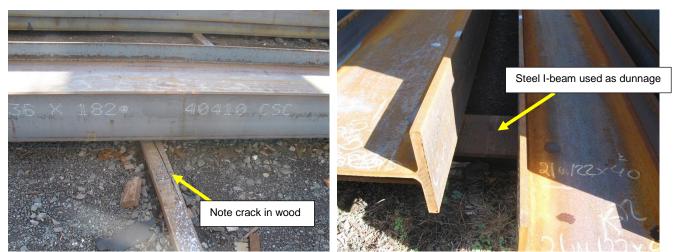
FIGURE 6a-b. Examples of different dunnage materials. a. wood; b. steel.

a. Wooden dunnage

b. Steel dunnage

Discussion: As per 29 CFR 1910.176(b), when storing materials (such as steel beams) in tiers, the materials should be stacked, blocked, interlocked, and limited in height in such a way that the stack is stable.¹ With respect to steel beams, this can be accomplished in several ways. Figure 4 illustrates recommended practices for stacking beams; they should be horizontal, with the widest beams at the bottom, shorter beams on top of longer beams. In addition, the stack should be centered; Figure 5 shows a centered stack of steel beams. In this incident, the beams were stacked with the narrowest at the bottom (see Figure 2), and not centered. In addition, NJ FACE recommends the use of steel dunnage rather than wood (Figure 6a-b).
