F.A.C.E.
INVESTIGATION REPORT
Fatality Assessment and Control
Evaluation Project

FACE #97-NJ-022-01
Marina Worker Drowns After Falling Into Water

SUBJECT: Face Investigation #97-NJ-022-01
Marina Worker Drowns After Falling Into Water

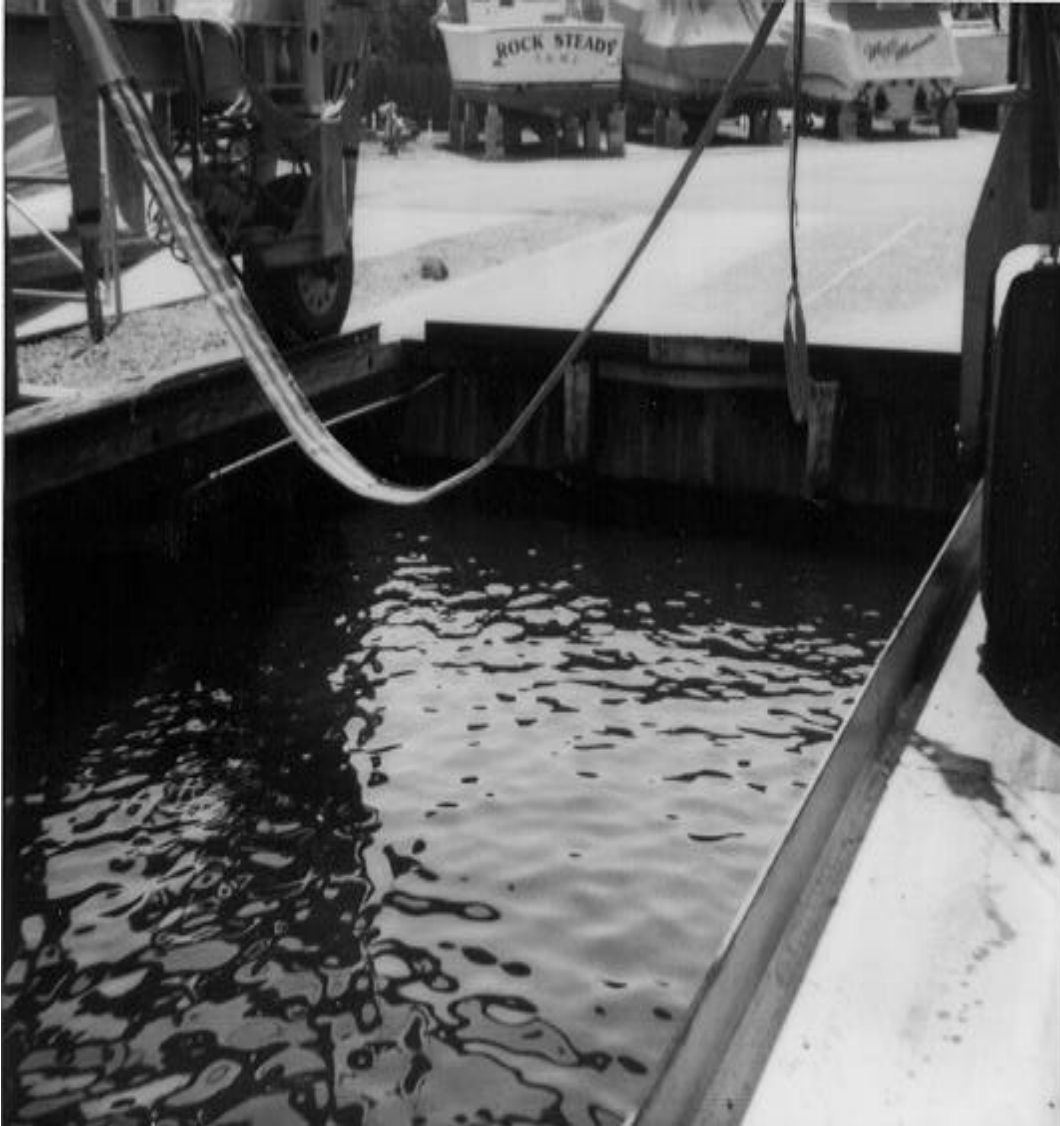
Photograph #1
View of Travel Lift Dock Area

The incident occurred at the marina that was on a bay leading to the ocean. The marina provided basic boat maintenance and repair services and was equipped with docks and slips for docking small craft. Boats were also stored out of the water on blocks and trailers in a nearby storage area. To remove the boats from the water, the marina used a travel-lift, a large machine designed to lift a boat from a large slip. This slip measured 40 feet long by 17 feet wide by 6 feet deep, with the water measuring 3 ½ feet deep at the time of the incident. To accommodate the travel-lift machine, the slip was built into the asphalt parking lot and boat storage area.

There were no witnesses to the incident. The victim was last seen around noon working in the travel-lift slip on a floating dock, a flat five by nine-foot pontoon raft. The travel-lift machine was not in the area and not involved in the incident. At about 1:30 p.m., someone noticed that the victim was missing and asked where he was. Two customers then found him floating in the water in the travel lift slip. One customer, who was a police officer for a neighboring town, started cardio-pulmonary resuscitation (CPR) immediately after the victim was pulled from the water. CPR was continued by arriving police and rescue units who transported the victim to the local hospital. He was pronounced dead at the hospital at 2:30 p.m.

It is not known how the victim fell into the water, although it appears that he fell directly from the floating dock or slip. Investigations by the county medical examiner and federal OSHA concluded that the victim's heart condition and seizure disorder contributed to this incident.
