# NJ FACE INVESTIGATION REPORT

FACE 13-NJ-015

## **Laborer Dies after Falling Through 40-Foot High Roof of Recycling Facility**

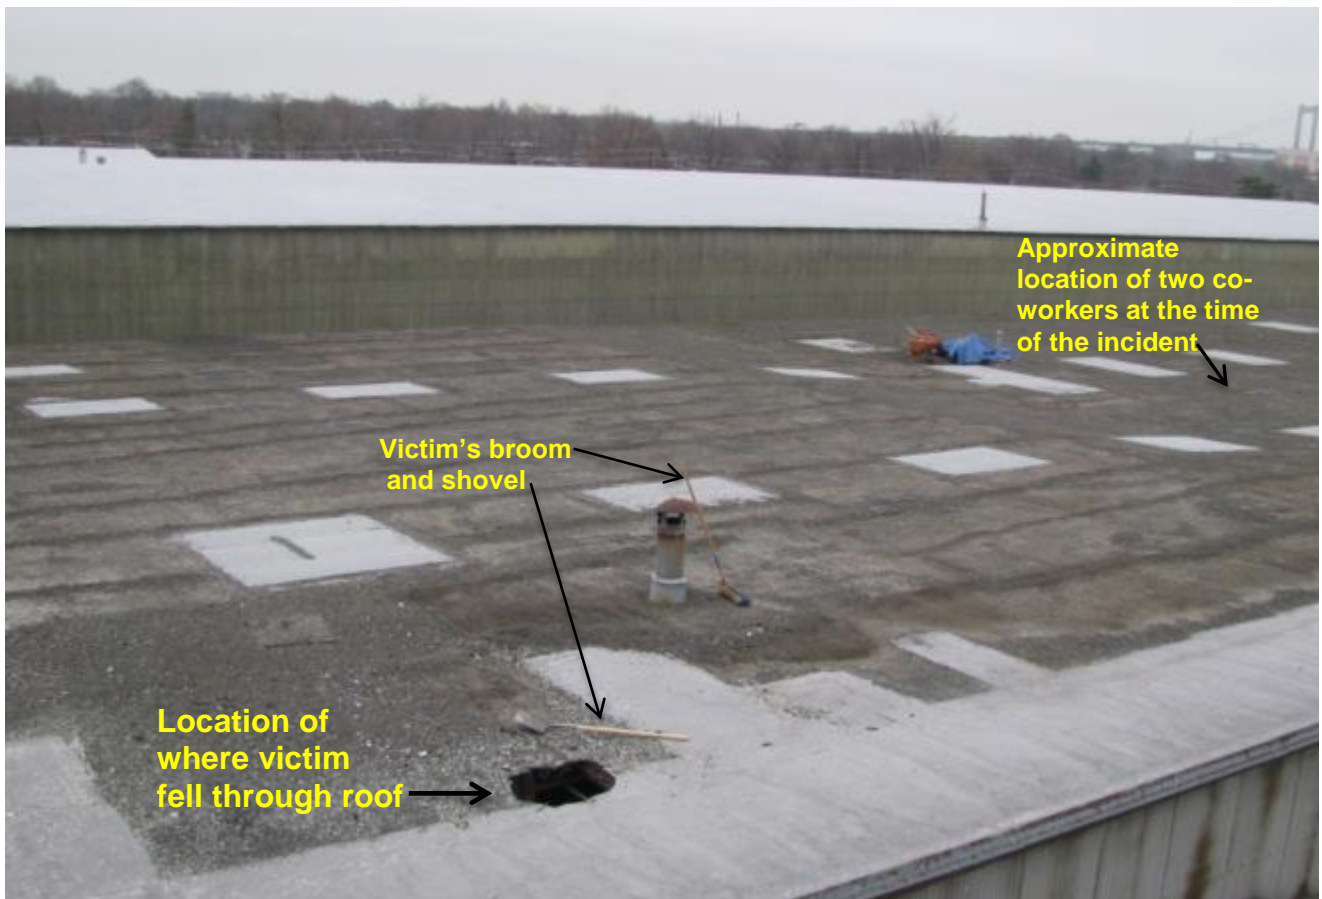
**FIGURE 2. Scene at time of incident with location of where victim fell through the roof.**

Articulating boom aerial lift (on ground)

Dumpster (on ground)

At the time of the incident, the decedent and two co-workers had split into two groups, with the decedent working about 250-feet away from the other workers (Figure 2). The stones were swept into lines, and then shoveled into wheelbarrows which, when filled, were brought to the edge of the roof and dumped

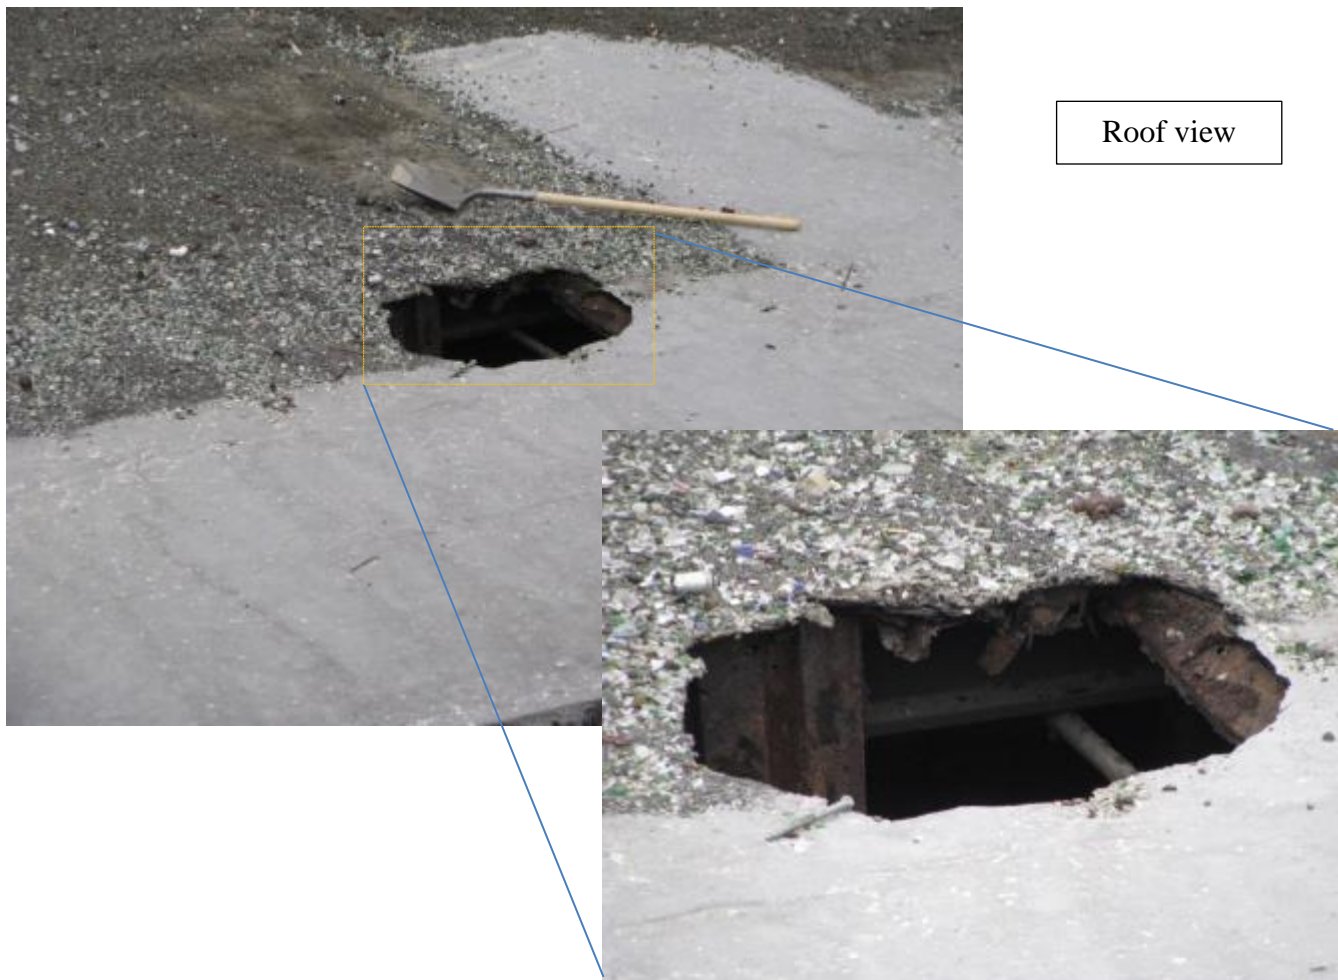
**FIGURE 3. Close up of roof where victim fell.**

**Discussion:** According to OSHA's fall protection standard (29 CFR 1926.501), any walking or working surface should be structurally sound, and employees should only be allowed to walk/work on surfaces that can support their weight.<sup>1</sup> In this case, the roof where the workers were clearing stones had areas where the steel decking had rusted/deteriorated. A thorough inspection of the roof from the inside may have revealed the issues with the underlying metal roof deck. The damaged areas may only be detectable through visual inspection from the inside of the building. In addition, water invading through deterioration at specific points can travel across beams/joists and drip to the ground in different locations. NJ FACE recommends developing a roof inspection checklist, and/or hiring a roofing expert to conduct a thorough investigation. An example of a roof inspection checklist can be found at the following: <http://www.gcr1.com/fpc/checklist.pdf>.

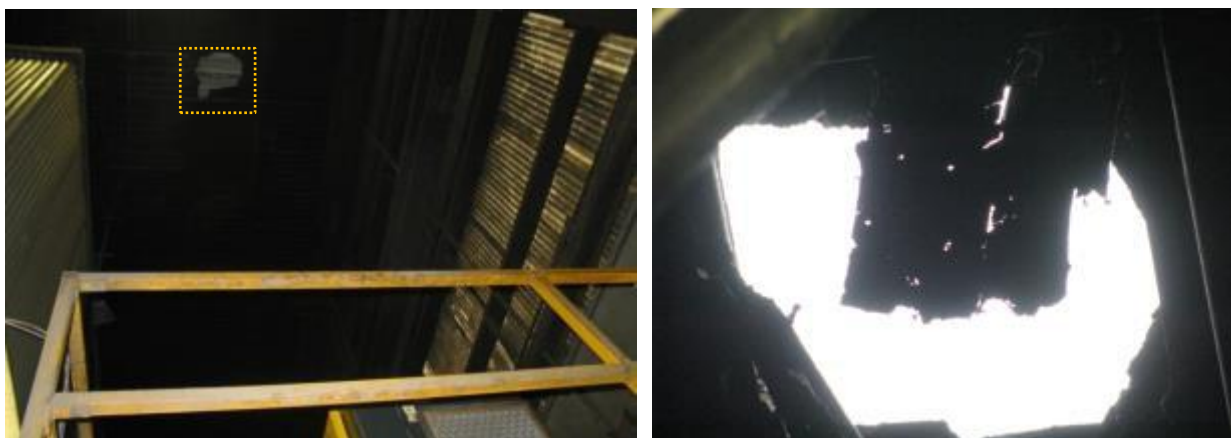
**FIGURE 4. Pictures from inside plant, underneath where victim fell (left: hole had been repaired since the incident; right: close up of hole on day of incident).**
