# NJ FOIS INVESTIGATION REPORT

FOIS 15-NJ-022

## Stagehand Falls To His Death While Dismantling Temporary Seating System

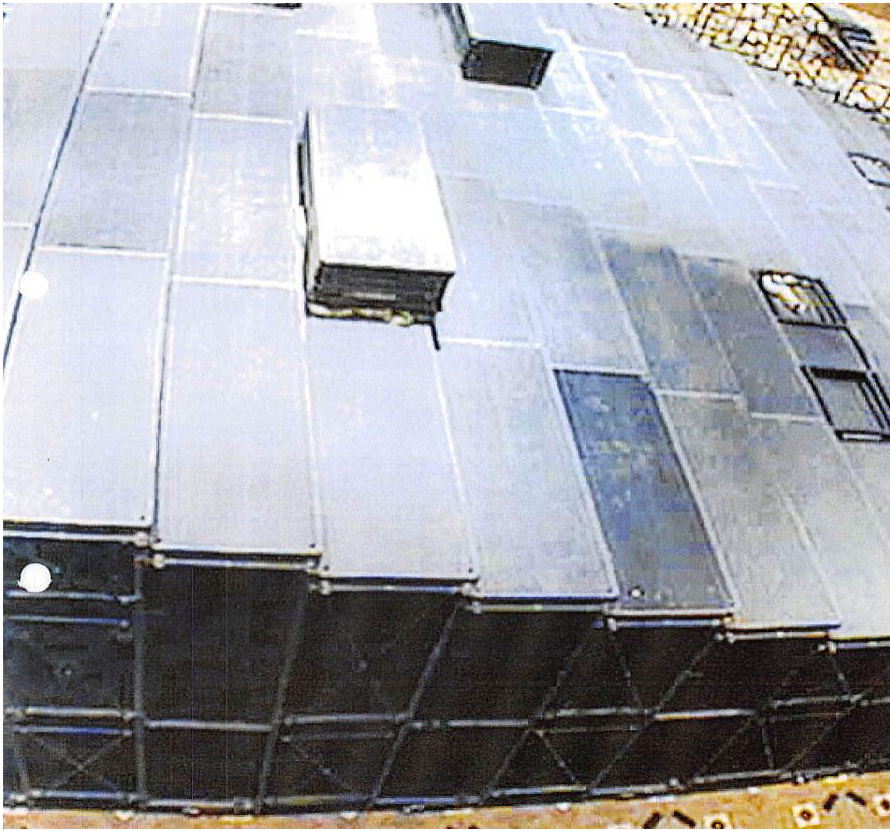
**FIGURE 1. Incident site, top view of multi-level seating system in auditorium.**

The incident occurred in the auditorium (approximately 31,000 ft<sup>2</sup>) of an entertainment facility in NJ, with several thousand employees staffed on site. On the day of the incident, a crew of 14 workers were assigned the task dismantling a large, custom-built temporary multi-level seating system used for an event the day before. Twelve of the 14 worker crew, including the victim, were considered service/on-call employees, and worked on an as needed basis. The tiered seating system was a complex structure of platforms (also called decks), metal frame units, boards, and railings (Figure 1). The system adds 21 rows of stadium-style seating that extend up to a height of 19 feet. It takes approximately eight hours to build the system and eight hours for it to be dismantled.

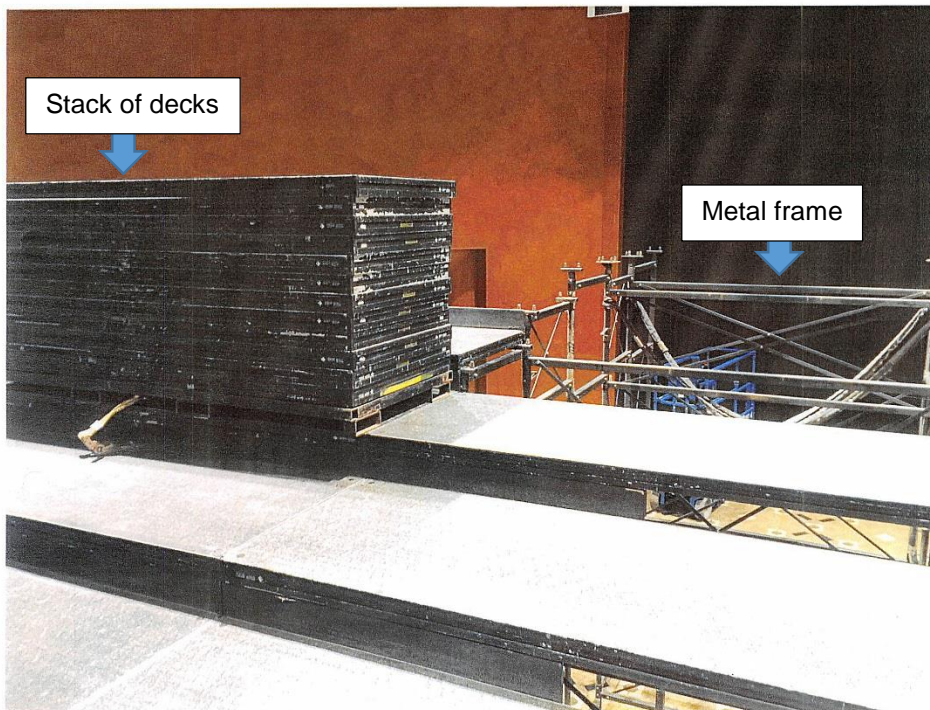
**FIGURE 2: Close-up view of multi-level seating risers.**

To build the seating system, units of the metal frame and stacks of decking (Figure 2) were brought in by forklifts. The metal frame was assembled (by unfolding and connecting the frame units), while workers in teams of two manually lifted and installed 395 decks into place; most of these decks measured three-feet-wide by eight-feet-long and weighed 86 pounds each. The decking installation began at the lowest level and then moved upward. Once the decks were in place, the railing was installed. The dismantling of the seating system, also known as a "loadout," was conducted in the opposite order to the building procedure. First, the railings were removed followed by team-lifting the decks and placing them in stacks. This began at the top of the system and continued until ground level. As the decks were being removed, scissor lifts were used to move the stacks of decking and frame units.

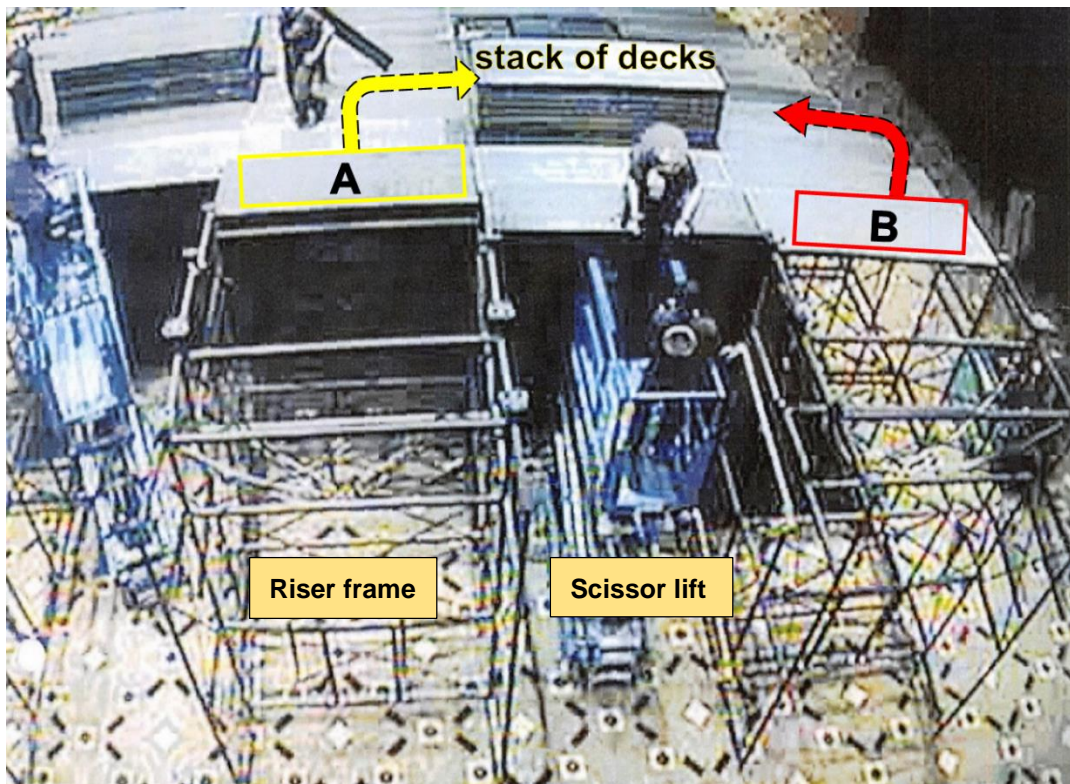
**FIGURE 3. Incident scene: workers dismantling tiered seating system shortly before incident. Note location of decks “A” and “B.”**

The incident occurred during the dismantling phase. The crew had already removed several rows of decking and were working approximately 12 feet off the ground. The victim and another worker were team-lifting 86-pound decks and carrying them back to stacks. Figures 3-4 illustrate what occurred. Approximately two minutes before the incident, there was another crew that was working parallel to the victim's crew (Figure 3). This parallel crew removed a deck (deck "A" in Figures 3-4) near the stack the victim and his coworker were using. A review of the video footage of the incident indicates that the victim saw the crew removing and stacking deck "A." A few minutes later, the victim and his coworker were team-carrying a deck (deck "B" in Figure 4) to the stack. The victim was walking backwards as they carried the deck. As they approached the stack, the victim stepped where deck "A" had been, and fell backwards through the opening. He landed on a metal cross member of the bleacher frame and sustained traumatic injuries to his back and head. He died of these injuries approximately two days later.

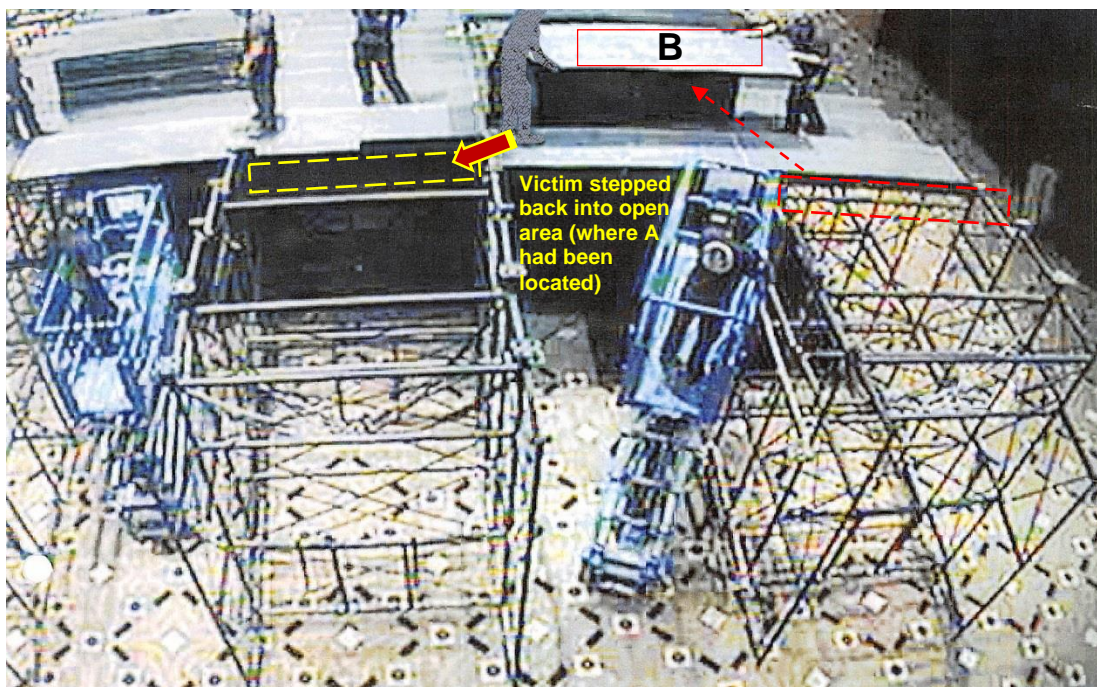
**FIGURE 4. Incident scene: workers dismantling tiered seating system Deck “B” being carried by victim and coworker to stack on right. Note open area where Deck “A” had been located.**

**Discussion:** As per 29 CFR 1926.501(b), any employee working on a walking surface that is at a height greater than six feet must be protected from falling by either fall prevention (guardrail, netting), or a personal fall arrest system.<sup>1</sup> In this case, no fall protection was in place during either the building or dismantling of the tiered seating system. Guardrails were in place on outermost edges of the system, but these are largely not in place during this work (see Recommendation #2). Personal fall arrest equipment should be worn at all times while working on the bleacher system (or at a minimum when at heights greater than six feet). NJ FOIS recommends a horizontal lifeline system be installed, to which workers can attach a retractable lanyard. The horizontal lifeline system could be either permanently affixed to the walls or ceiling of the auditorium (Figure 5a), or be a type of free-standing, mobile horizontal lifeline system (Figure 5b). The mobile system could be setup such that the overhead horizontal bar runs perpendicular to the workflow. The workers could attach their personal fall arrest systems onto the overhead bar. The attachment point can slide across the bar, allowing the workers to move freely across the seating system. In addition, the lifeline system itself can be moved to better accommodate the position of the workers as the bleachers are being built or disassembled.

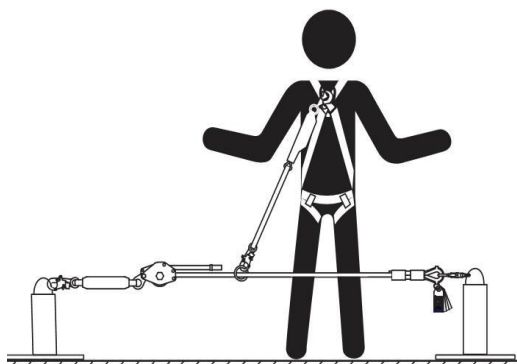
**Figure 5a-b. Examples of horizontal lifeline systems.**

**a) Permanently affixed anchor points\***

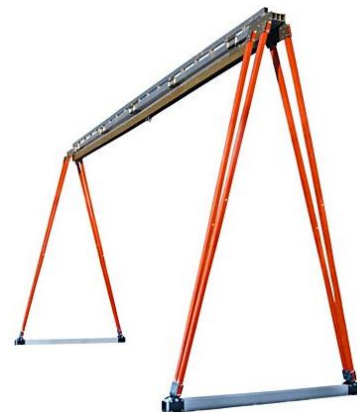
**b) Mobile overhead A-frame system\*\***
