# **SUPPLEMENTAL STAGE IB CULTURAL RESOURCES SURVEY**

## **SOUTH JERSEY GAS PIPELINE PROJECT**

**Mt. Pleasant ROV Site**

**Upper Township, Cape May County, New Jersey**

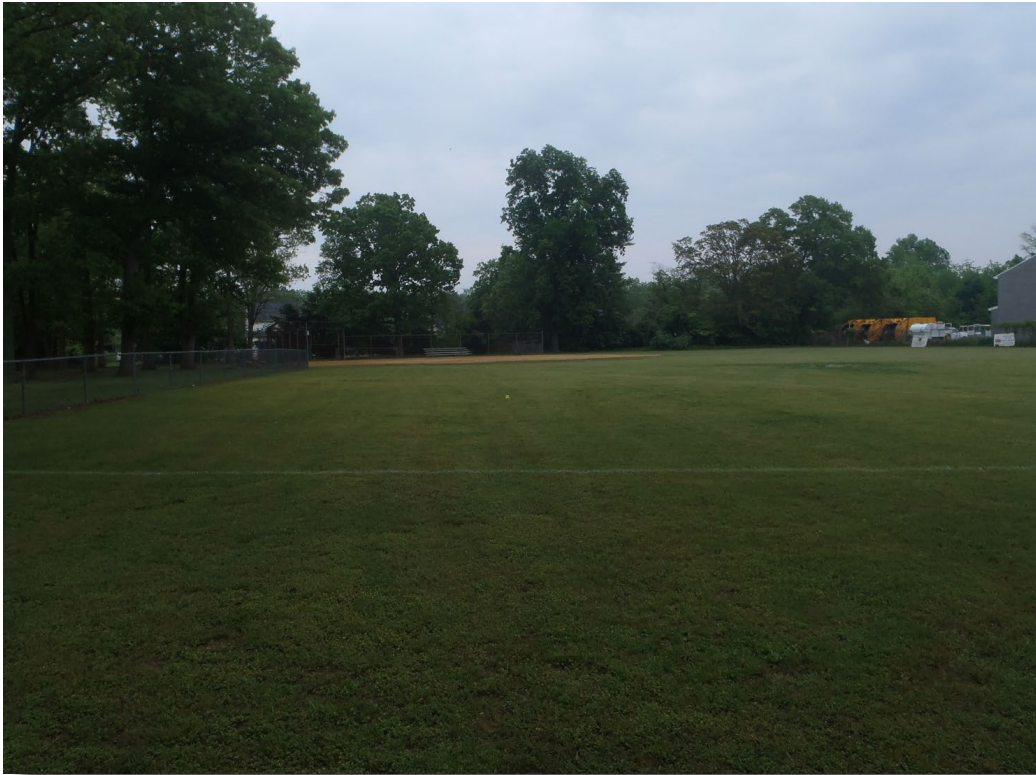
Plate 1: Overview of the athletic field portion of the Mt. Pleasant ROV Site.

1. Conditions affecting surface inspection. The Mt. Pleasant ROV Site consists of a manicured lawn/athletic field used for Little League baseball to the south and a wooded area to the north (Figure 3; Plates 1 and 2).
2. Delineation of any areas not inspected and justification. None
3. Results of surface inspection. Obvious surface disturbances in the Mt. Pleasant ROV Site were minimal and consisted of the installation of fencing, bleachers, and baseball field markers.
