ENGINEERING INVESTIGATION & ANALYSIS GEOTECHNICAL & STRUCTURAL ASSESSMENT REPORT

104 BIG PIECE ROAD FAIRFIELD, NEW JERSEY 08203

Matrix No. 20-1052

August 2021

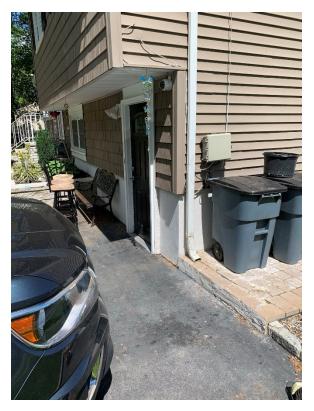
Photo 3. Second Floor Cantilever Overhang in Front of House

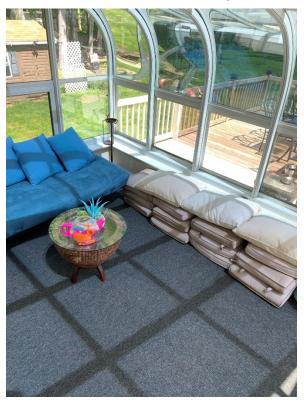
A timber deck was observed spanning the full width of the building's rear wall. The deck's timber subfloor is supported by timber posts embedded in concrete Sonotube footings. The northeast corner of the deck, adjacent to the building, is enclosed with full length glass windows, creating a sunroom. The deck is approximately 24" below the adjacent first-floor surface on the east side, but is higher in the west half of the deck area.

Photo 4. Rear Sunroom on Timber Deck (Looking East)

masonry block column. The new column will need to include a spread footing beneath to sufficiently support the building loads. Additionally, the rear timber deck and covered porch are anticipated to require raising to match the current ingress/egress heights of the main structure. This would require replacement or extension of the timber support posts.

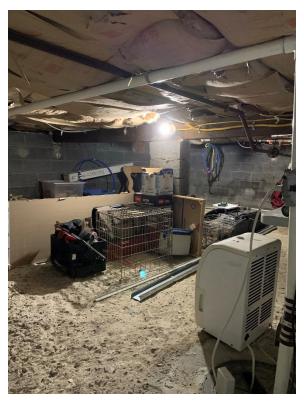
Encompassing the east portion of the house, beneath the first-floor level, is a rectangular crawl space with CMU foundation walls ranging from 53" to 54" in height. The first-floor surface above was measured at approximately 63.5" above the crawl space floor surface (surface is uneven). The subfloor of the level above is comprised of nominal 2x8 timber joists running north to south (front to rear of building). A support girder consisting of (3) nominal 2x8 timber beams runs perpendicular to the floor joists to provide additional support along the center of the crawl space. The girder bears on the CMU foundation walls at each end and is supported at its midspan by a CMU block column consisting of (6) stacked 8x8x18 blocks.

Photo 5. East Crawl Space (Looking East)

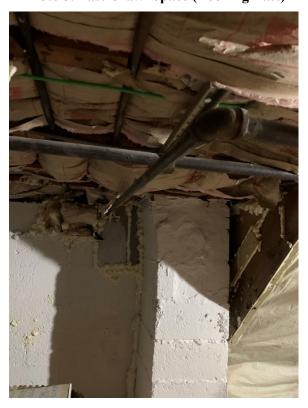
A cinder block chimney was observed protruding from the west wall of the crawl space, near the southwest corner. This chimney can be seen to extend up and through the roof of the first-floor level of the house.

Photo 6. Block Chimney East Crawl Space (West Wall)

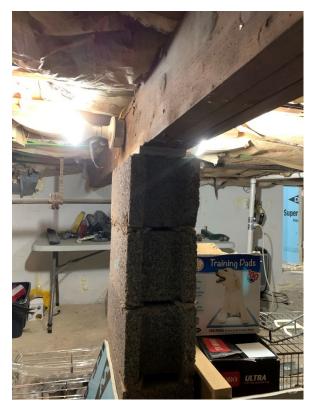
The building at 104 Big Piece Road sits atop a crawl space area and two finished ground-level/basement areas. The timber frame and subfloor are supported by the CMU (8x8x18 block) foundation walls, as well as a nominal 2x8 timber girder in the crawl space area.

Photo 7. Girder with CMU Pedestal in East Crawl Space (Looking West)

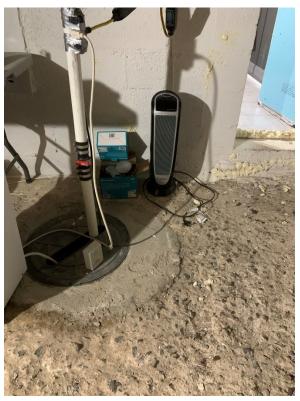
The only machinery observed within the crawl space was a sump pit located in the northwest corner of the area, near the entrance opening. Multiple metal and PVC pipes were also observed throughout the crawl space at varying elevations.

Photo 8. Sump Pit in East Crawl Space (Northwest Corner)

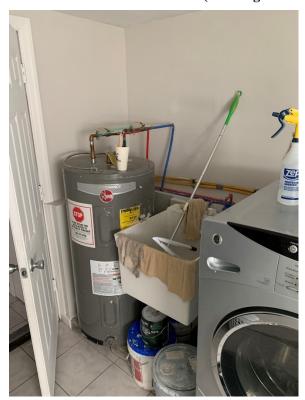
Within the laundry room located in the southern portion of the west ground-level area, a water heater was observed on a 4" high concrete block pad. A washer and dryer were also in this room, situated at the ground level. An electrical panel was noted within the closet of the north room of the west ground-level area, also at the ground level.

Photo 10. Water Heater in Ground-Level Laundry Room (Looking East)

Additionally, any service equipment, whether outside or in the crawl space/ground floor rooms, such as air conditioning, heat pump compressors, gas meters, electric meters, and hot water heaters, must be elevated 3 feet above the BFE. For interior elements, this may include relocation to an upper floor and thus less usable living space. For this residence, the hot water heater in the ground-floor laundry room and the electrical panel in the ground-floor west closet would require elevating 3 feet above the BFE onto the raised first floor. The exterior air conditioning unit would also require elevating 3 feet above the BFE on a new or extended exterior platform.

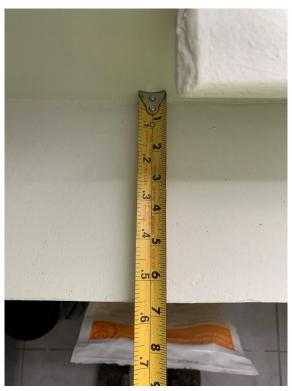
The remainder of the CMU foundation walls are covered in a plaster coating, as the basement and ground-level spaces contain three finished, habitable rooms in the split-level house. The foundation walls can be differentiated from the timber house frame by their protrusion approximately 6.5" into the building (thinner walls above). The floor of the central finished basement measured approximately 9" higher than the adjacent crawl space floor, and the west finished ground-level area was approximately 10.5" higher than the central basement. The floor of the west ground-level area is flush with the adjacent asphalt driveway in front of the property.

Photo 12. Protrusion of CMU Foundations Walls into Building (Typical Around Perimeter)

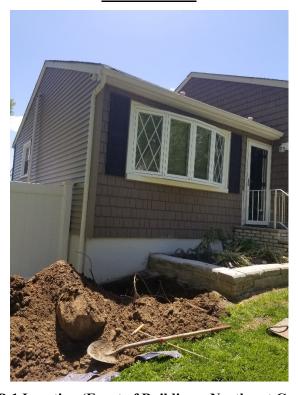
Photo 13. Test Pit TP-1 Location (Front of Building – Northeast Corner of Crawl Space)

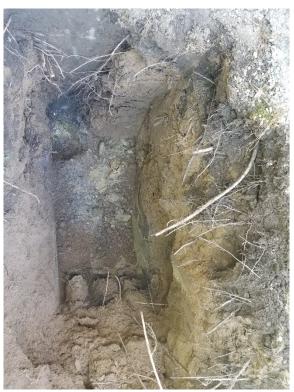
Top of concrete was uncovered in TP-1 (Northeast Corner) at 48" bgs. The concrete protrudes 2" from the wall and extends 8" deep at this location.

Two test pits were conducted around the perimeter of the east crawl space, in the northeast corner and along the east wall. Below the foundation walls in the crawl space area, an approximately 20" wide concrete spread footing was revealed during the test pit excavation program. Based on our findings within the test pits and from conventional foundation construction, Matrix utilized a 16" wide footing as a minimum value for analysis, but believes the actual footings for the building to likely range from 16" to 24" in width. Prior to raising the house, Matrix recommends that the contractor confirm the foundation size and bearing adequacy with multiple test pits around the building perimeter.

Photo 14. Test Pit TP-1 Foundation Conditions

Matrix recommends that the existing foundation system of the residential building at 104 Big Piece Road be kept and extended to achieve the required design flood elevation. The existing CMU foundation walls and concrete footings are expected to provide sufficient support for the additional height of the newly raised building. Based on loading estimation and analysis for the existing building, Matrix estimates that the anticipated additional dead load of the required new courses of CMU would remain under an allowable bearing capacity of 2,500 psf for the shallow concrete strip footings at the Site.

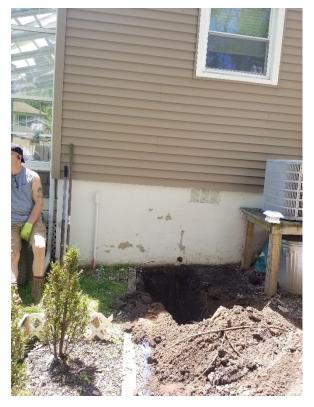
Photo 15. Test Pit TP-2 Location (East Wall of Building – Crawl Space)

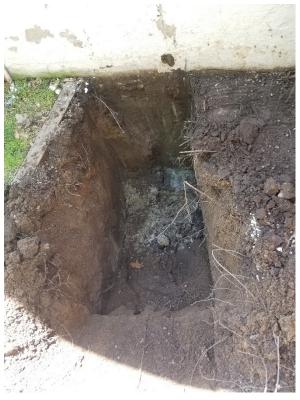
In TP-2 (East Wall) the top of concrete was uncovered at 37" bgs. The concrete protrudes 6" from the wall and extends 12" deep at this location.

Photo 16. Test Pit TP-2 Foundation Conditions
