NEW JERSEY DIVISION OF FIRE SAFETY

Firefighter Fatality and Serious Injury Report Series

Firefighter Issues “Mayday” and Runs Out of Air While Operating at a Structure Fire

**Perth Amboy, New Jersey
March 26, 2013**

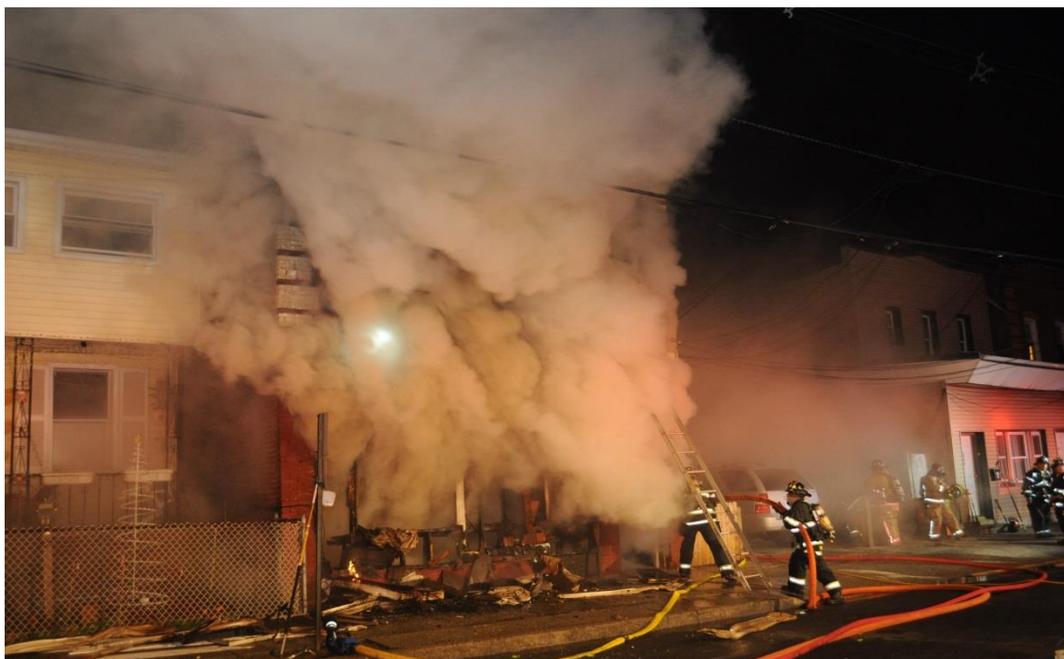
Photo 1: Heavy smoke still pushes from the structure, after multiple attempts to extinguish it from the exterior and interior. This photo is approximately an hour after arrival on scene, shortly before BC Simon's "Mayday".

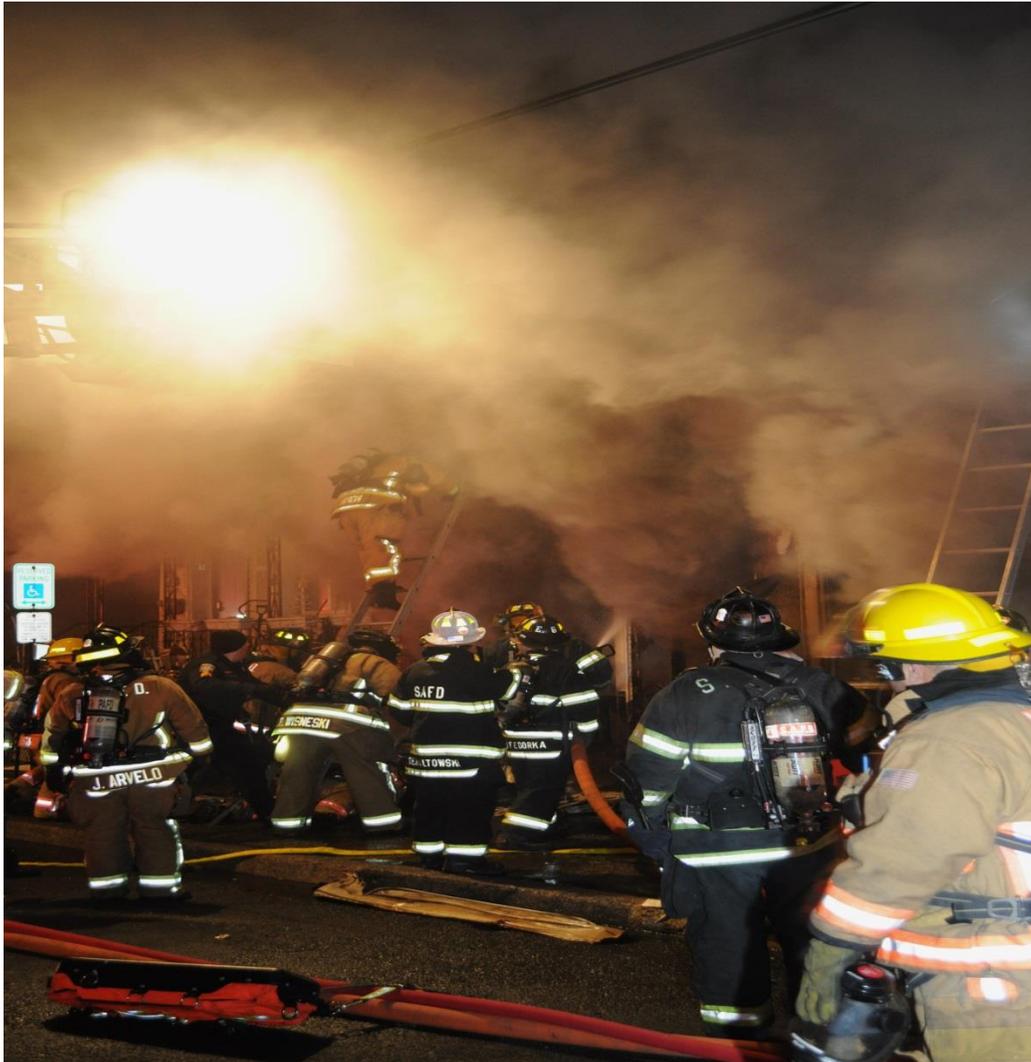
Photo 2: Following his “Mayday”, BC Simon exits through the 2nd floor Div. A window, and descends down the ladder immediately after the assisting FF (Macri) fell to the sidewalk below. Note the heavy smoke condition throughout, over an hour after arrival on scene.
