Mapping Shoreline Change in Maurice River

Purpose:

Identify eroding shorelines around the mouth of the Maurice River to target coastal restoration efforts.

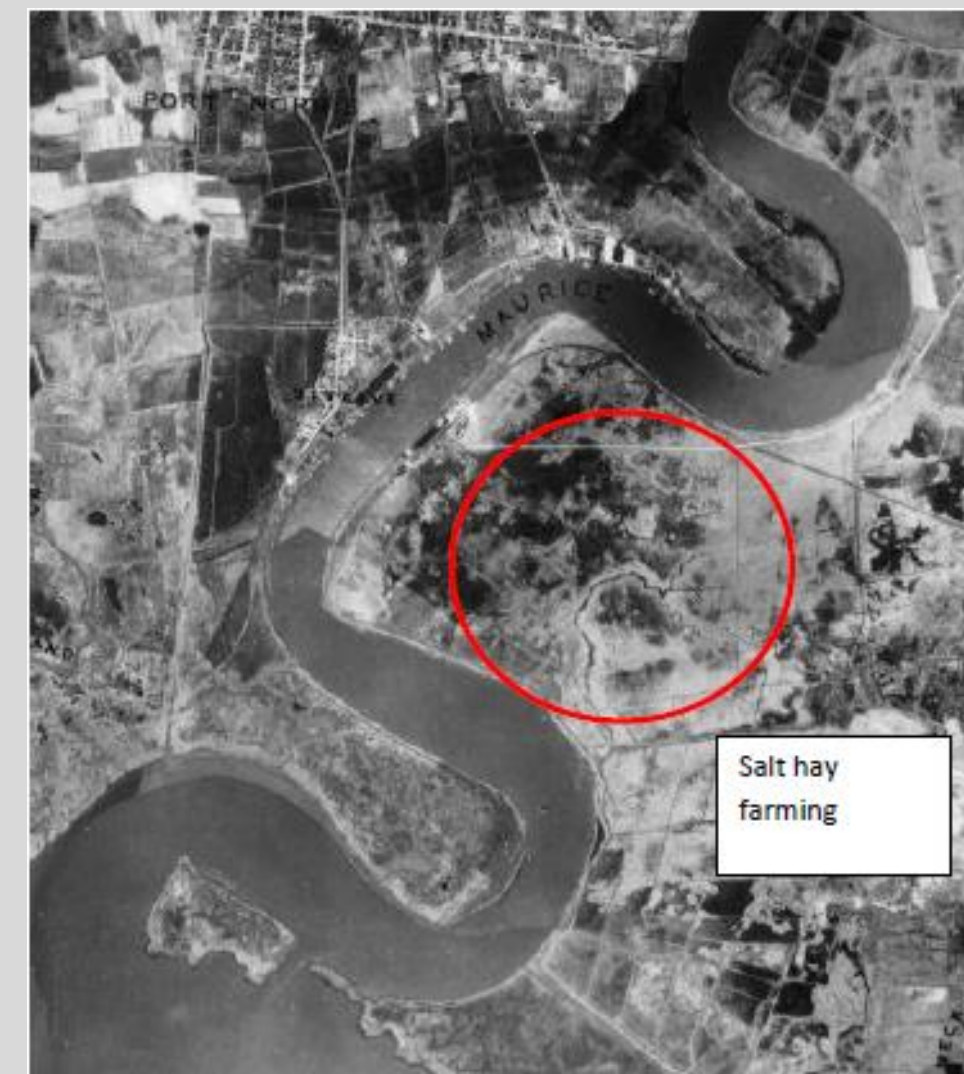
This area was also historically used for *Spartina* or "salt hay" farming. The photograph to the right is an image from the 1932 aerials showing one of the most significant areas of salt hay farming in the region. This old practice involved diking off wetlands from the surrounding river and cultivating the vegetation to be used in everything from cow feed to coffin bed lining. Because the farming plots were cut off from the diurnal tidal cycle, they no longer received sedimentation and were unable to keep pace with sea level. When this farming practice was ended and the plots were abandoned, the dikes blew out and the compacted land was quickly converted to mudflat (see historical shorelines below). The loss of vital wetlands from salt hay farming has left Matt's Landing and the surrounding area more exposed to hazards and could threaten local crab fisheries and wildlife. (5)

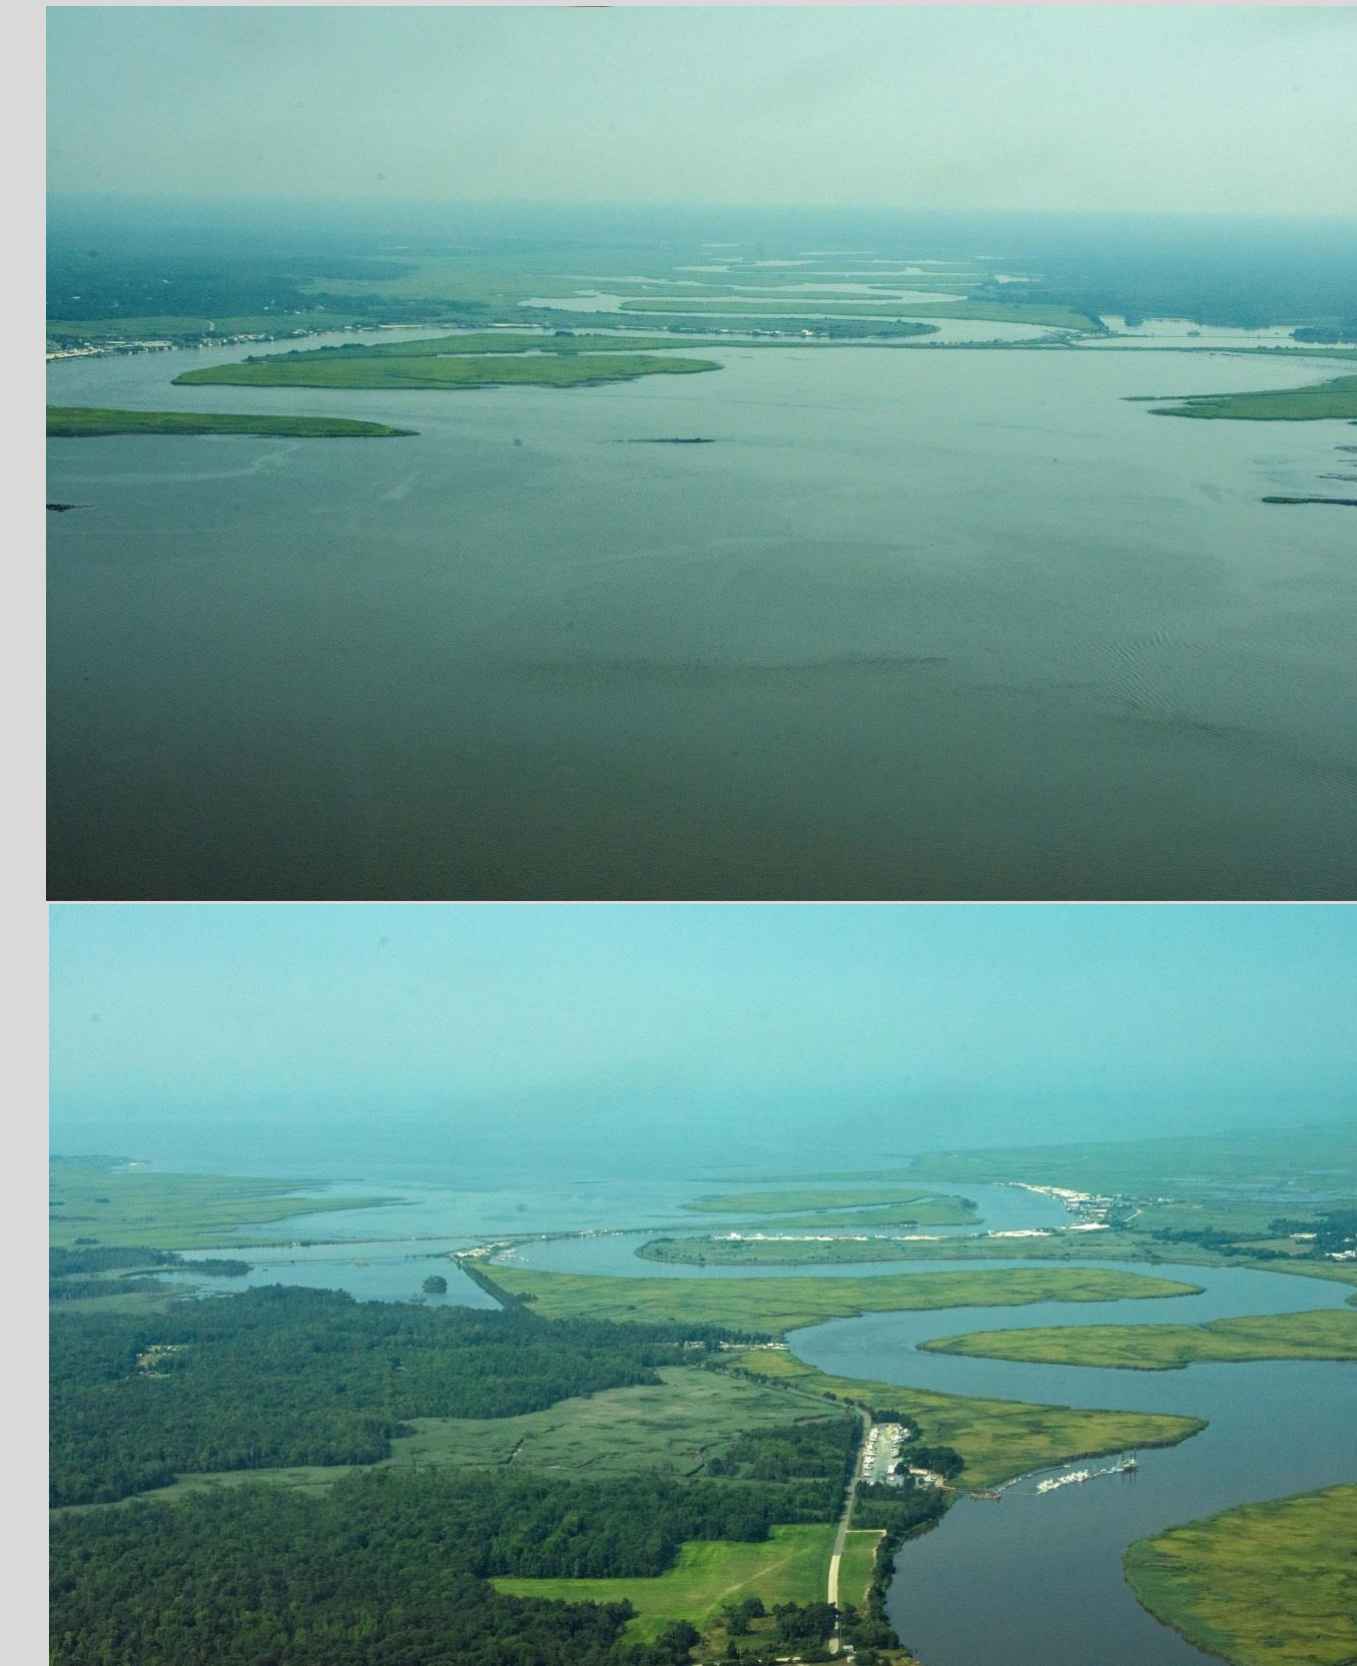
North facing view, top, and south facing view, bottom, of the mouth of the Maurice River. (Photos by Steve Jacobus.)

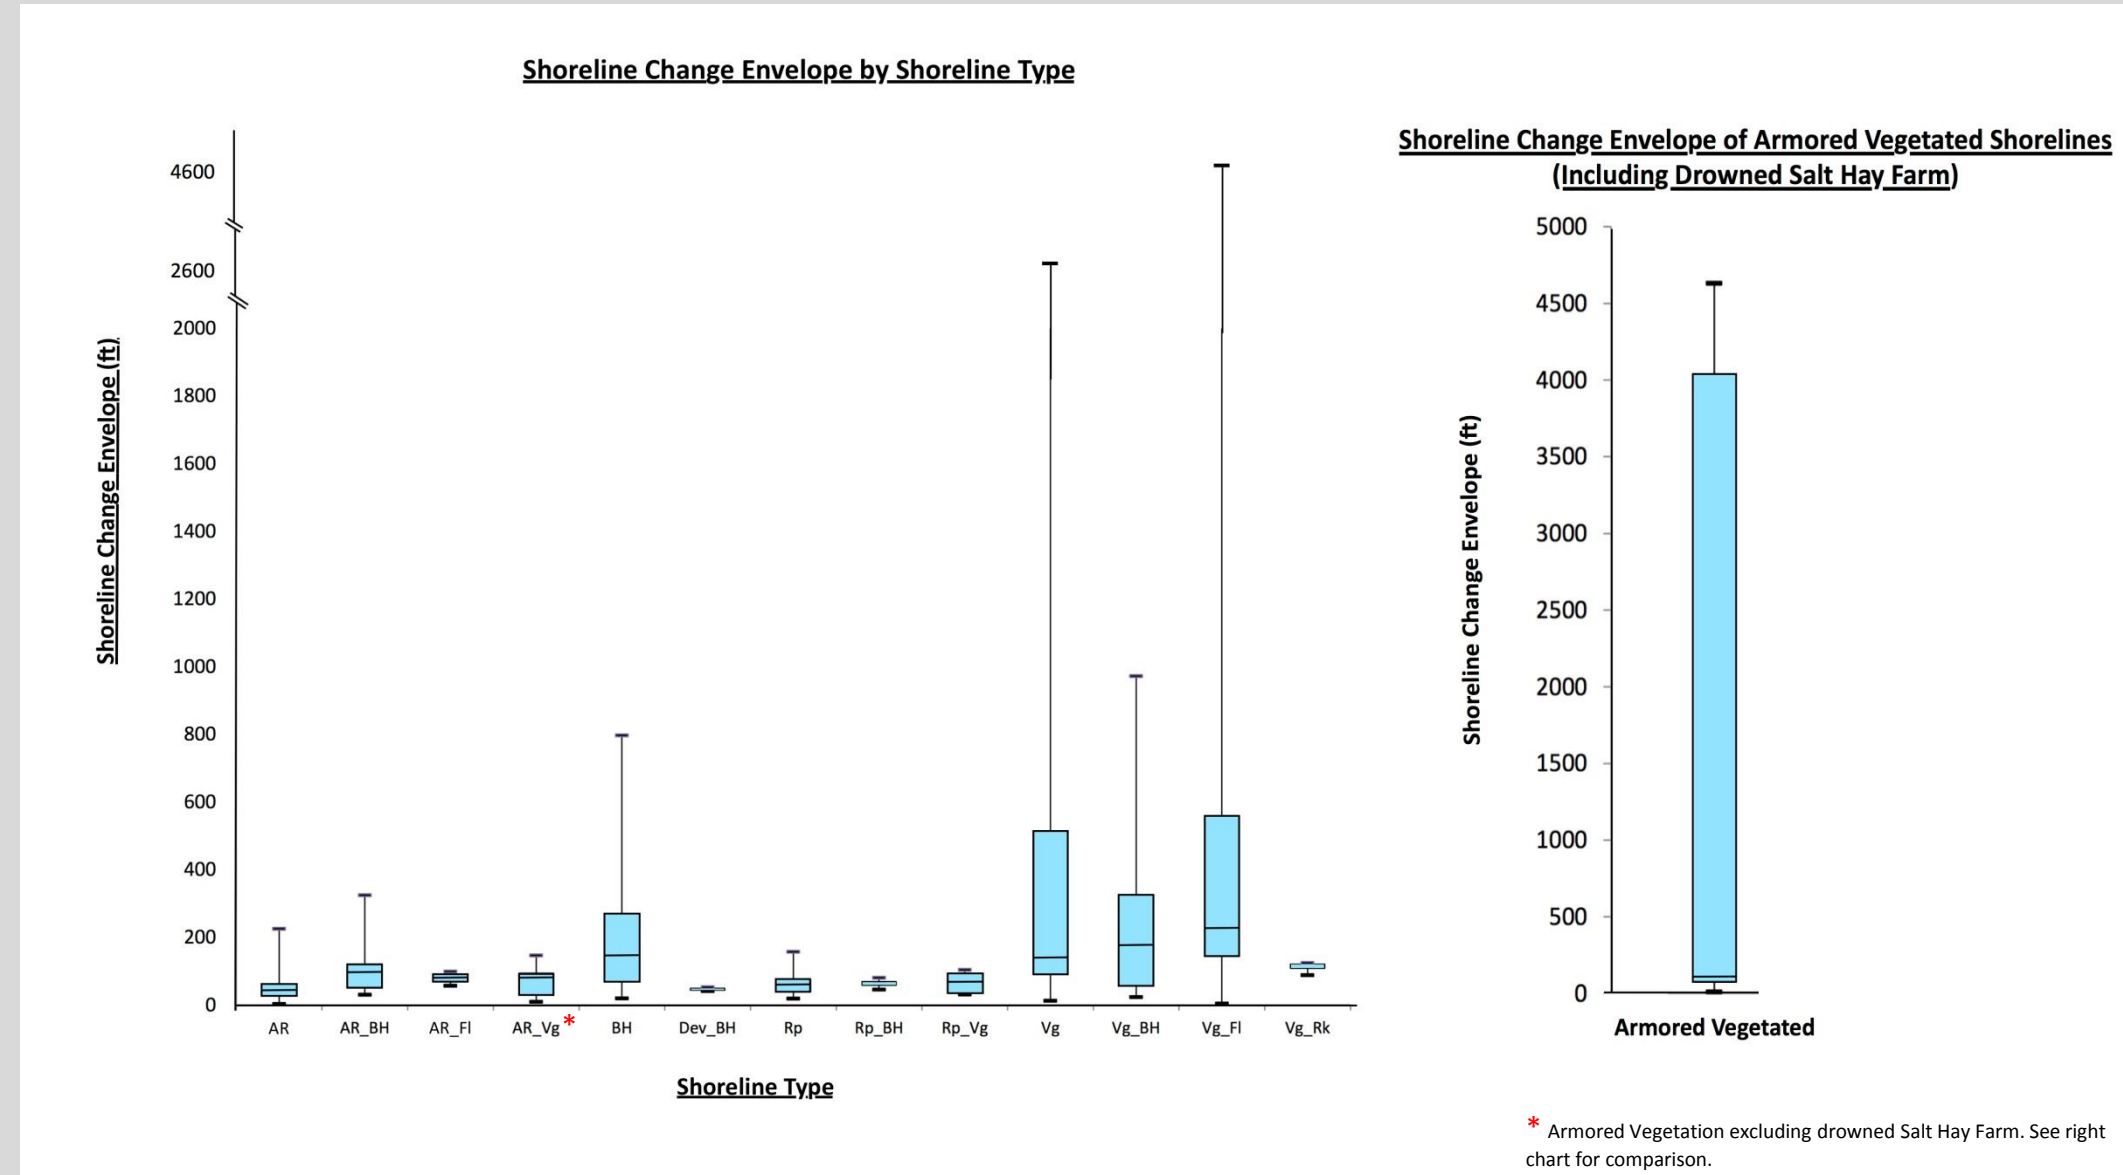
This plot depicts the shoreline change envelope by shoreline type. The area within each blue box represents the interquartile range (middle 50% of the data). The line in the middle of each box is the median and the ends of the whiskers represent the maximum and minimum shoreline change rates for each shoreline type. AR – Armored; AR_BH – Armored Beach; AR_FL – Armored Mud Flat; AR_Vg – Armored Vegetation; BH – Beach; Dev_BH – Developed Beach; Rp – Riprap; Rp_BH – Riprap Beach; Rp_Vg – Riprap Vegetation; Vg – Vegetation; Vg_BH – Vegetated Beach; Vg_FL – Vegetated Mud Flat; Vg_Rk – Vegetated/ Rocky and Steep Shoreline.

All statistics were performed using R statistical software (version 3.2.3) with the assistance of Evan Sherer. The shoreline change envelope (SCE) for each shoreline type were compared using a Kruskal-Wallis test, followed by a Dunn's test for multiple comparisons (using the Holm method to adjust p-values). The results suggest that Armored Vegetation, Vegetated, and Vegetated Flat areas experience the highest level of erosion at the mouth of the Maurice River, with maximum values in excess of 4500 ft. The area with the largest change, the east side of the river on the second meander, was most likely the result of the blowout of the dikes surrounding *Spartina* farms. To account for this, statistics were run separately on Armored Vegetation when excluding this area. As seen on the charts below, without this large blowout erosion on the armored vegetation shorelines were significantly lower. The submersion of the *Spartina* farms caused a dramatic increase in erosion levels in this region. Other areas of particularly high erosion include the Delaware Bay shore immediately to the west of the river and the first few meanders of the river, presumably due to higher wave energy. Coastal restoration efforts should be focused on these shoreline types and locations. Future studies will incorporate wave energy analysis to determine the relationship between wave energy, shoreline type and shoreline change.
