New Jersey Department of Environmental Protection
Water Resource Management
Division of Water Monitoring and Standards

Cyanobacterial Harmful Algal Bloom (HAB) Freshwater Recreational Response

2020 Summary Report

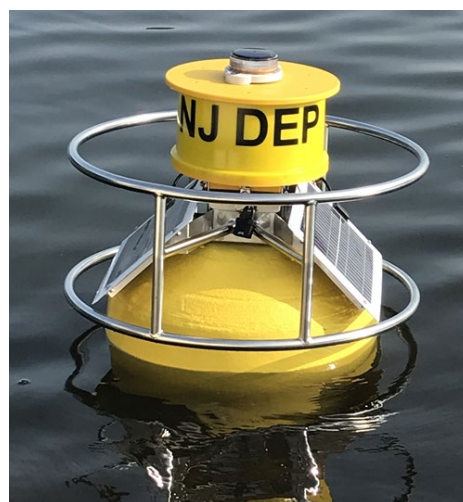
Figure 4. Continuous multi-parameter meter.

BFBM uses three types of fluorometers: a field meter, laboratory meter, and a YSI data sonde. The YSI data sonde is used for real time continuous monitoring in conjunction with telemetry buoys (Figure 4), but units can also be used for discreet measurements by samplers.

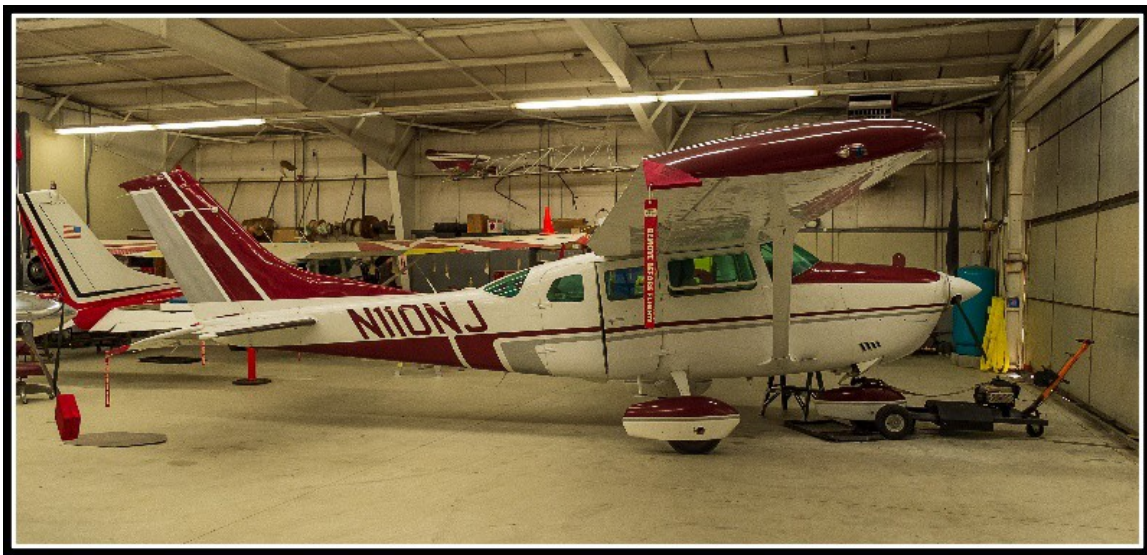
Figure 13. Forest Fire Service

NJ Forest Fire Service perform flight (Figure 13) surveillance at several larger Northern NJ lakes of concern. Visual observations are recorded as well as remote sensing of phycocyanin pigment. DWMS Bureau of Marine Water Monitoring developed a customized algorithm that can reliably detect and estimate phycocyanin concentrations in freshwaters through wave length reflectance signatures. These measurements are not used as a replacement for confirmation analysis, but as a screening and status monitoring tool to detect relative increases and decreases in phycocyanin pigment concentrations. When levels change significantly, sampling staff are deployed for confirmation laboratory analysis.
