UPPER SALEM RIVER WATERSHED RESTORATION AND PROTECTION PLAN

Developed by the Rutgers Cooperative Extension Water Resources Program

November 20, 2012

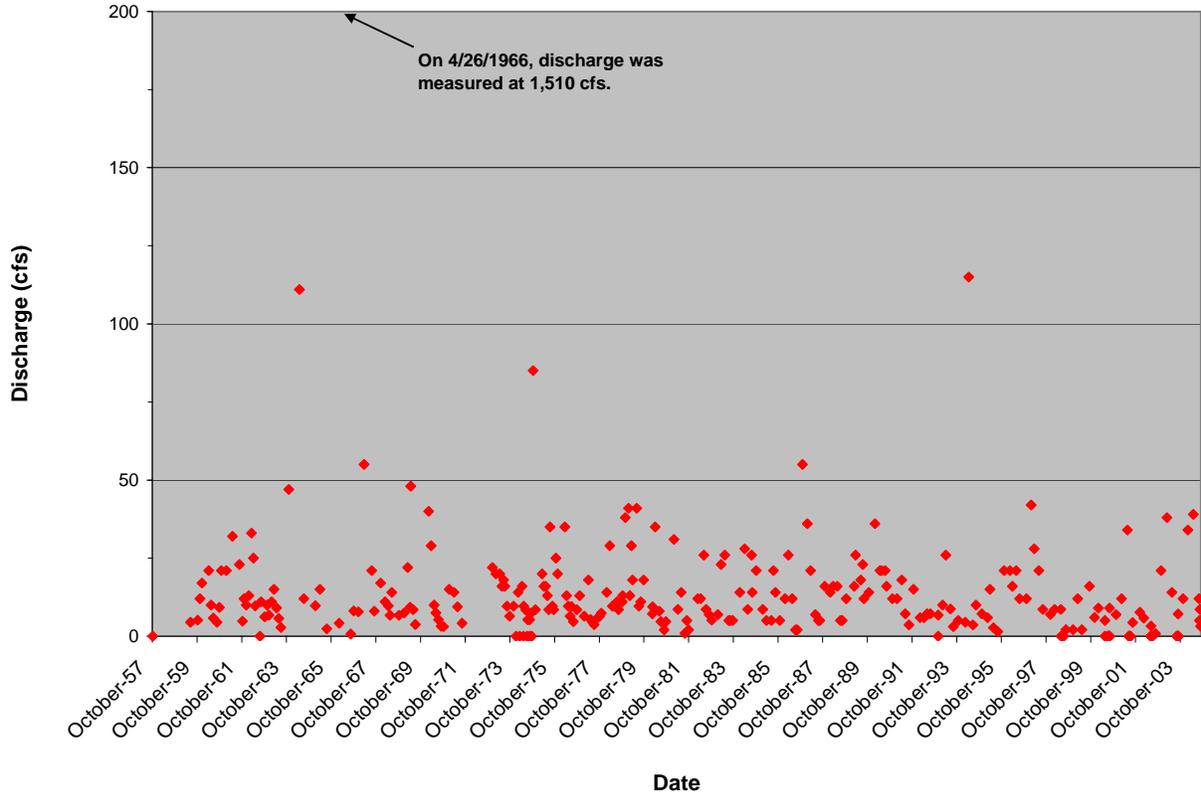
Figure 6: River discharge measurements at USGS gauge 01482500 (Salem River at Woodstown, NJ).

Since 1957, USGS has monitored flow on the Salem River at USGS gauge 01482500 (Figure 1). The mean discharge is 17.8 cubic feet per second (cfs) (Figure 6). The artificial lakes created by various impoundments along the main stem of the Upper Salem River are most likely keeping flow rates low (Figure 1).

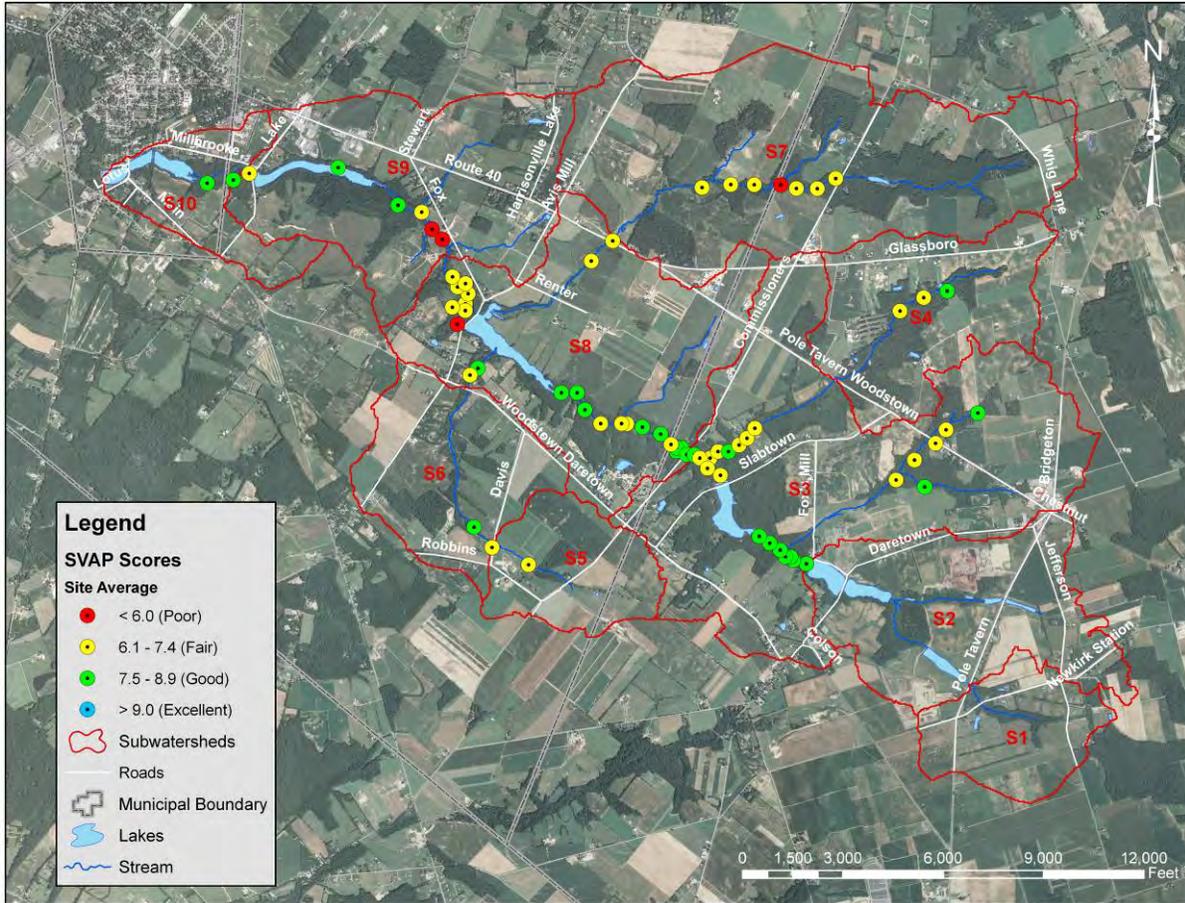
Figure 9: SVAP assessment site averages for the Upper Salem River Watershed.

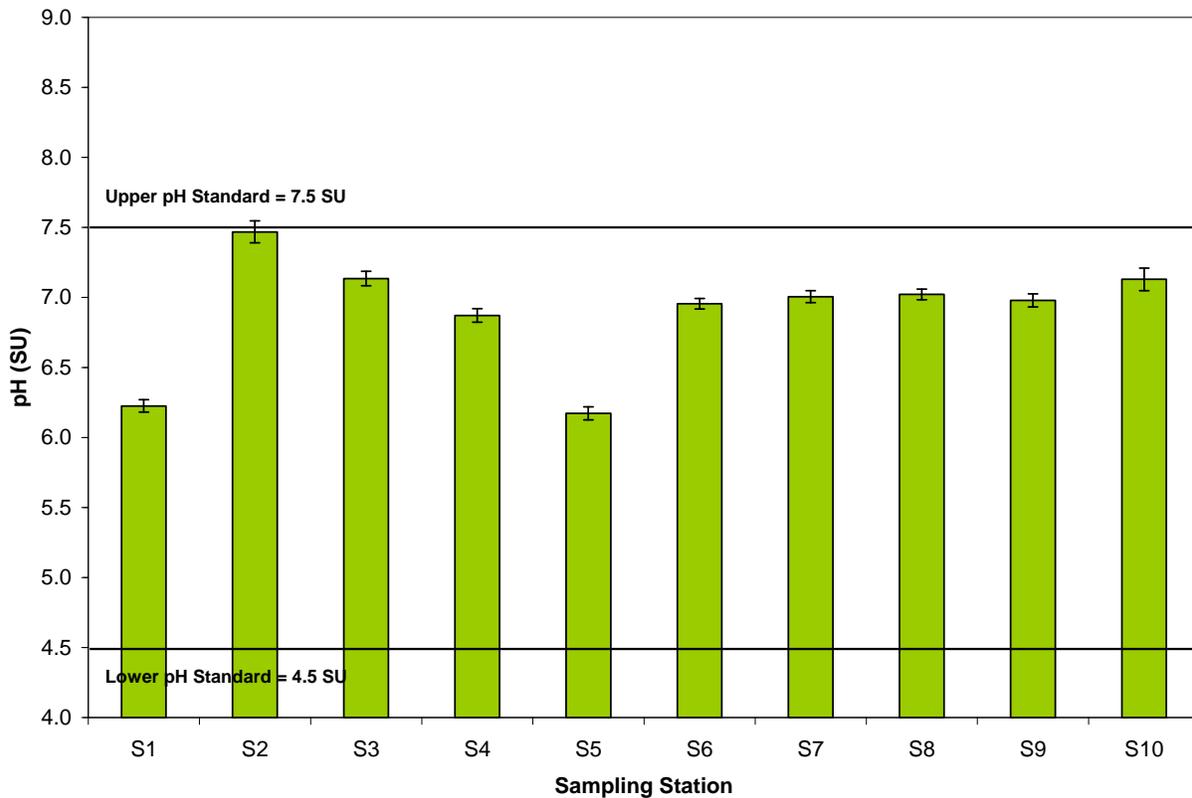
Figure 15: Mean pH levels for RCE monitored stations in Upper Salem River Watershed. Note that levels greater than 7.5 SU or below 4.5 SU are in violation of the state water quality standard. (Error bars indicate standard error of the mean.)

Mean pH levels for all stations were within the state's water quality standard (Figure 15). However, many sites had two (2) or more exceedances during the sampling period (Table 5) with violations due to elevated pH levels. Only stations S1, S5 and S6 did not exceed the water quality standard two (2) or more times. Sampling station S2 had 22 exceedances and S10 had 18 (Table 5). Elevated levels of pH can be caused by the loss of carbon dioxide (CO₂) from surface waters due to heightened photosynthesis. The large amounts of nutrients entering the Upper Salem River from the watershed could be stimulating plant growth and causing the loss of CO₂ in waterways (Figure 16).

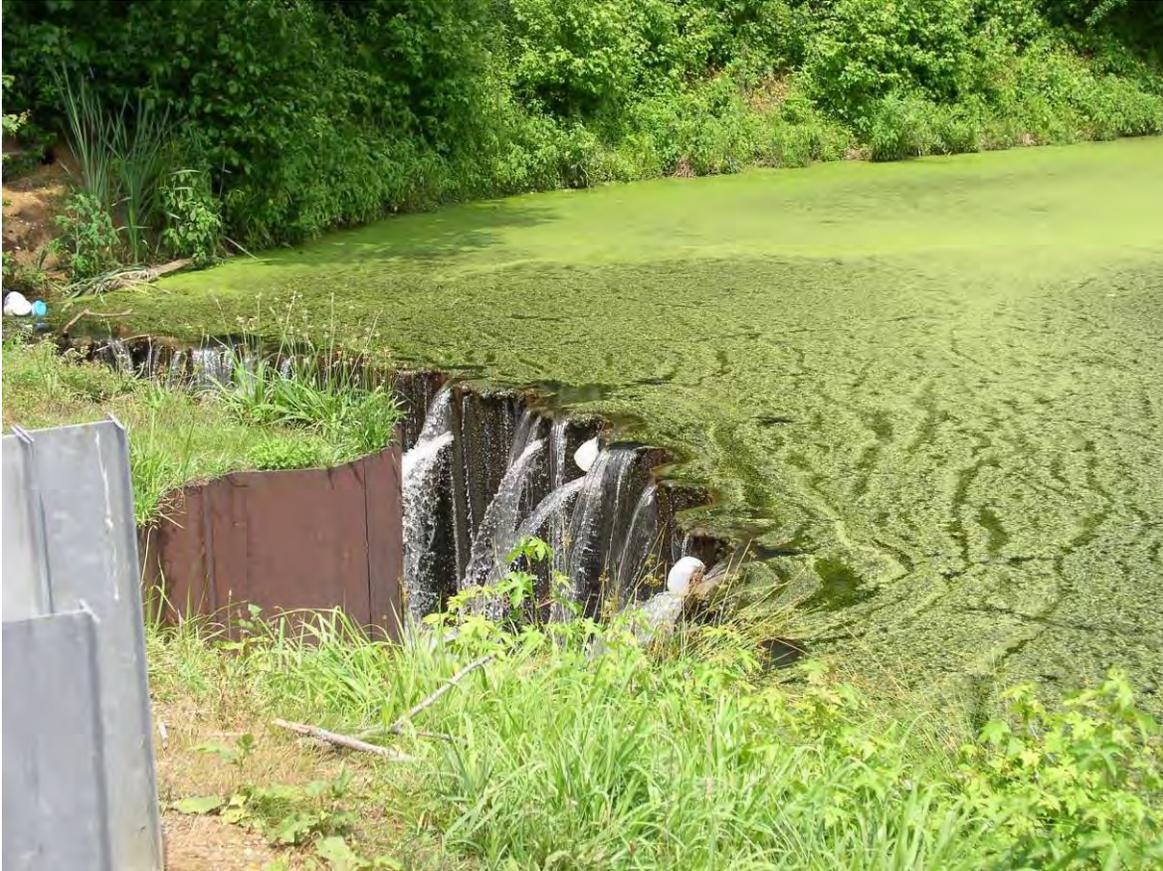
Figure 16: An impoundment along the Upper Salem River showing heightened plant growth.

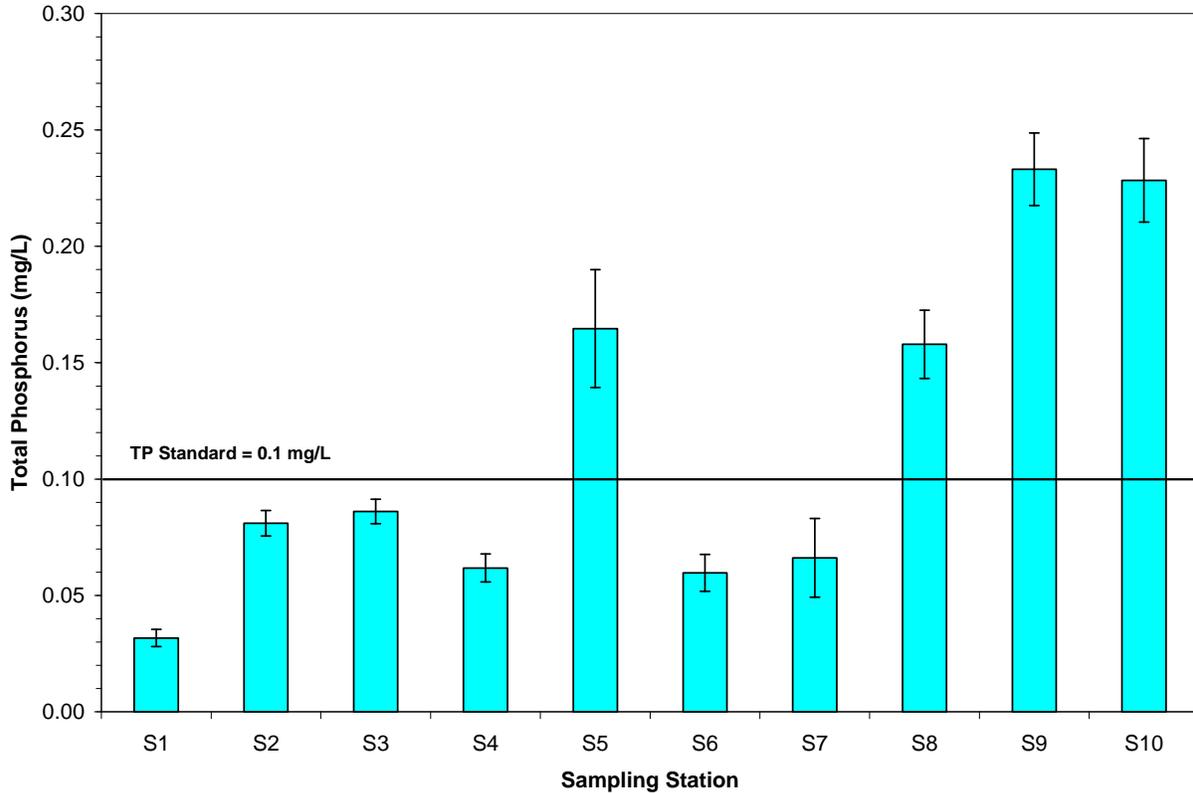
Figure 17: Mean total phosphorus (TP) concentrations for RCE monitored stations in Upper Salem River Watershed. (Error bars indicate standard error of the mean.)

exceeded the 0.1 mg/L standard most frequently (on 52 occasions, each) (Table 5). This may be from cumulative impacts from throughout the Upper Salem River Watershed. Stations S5, S7, and S10 (Figure 4) had the highest single concentrations of TP over the course of the monitoring period (0.97 mg/L, 0.88 mg/L, and 0.87 mg/L, respectively). Standard error of the mean for TP had a narrow range of 0.01 to 0.02 (Figure 17).

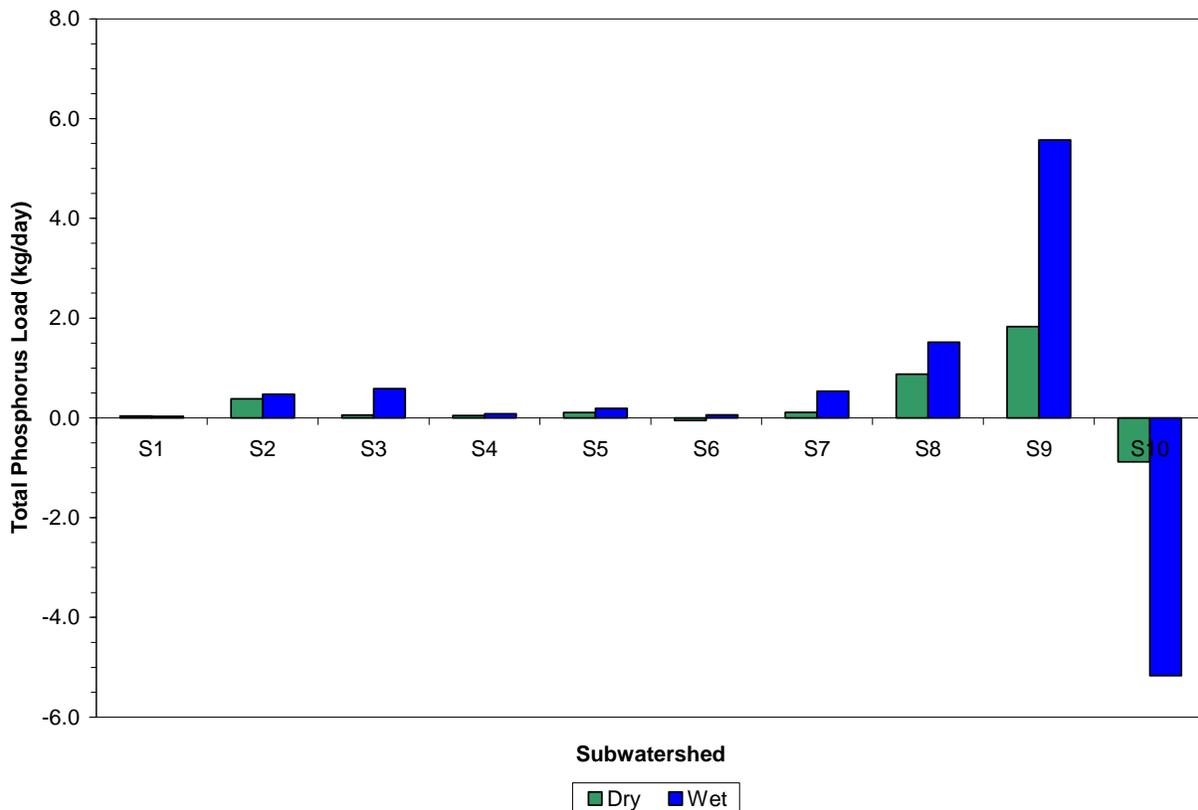
Figure 18: Comparison of daily total phosphorus (TP) loads per subwatershed under dry and wet conditions.

the Upper Salem River Watershed. Baseflow is calculated in this method and any flows measured during the course of this project that are above the calculated baseflow are considered “wet” events, while those below are considered “dry” events (Sloto and Crouse, 1996). In addition, downstream stations had upstream station loads subtracted from their total load to determine the contribution of individual subwatersheds. In some cases, this can lead to negative loads at a station (e.g., S10) due to there being a larger load upstream of that station (e.g., S9). By using these methods, subwatersheds S8 and S9 were found to have the largest mean TP loads in the Upper Salem River Watershed for both dry and wet weather events (Figure 18). These subwatersheds have the greatest impact in regards to TP results at the most downstream monitoring point for the project area (station S10; Figure 4) and may be contributing to the high concentrations measured during monitoring (Figure 17). High nutrient loading from subwatersheds S8 and S9 are priorities for water quality management.

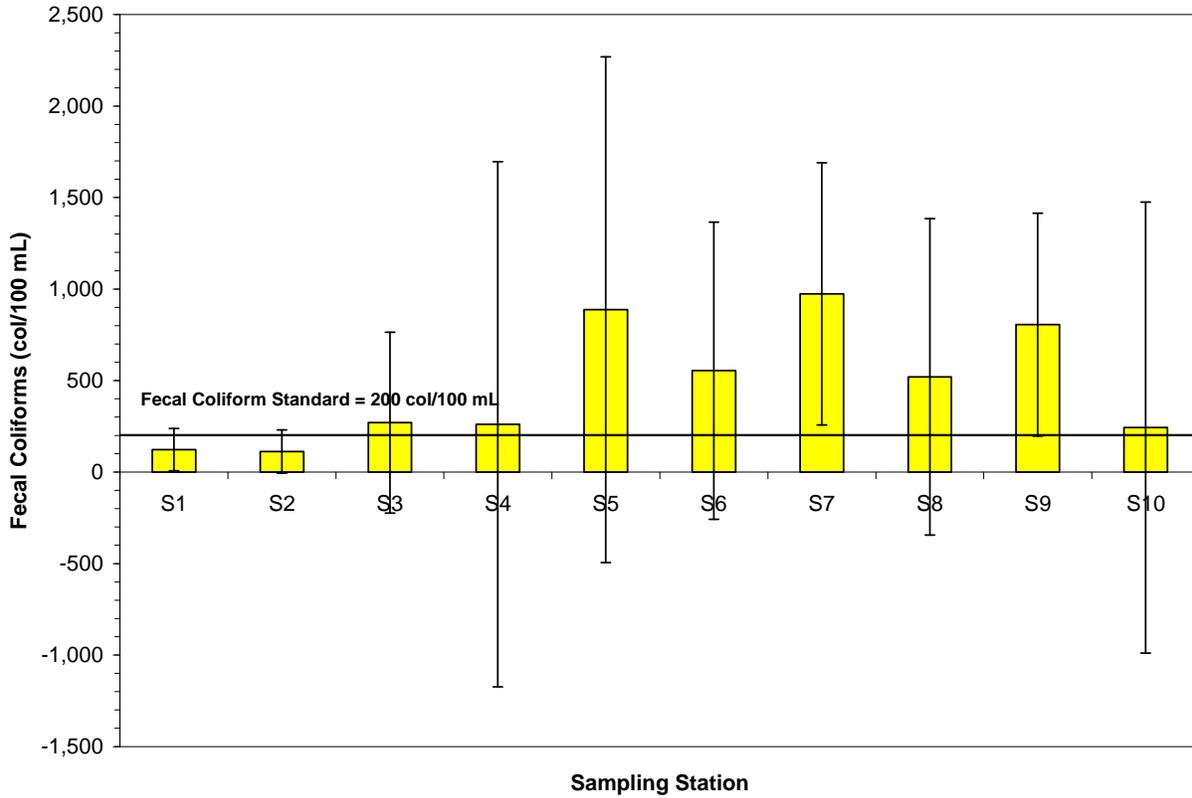
Figure 19: Geometric mean fecal coliform (FC) concentrations for RCE monitored stations in Upper Salem River Watershed. (Error bars indicate standard error of the mean.)

The former surface water quality standard for bacterial quality of FW2 surface waters was that the geometric means of fecal coliform samples not exceed 200 counts of organisms (colonies) per 100mL (col/100mL). Since initiation of this project, the indicator organism of bacterial quality has changed for freshwaters in New Jersey to the use of *Escherichia coli* (*E. coli*). For this report, however, both the former standard for fecal coliform and *E. coli* will be applied to data collected in the Upper Salem River Watershed since it is a fecal coliform TMDL that is the driver of restoration efforts (Table 4). In the Upper Salem River Watershed, eight of the ten monitoring stations exceeded the geometric mean of 200 col/100 mL over the course of the data collection period with maximum fecal coliform concentrations exceeding 400 col/100 mL at least once at all stations throughout sampling (Figure 19; Table 5). The geometric mean of fecal coliform concentrations was above the standard at stations S3 through S10 (Figure 19). Only stations S1 and S2, in the headwaters of the Upper Salem River, were below the state water quality standard (Figure 19). In addition, all stations exceeded the 400 col/100 mL standard on ten or more occasions during the sampling season (Table 5). Stations S4 and S10 had the highest fecal coliform counts across all stations over all events (60,000 col/100 mL). Standard error of the mean was large, and ranged from 115.49 to 1,439.99 (Figure 19), indicating large variability in fecal coliform levels measured in the Upper Salem River Watershed.

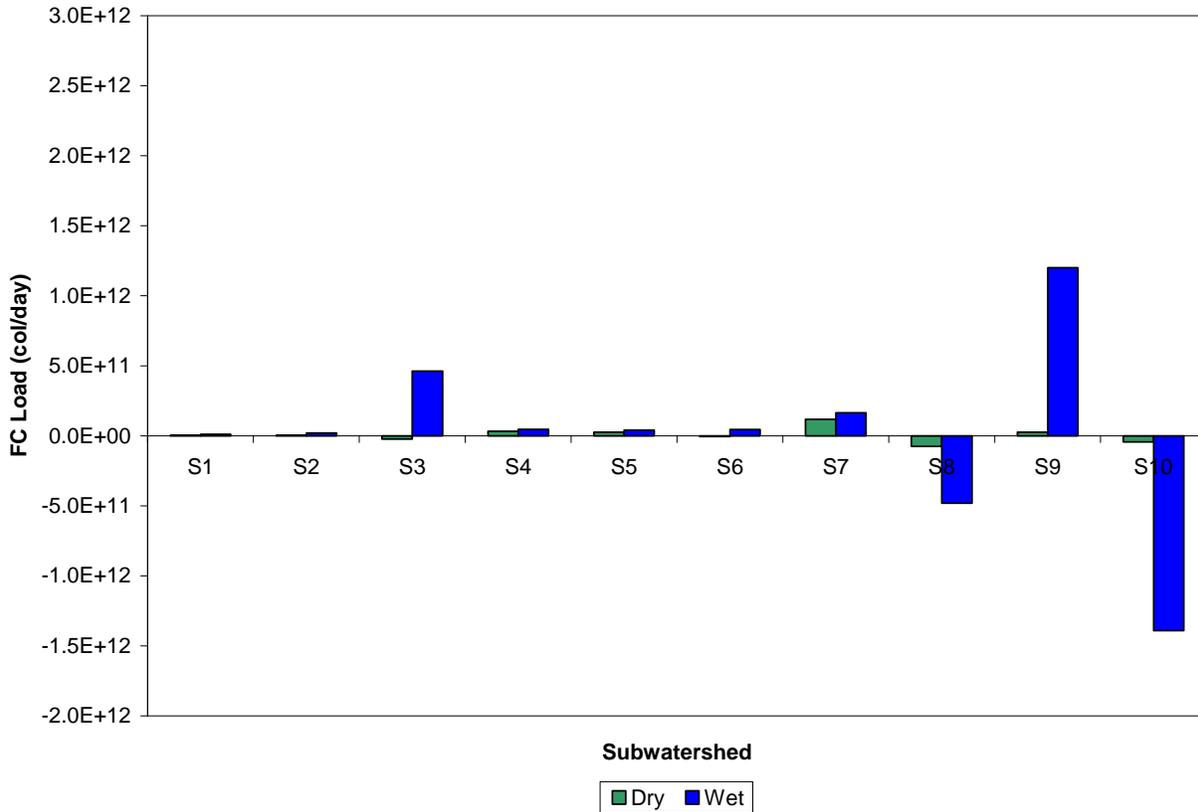
Figure 20: Comparison of daily fecal coliform (FC) load by subwatershed under dry and wet conditions.

As stated in the TMDL, occurrences of high fecal bacteria in surface waters are largely due to storm events (NJDEP, 2003a). Fecal coliform (FC) loads were calculated in the same manner as TP loads and were also compared between wet and dry events. Fecal coliform loads were greater in almost every subwatershed during sampling events when stream volume was greater than baseflow (wet weather events; Figure 20). Only subwatersheds S8 and S10 had lower loadings during wet events (Figure 20). Assimilation, predation, or some other loss of FC may be occurring upstream of these locations. The S9 subwatershed was found to have the greatest influence on water quality at S10, where USGS gauge 01482500 is located (Figure 1). The S9 subwatershed is a priority for controlling pathogens in the Upper Salem River, as is subwatershed S3, which have the largest fecal coliform loads during wet weather events (Figure 20).

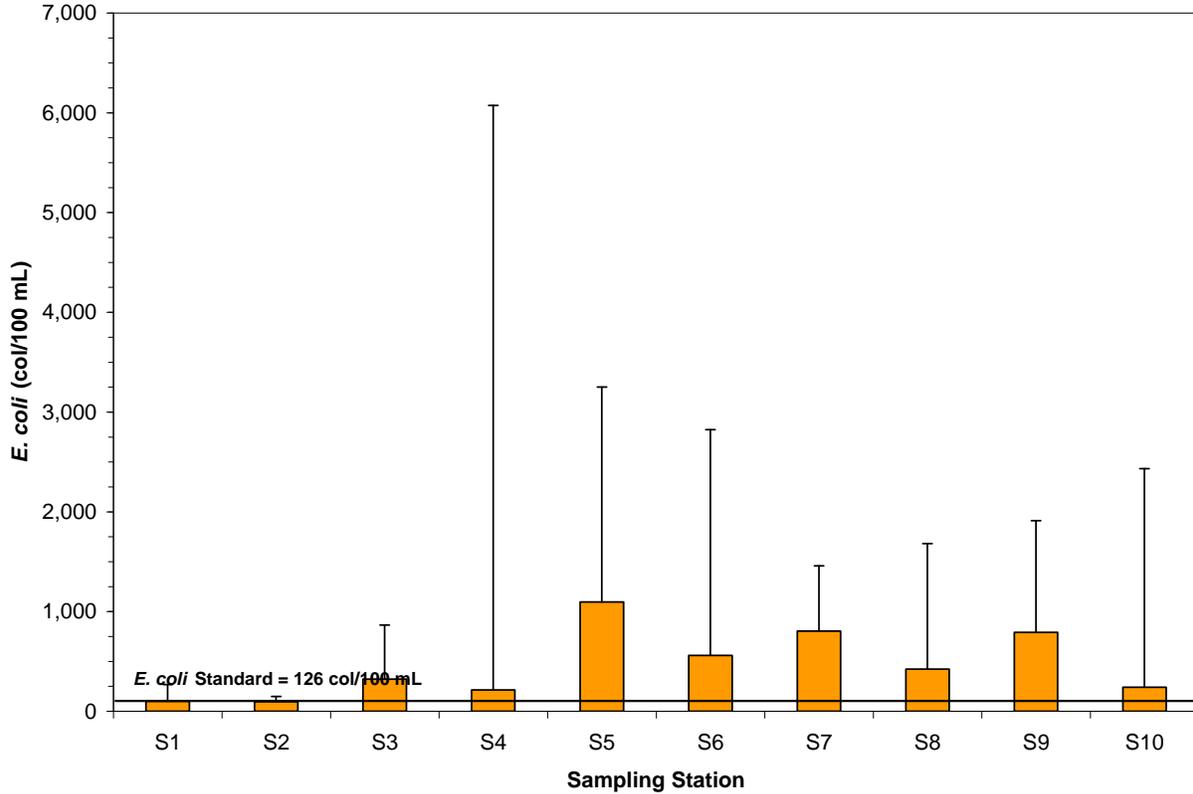
Figure 21: Geometric mean *E. coli* concentrations for RCE monitored stations in Upper Salem River Watershed. (Error bars indicate standard error of the mean.)

standard error of the mean was large and ranged from 50.82 to 5,860.55 (Figure 21), indicating large variability in *E. coli* levels measured in the Upper Salem River Watershed.

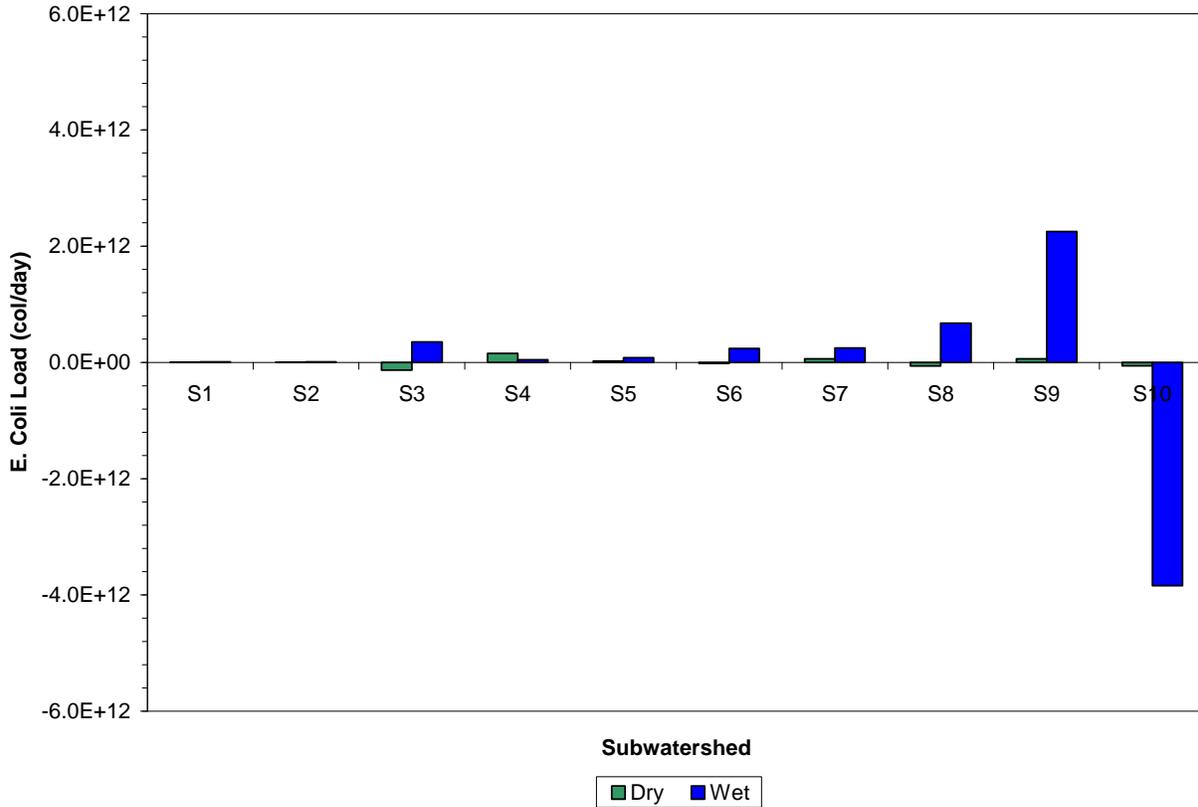
Figure 22: Comparison of daily *E. coli* load by subwatershed under dry and wet conditions.

E. coli loads were calculated in the same manner as TP and fecal coliform loads and were also compared between wet and dry events. *E. coli* loads were greater in many of the subwatersheds during wet sampling events (Figure 22). Only subwatersheds S4 and S10 had lower loadings during wet events (Figure 22). The suspected loss mechanisms for fecal coliform (e.g., assimilation, predation) would also reduce *E. coli* levels upstream of these locations. The S9 subwatershed, which has the highest loads of *E. coli* during wet weather, is a priority for controlling pathogens in the Upper Salem River (Figure 22).

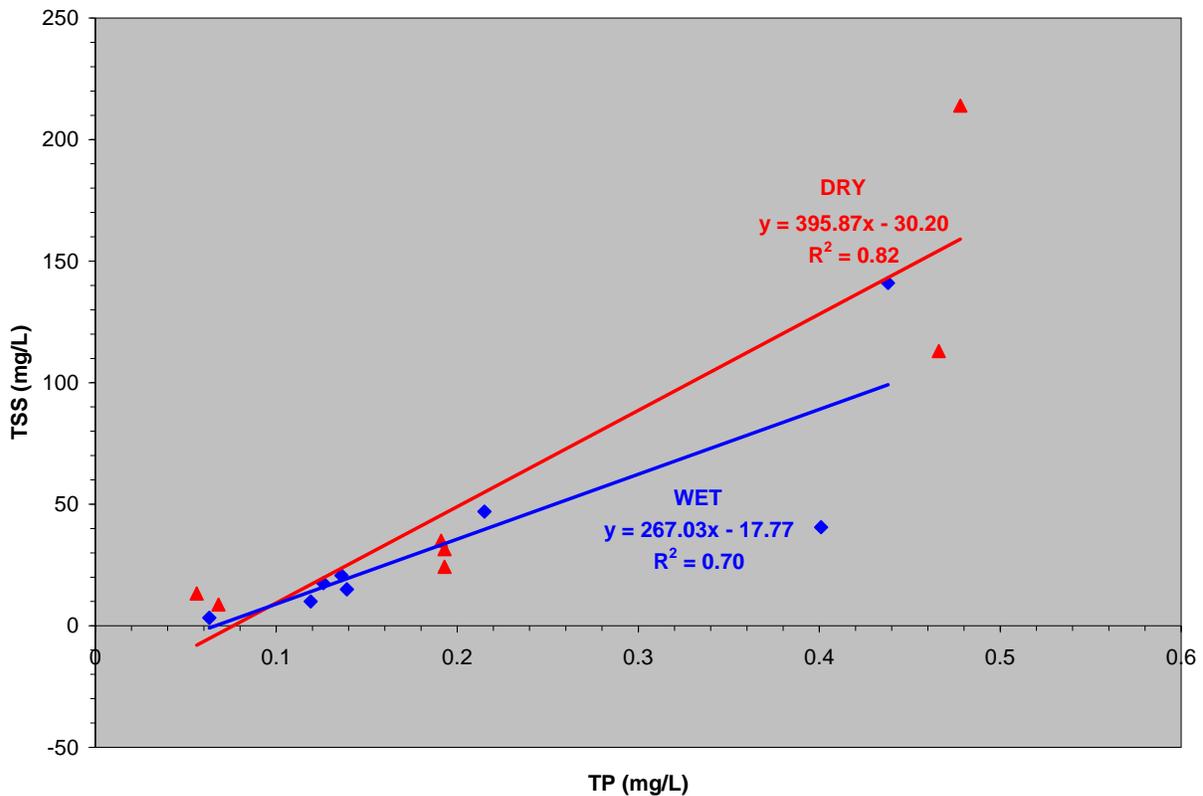
Figure 23: Plot of TP versus TSS concentrations at station S5 for wet and dry events.

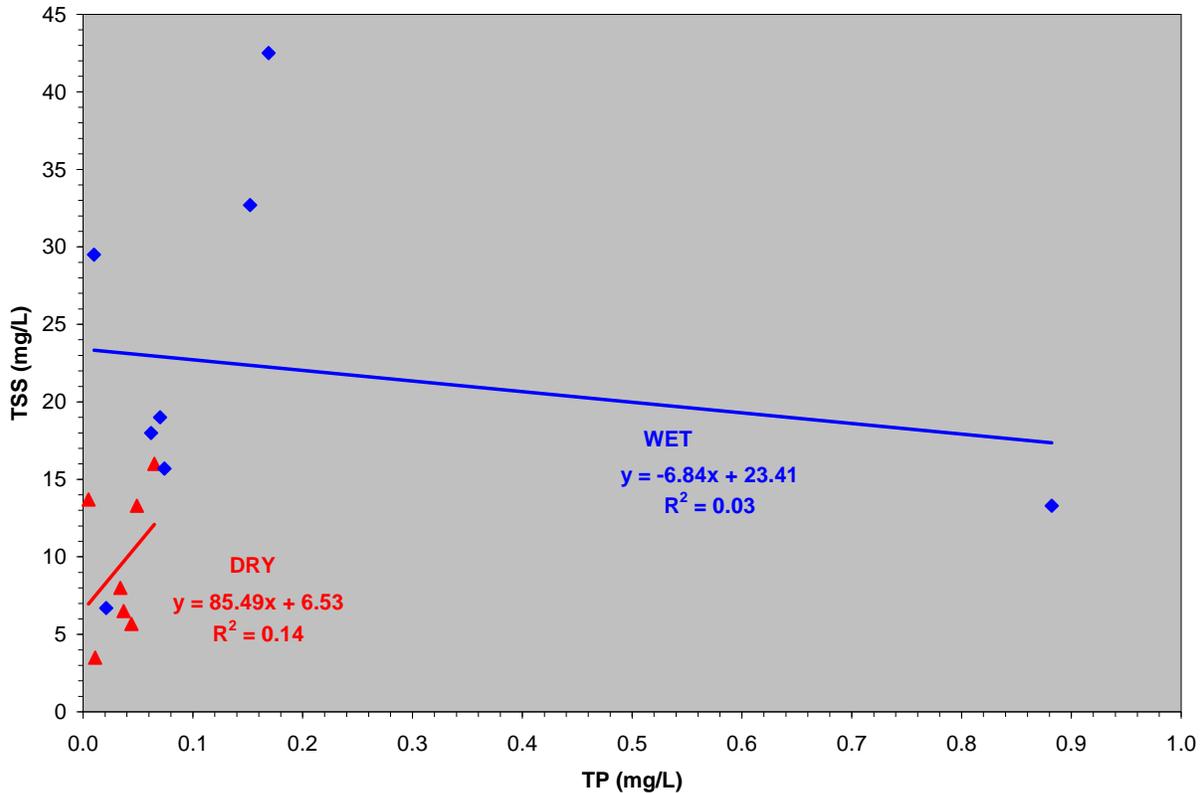
Figure 24: Plot of TP vs. TSS concentrations at station S7 for wet and dry events.

conditions. TSS averaged 9.52 mg/L in dry conditions and 22.18 mg/L in precipitation events. In addition, TSS levels only violated the state water quality standard three times throughout sampling at station S7 (Table 5). TP concentrations violated the state water quality standard six times (Table 5). There may be a source of phosphorus within the S7 subwatershed independent of suspended sediments in the Upper Salem River.

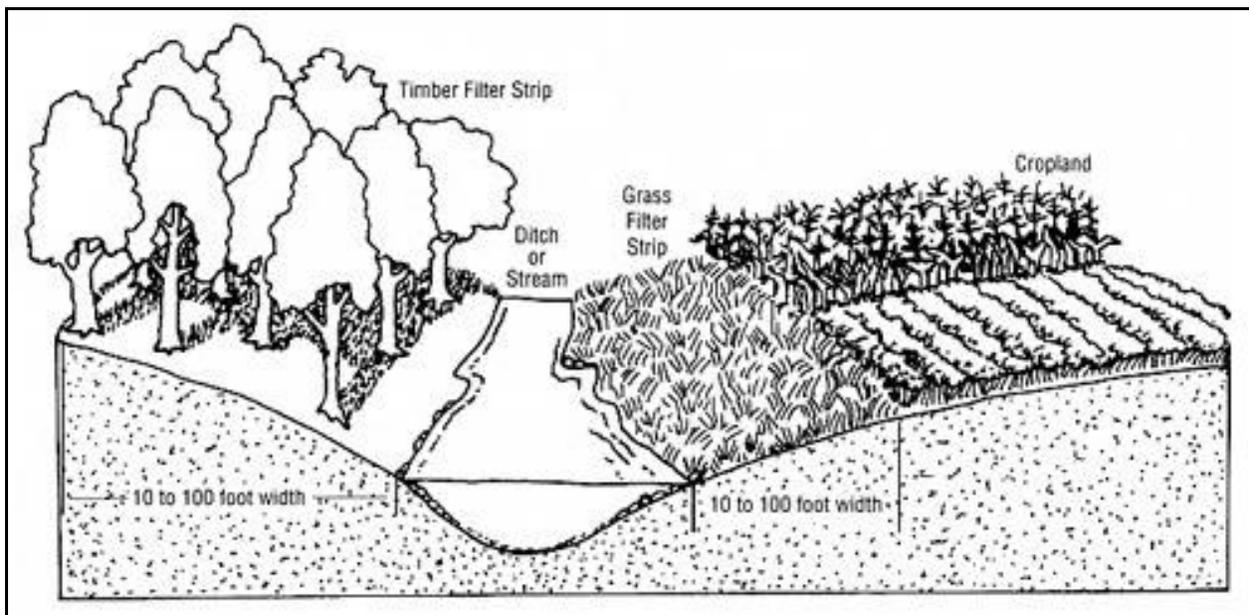
Figure A-3: Typical profile of a vegetated buffer in agricultural areas (FISRWG, 1998).

Vegetated filter strips can be effective in reducing sediment and other total suspended solids (TSS), as well as associated pollutants such as hydrocarbons, heavy metals, and nutrients. The TSS removal rates for vegetative filters depend upon the vegetation planted in the filter strip, but are estimated to range from 60 to 80% (NJDEP, 2004). The pollutant removal mechanisms include sedimentation, filtration, adsorption, infiltration, biological uptake, and microbial activity. Vegetated filter strips have a removal rate of 30% for phosphorus and nitrogen (NJDEP, 2004). Vegetated filter strips with planted or indigenous woods may also create shade along water bodies that decrease aquatic temperatures, provide a source of detritus and large

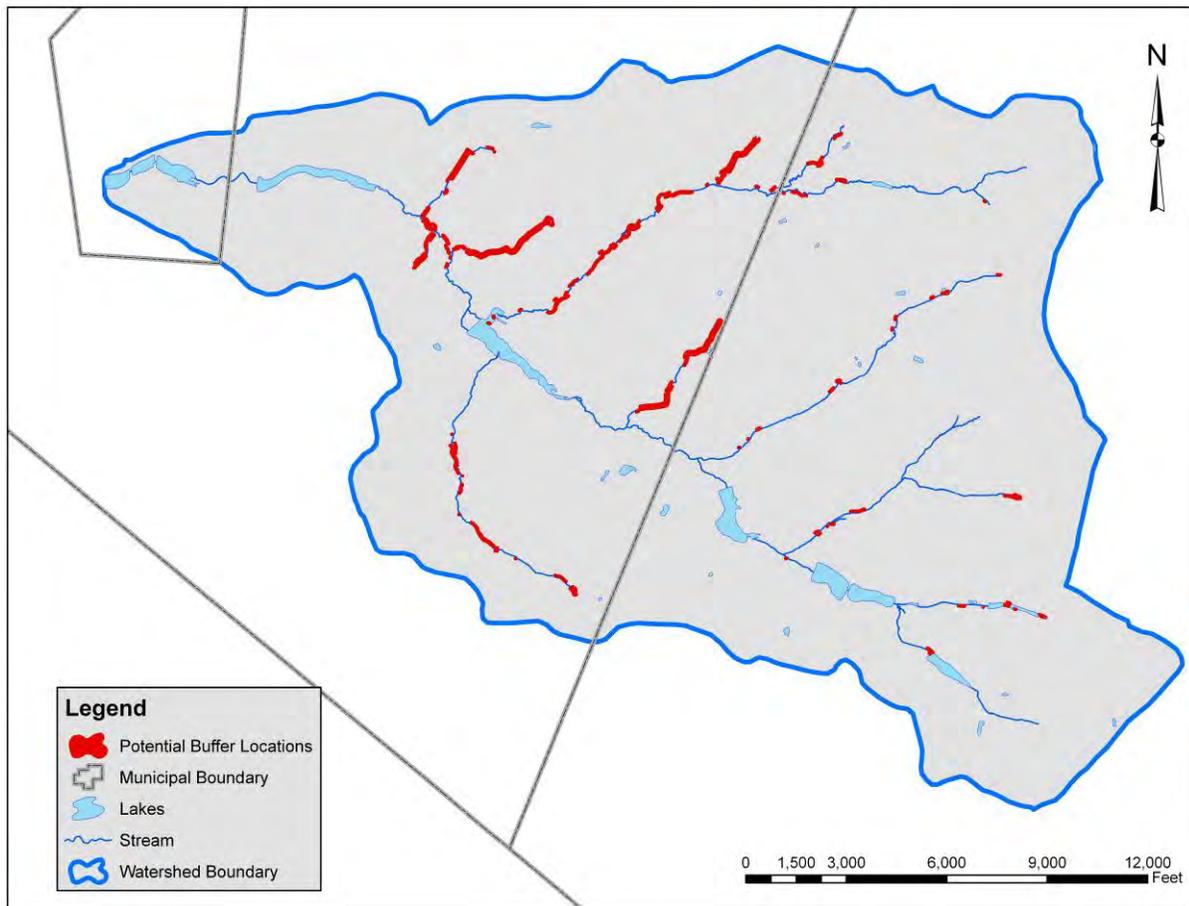
Figure A-4: Potential locations for vegetated buffers within the Upper Salem River Watershed.

Potential locations for vegetated stream buffers are found throughout the Upper Salem River Watershed (Figure A-4). The criteria used to determine buffer locations was to locate any agricultural land from the 2007 NJDEP land use data that was within 50 feet of streams and rivers (NJDEP, 2010). Any sites that met this criterion were chosen as potential sites for this BMP. This results in approximately 102,900 feet (19.5 miles) of potential vegetated buffer.

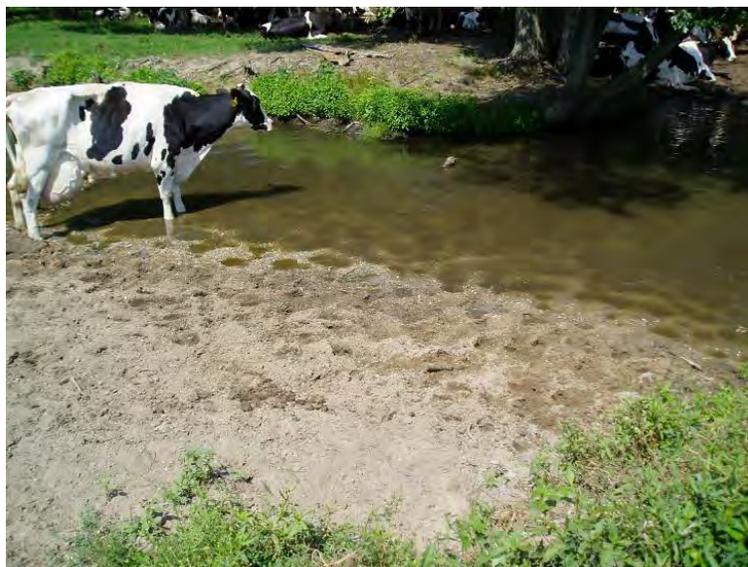
Figure A-6: Cattle with direct access to the Salem River.

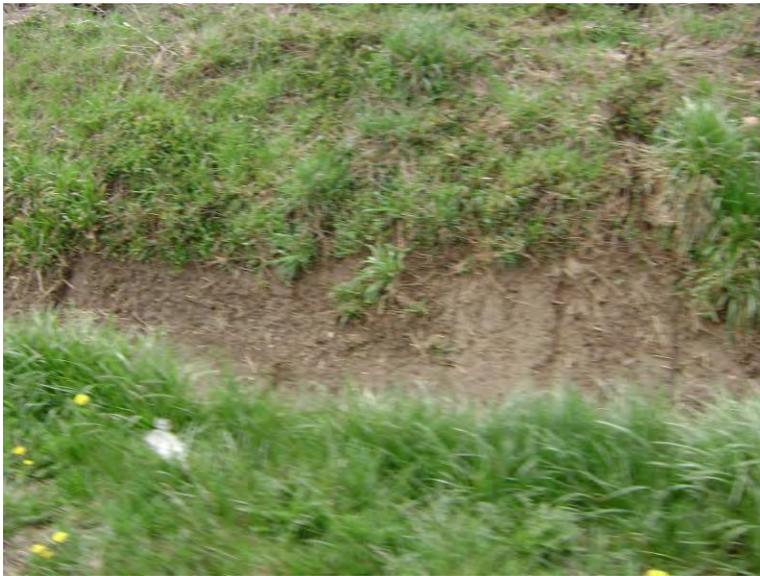
Figure A-7: Existing rural road drainage system in the Upper Salem River Watershed.

Water quality data collected in the Upper Salem River Watershed show total suspended solids (TSS) above the Surface Water Quality Standards (SWQS) in a few sampling locations. To address this concern for TSS and other pollutants (total phosphorus (TP) and bacteria) in the watershed, site visits were conducted. It was noted during these visits that TSS could originate from drainage systems along roadways in the watershed (Figure A-7). This appears to be a common problem in rural areas throughout the watershed.

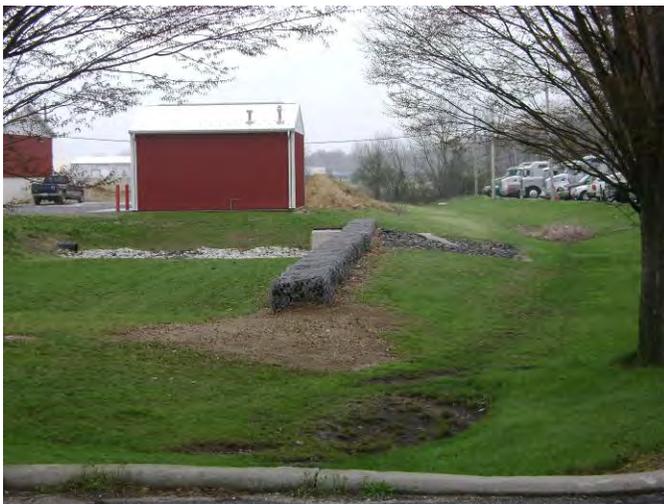
Figure A-9: Detention basin adjacent to the Pilesgrove Township Municipal Building.

After field inspection of potential sites in the Upper Salem River Watershed, the detention basin at the Pilesgrove Township Municipal Building was determined to be a priority location for retrofitting (Figure A-9). Due to the lack of vegetation in parts of the basin and high visibility of this project, the best option for improving water quality is to implement Alternative D: Native and Low Maintenance Grasses and Vegetation at this site.

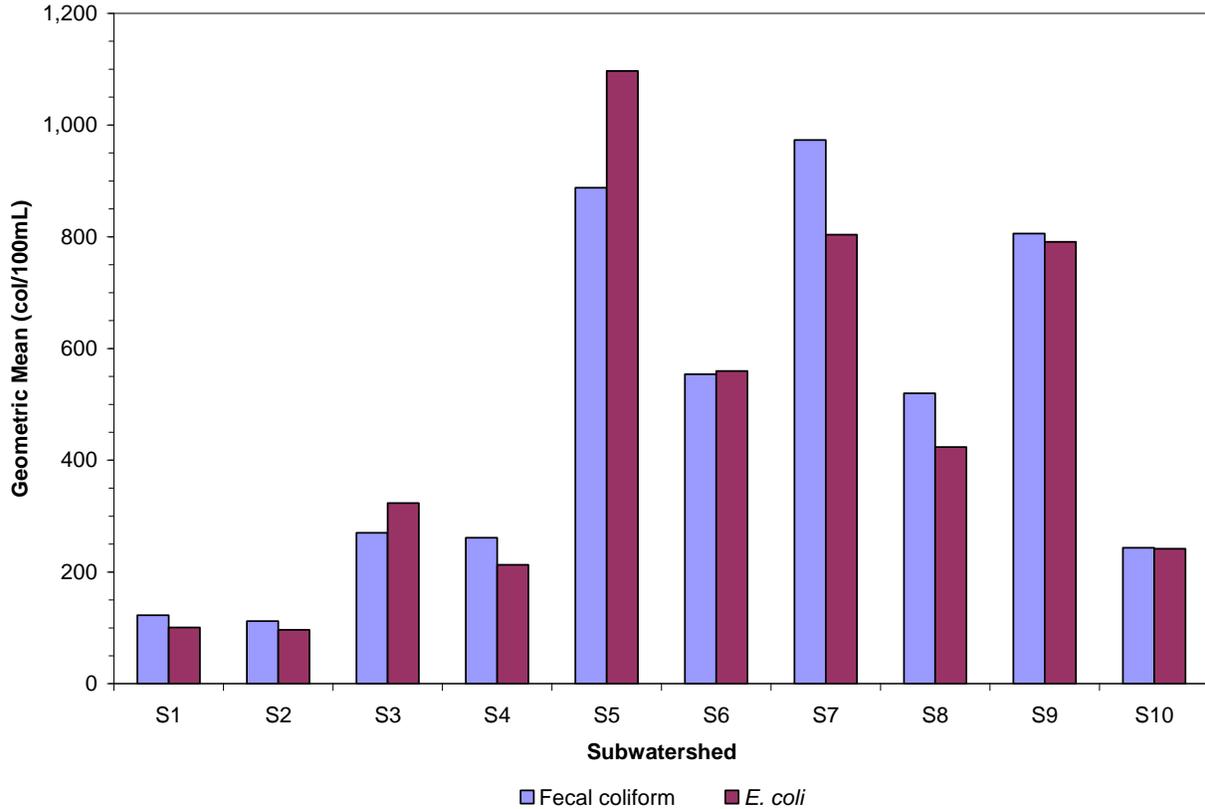
Figure A-11: Geometric mean concentrations of fecal coliform and *E. coli* in the Upper Salem River Watershed.

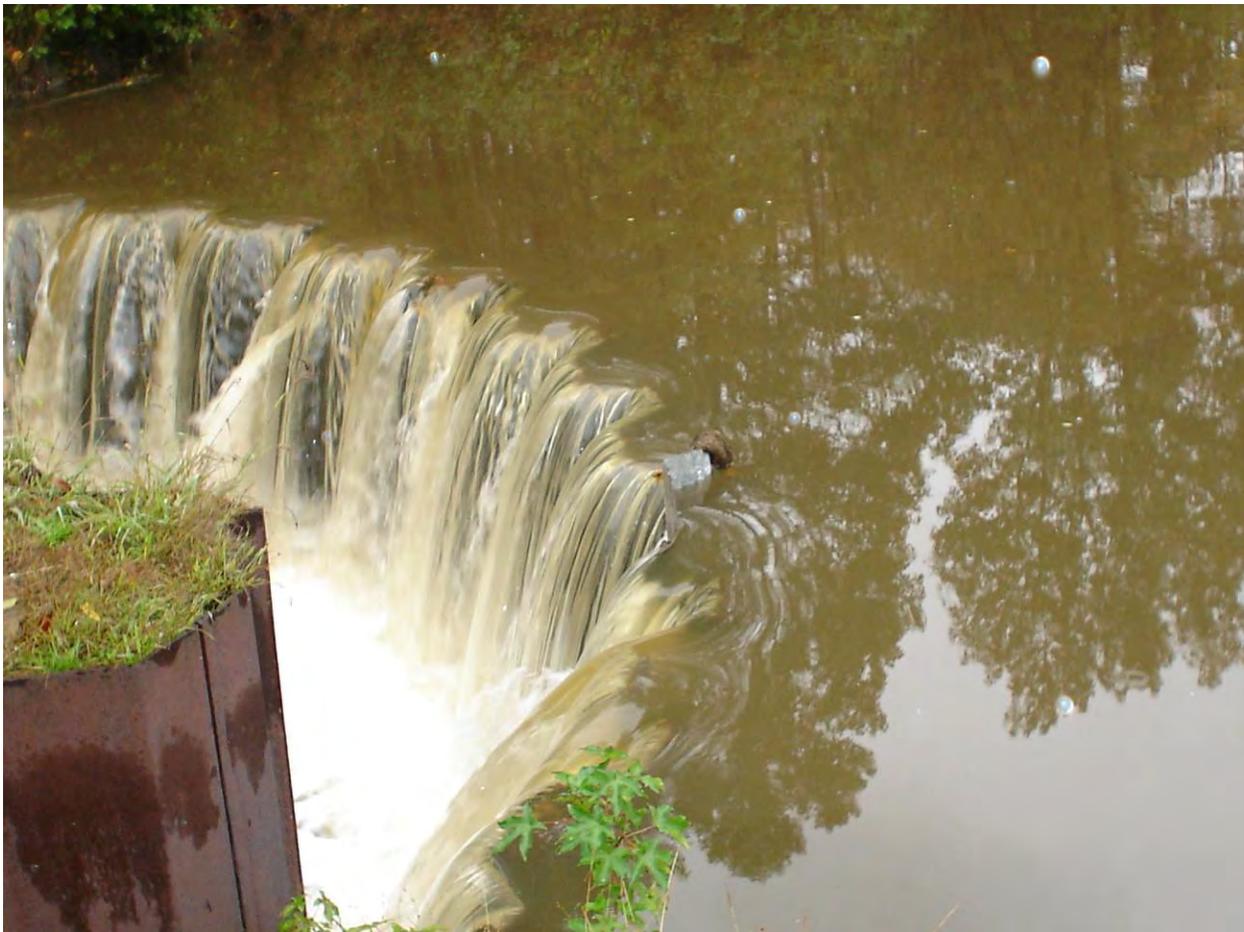
Figure A-15: Turbid discharge from Avis Mill Pond in the Upper Salem River Watershed.

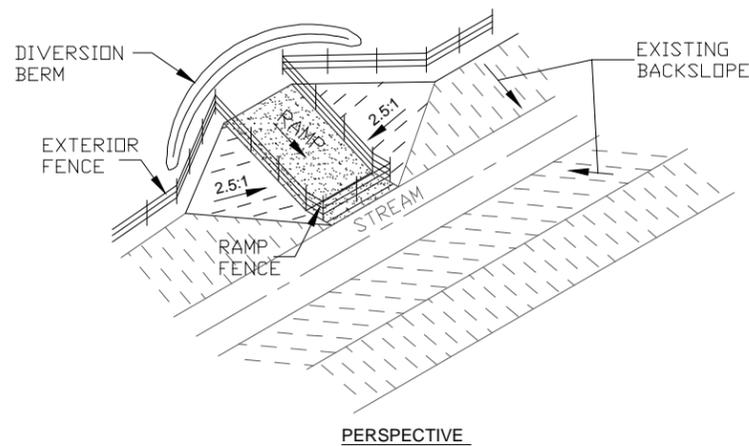
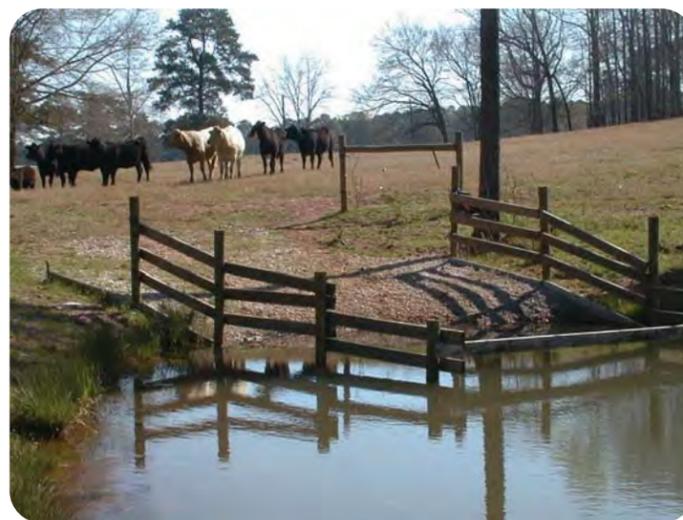
WATER ACCESS RAMP

Example of Access Ramp with Wooden Board Fencing

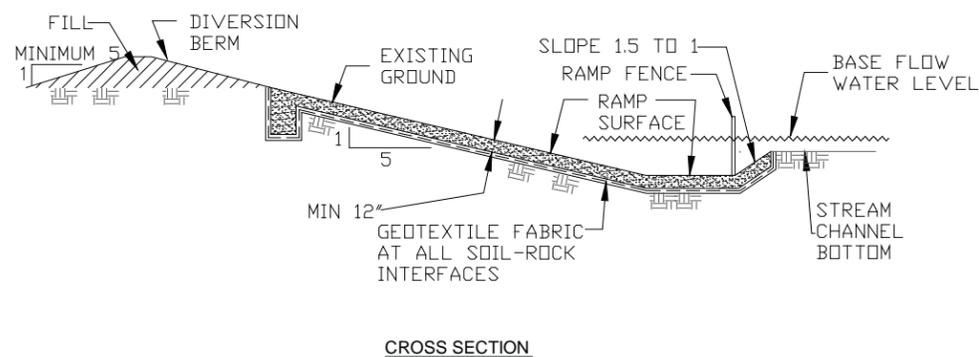
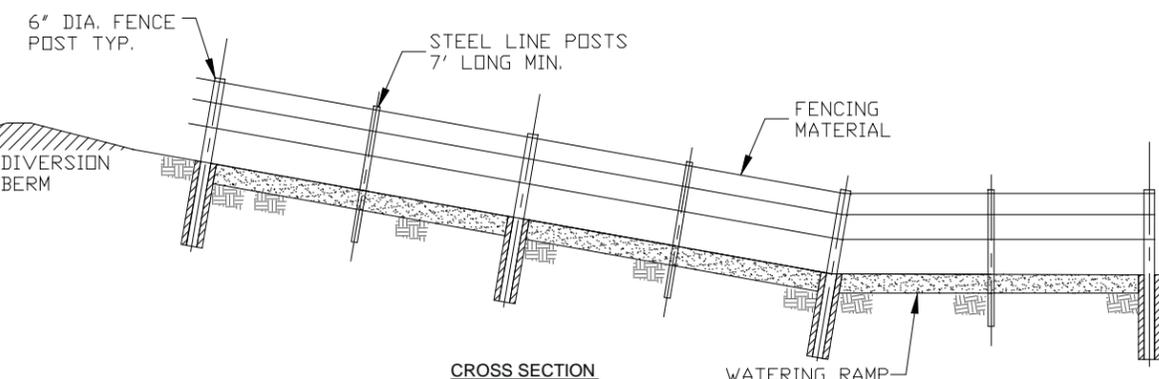
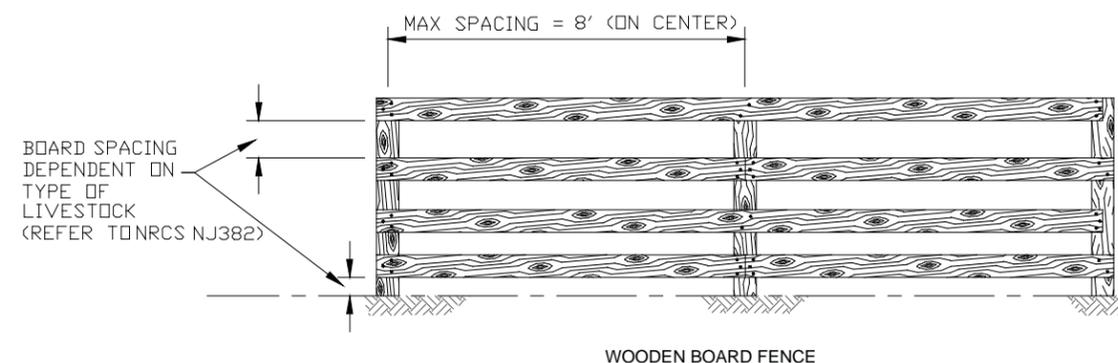
EXCLUSION FENCING

Woven Wire Fence

Barbed Wire Fence

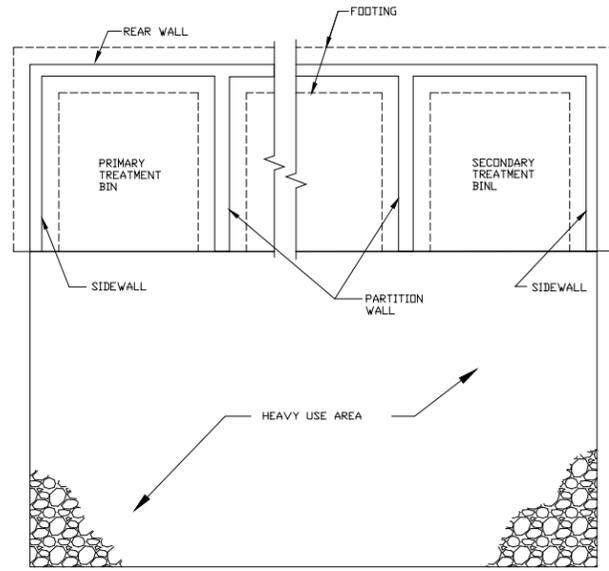
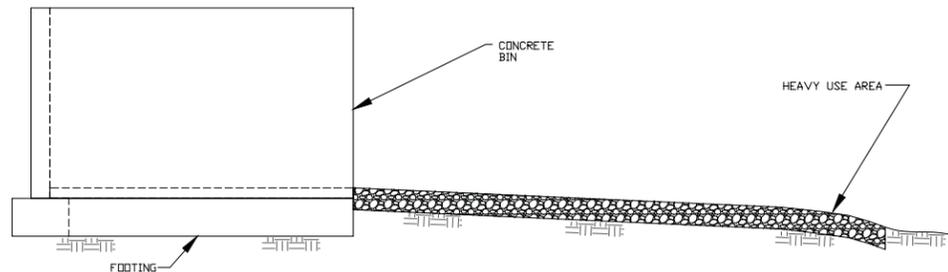
CONCRETE MANURE COMPOST BIN

PLAN

PROFILE

CROSS SECTION

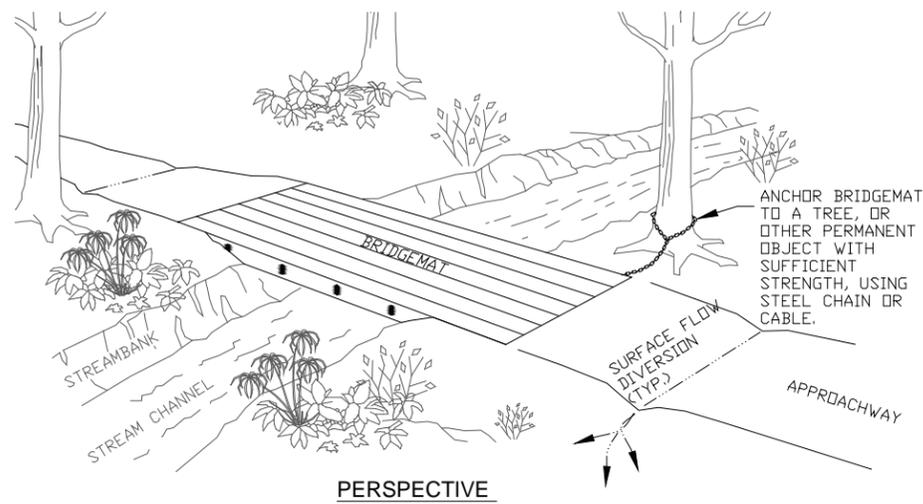
BRIDGEMAT CROSSING

Bridgemat Stream Crossing
