UPPER SALEM RIVER WATERSHED RESTORATION AND PROTECTION PLAN

Developed by the Rutgers Cooperative Extension Water Resources Program

November 20, 2012

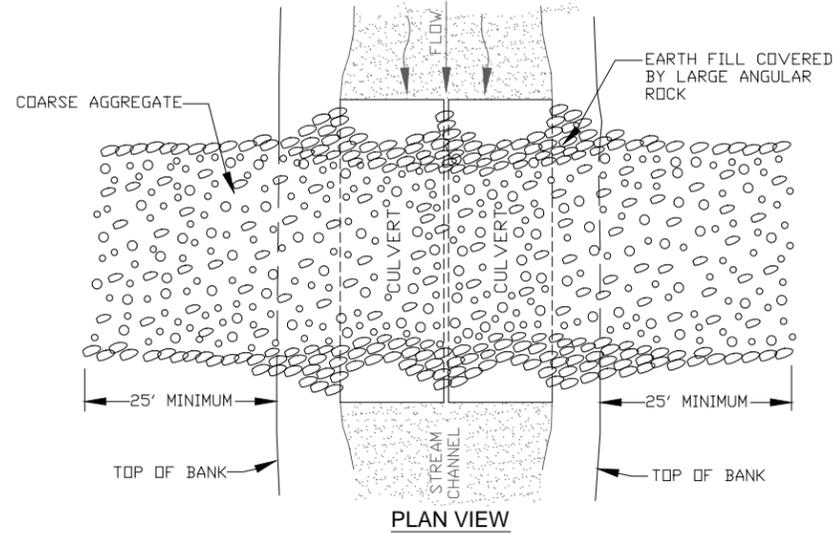
Single Pipe Stream Crossing

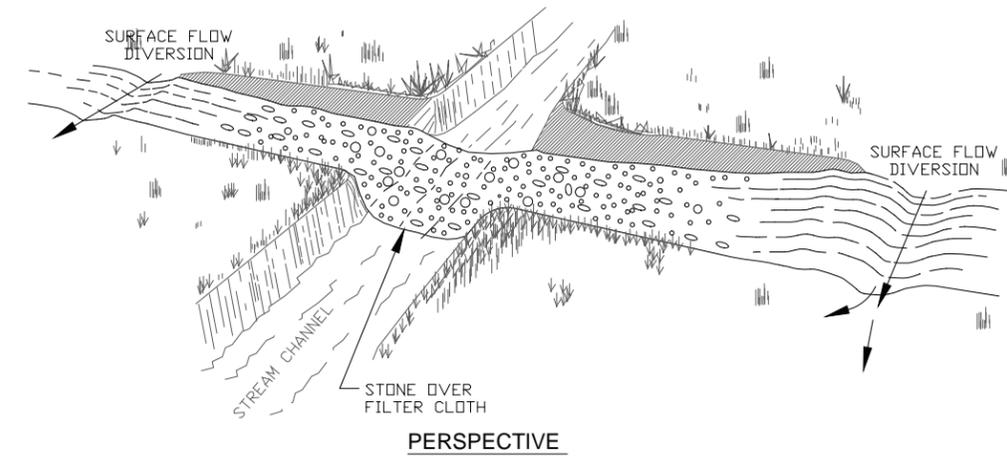
Construction of Stone Stream Crossing

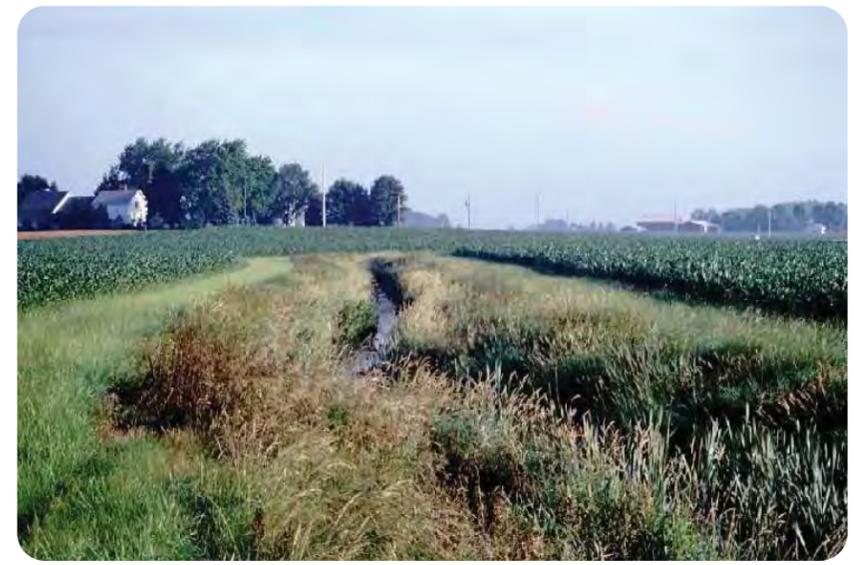
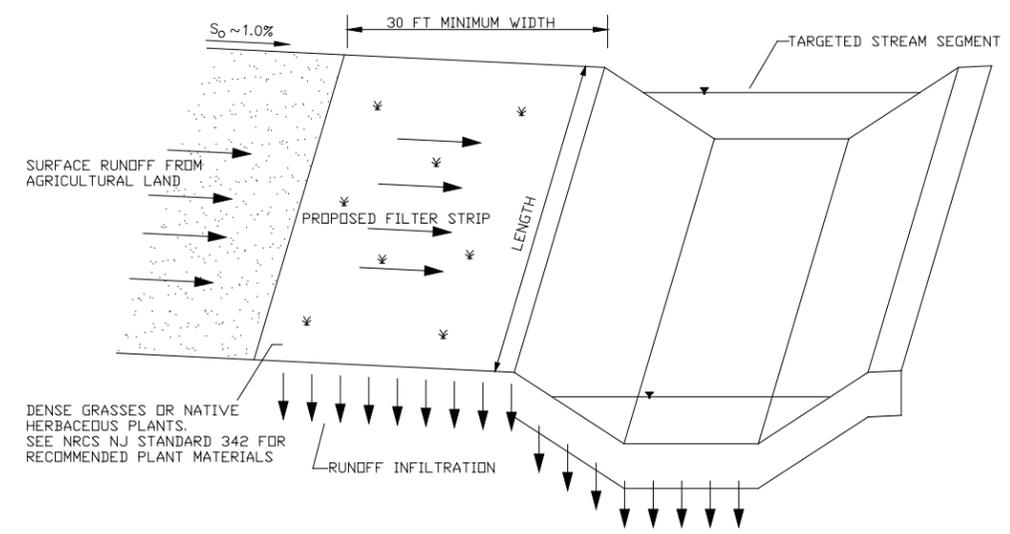
Grassed Filter Strip

PERSPECTIVE VIEW

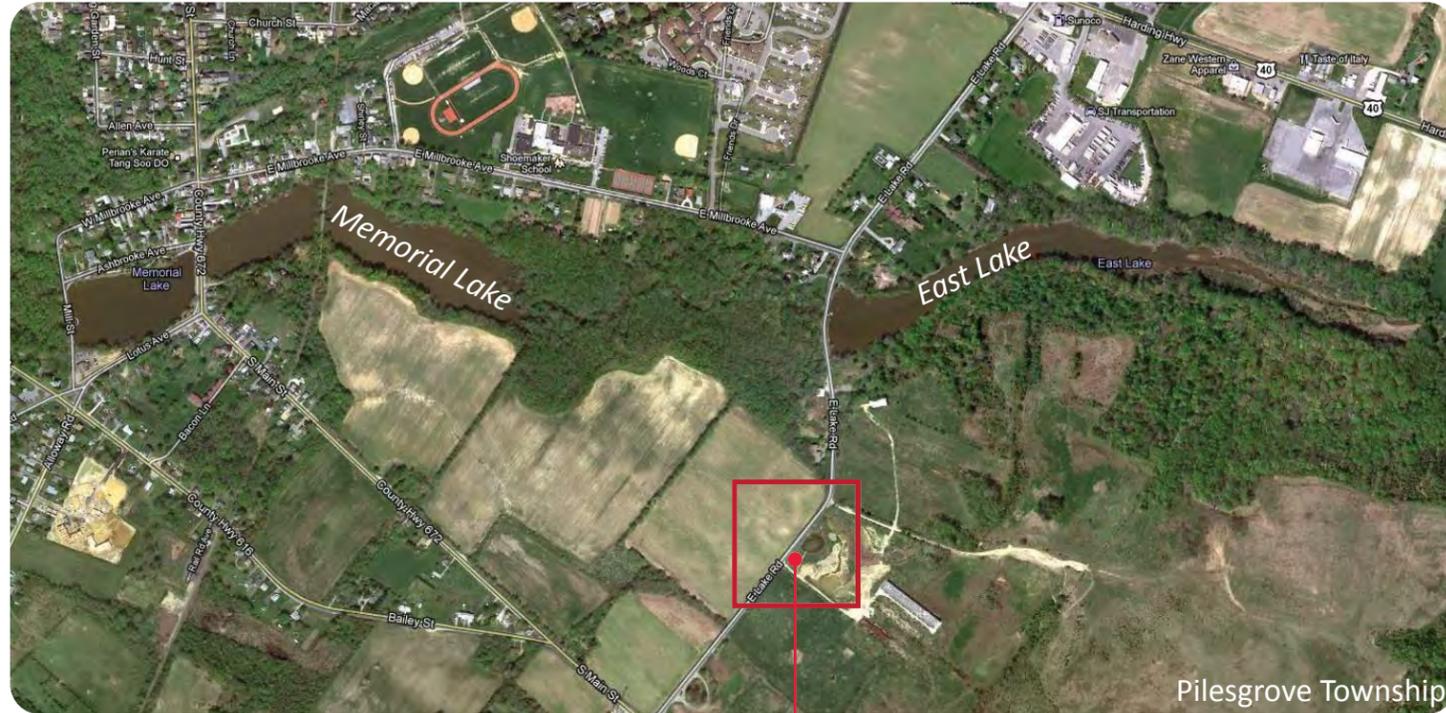
The drainage systems along East Lake Road convey runoff directly to East Lake.

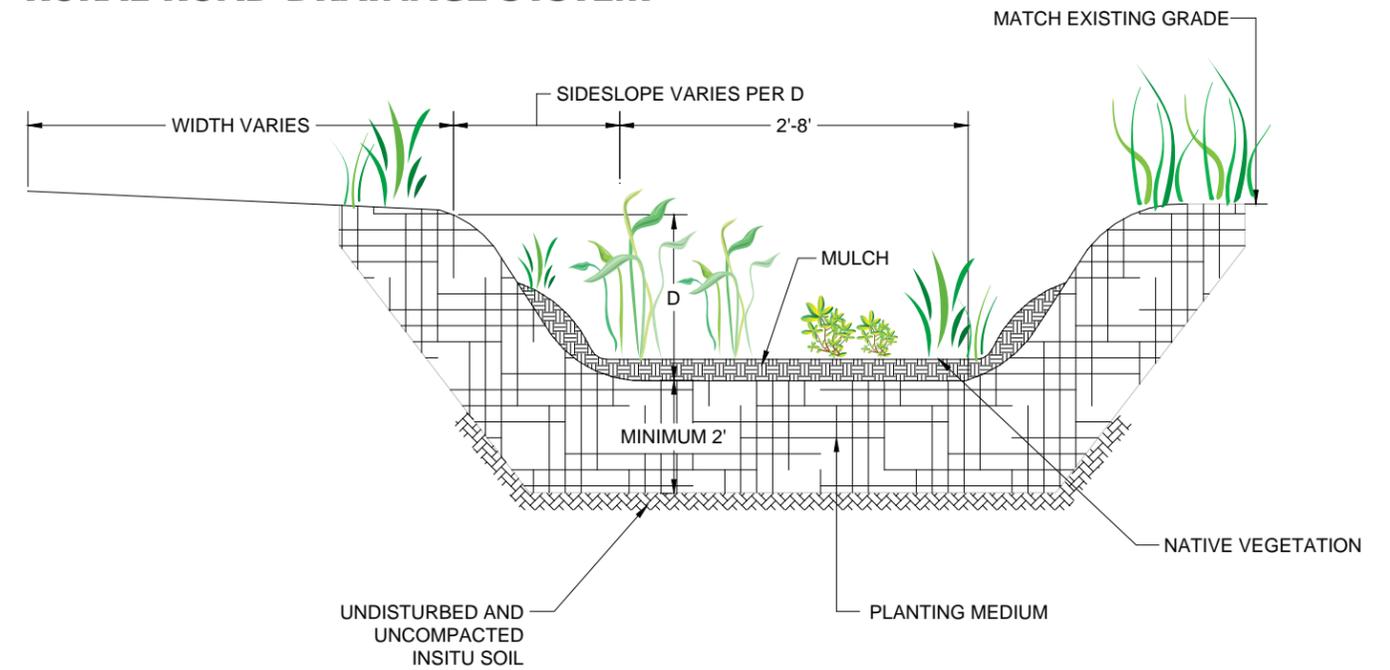
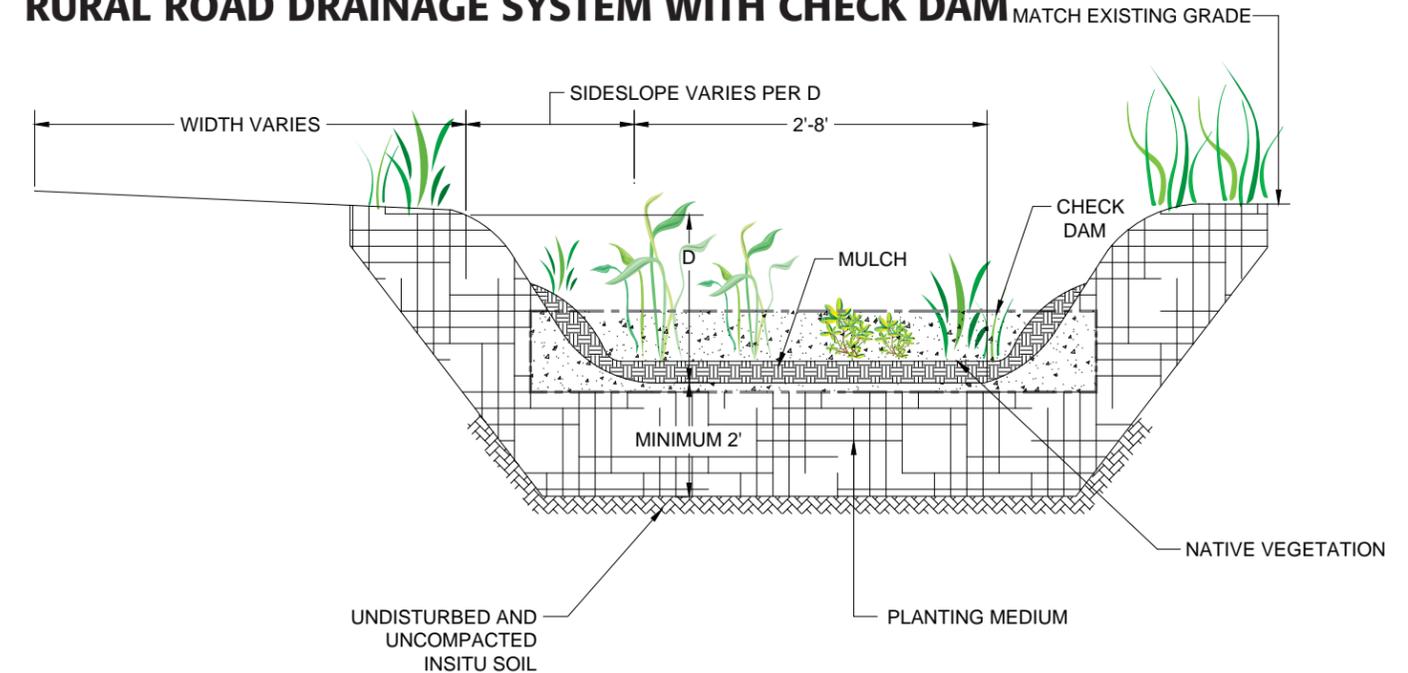
RURAL ROAD DRAINAGE SYSTEM WITH CHECK DAM

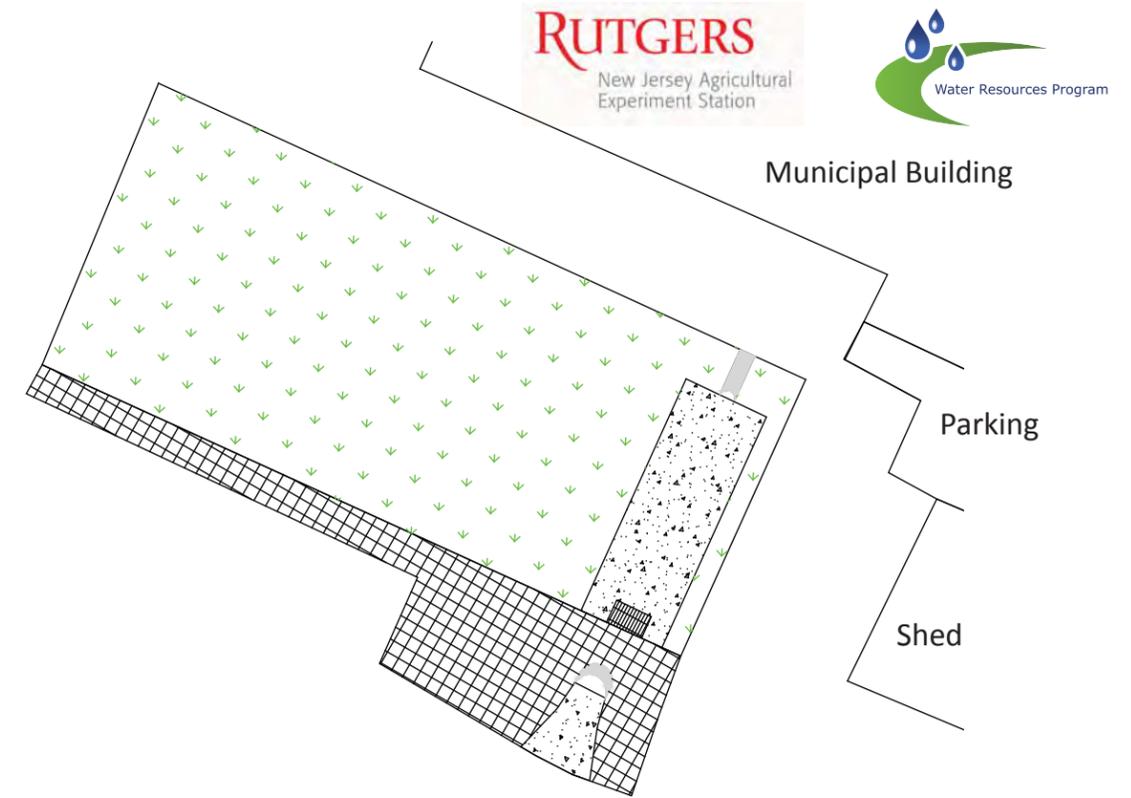
To improve the function of the detention basin, native vegetation should be established and the outlet modified to allow water to infiltrate into the basin. A stone sock will be placed in front of the outlet structure to allow small storms to infiltrate while larger storms will bypass over the sock.
