NJ FACE INVESTIGATION REPORT

FACE 05-NJ-077

Recycling Collector Dies After Falling Under the Wheels of His Truck

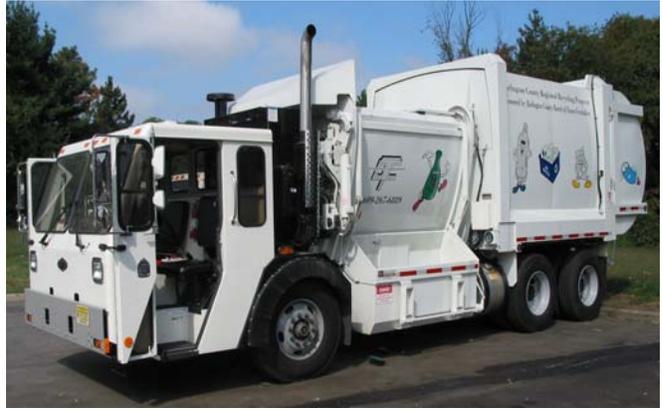
This truck was a new vehicle that had been in service for two months and had only been used about ten times. The chassis was designed with the cab located forward of the front tires, allowing the cab to be low to the ground for easy entry. The cab was equipped with bi-fold

doors on each side that could remain open during operation. The doorways were equipped with large handrails and a small step for entering the truck. The cab had seating for three people, and both the driver's and passengers' seats could be folded down for easy entry and exit. This allowed the truck to be operated from a standing position so the driver could easily leave the cab to collect.

Photo 1
Recycling Collection Truck

Mounted to the chassis was a collecting and compacting device, which had been built by a different manufacturer than the truck chassis. This device was designed to be side-loading, with large bins mounted to each side of the truck. The collectors would deposit recyclables into the bins and then would activate a mechanism that raised the bins to the top of the truck where the contents were dumped into the truck's compactor.

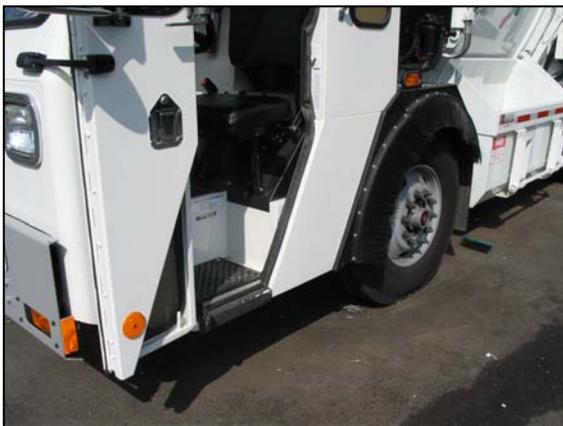
Photo 2
Entry Step to Recycling Truck

Discussion: The recycling center was using a new truck that had just been put into service. Most of the center's 34 other trucks were equipped with riding steps for the collectors to stand on between pickups. This truck was designed without a riding step, and the crew was to ride in the passenger compartment between stops. However, the crew had apparently not been properly trained on this type of truck, and improvised by using misusing the entrance step as a riding step. To prevent future incidents, all employees should be trained on the safe use of all the different types of collection vehicles, including the use of riding steps, roadway collection procedures, compactor operation, and basic maintenance. This training may be reinforced by using safety signs that clearly identify riding and non-riding steps on each truck.

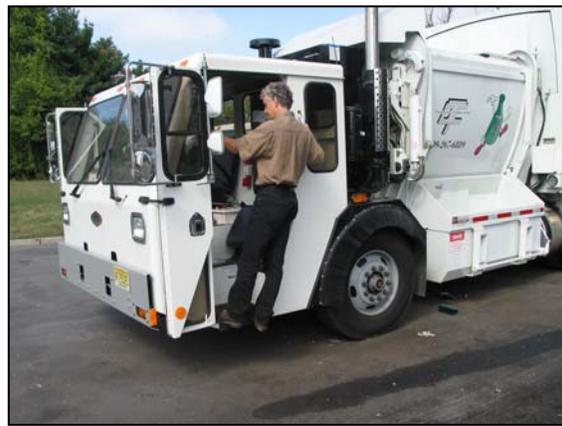
Photo 3
Position of Victim on Entry Step

The driver prepared to back the truck to collect recyclables on the street they had just passed. The victim, wearing a florescent vest, stood behind the truck to spot for the driver as the second collector entered the passenger side of the truck. After backing the truck to the turn, the driver called for the victim to jump or hop onto the truck, which he did by standing on the small step leading to the cab and holding on to the metal handles beside the door. This step was not designed to be a riding step and was built only to access the truck cab. As the driver started to move forward to make the turn, the victim's hands slipped off the handles and he fell forward of the turning front tire. The driver felt a bump and heard a popping noise and immediately heard the victim yell, "You're on my legs!" The driver stopped the truck and put it in reverse to back off of the victim, who was lying face down on the road and bleeding from leg and pelvic injuries. The driver went to check on the victim and called 911 on his cell phone as the other laborer went to the nearby intersection to get help. The first 911 call was received at 9:41 a.m., and the first responding police units started first aid on the victim. EMS arrived and transported the victim to a schoolyard where he was picked up by a Medevac helicopter and airlifted to the regional trauma center. Despite treatment, the victim went into shock and was pronounced dead of his injuries at 12:48 p.m. that day.
