CONCEPT DEVELOPMENT REPORT

ROCKFALL MITIGATION OF ROUTE I-80 WESTBOUND MILEPOSTS 1.04-1.45 TOWNSHIP OF HARDWICK WARREN COUNTY

SEPTEMBER 2011

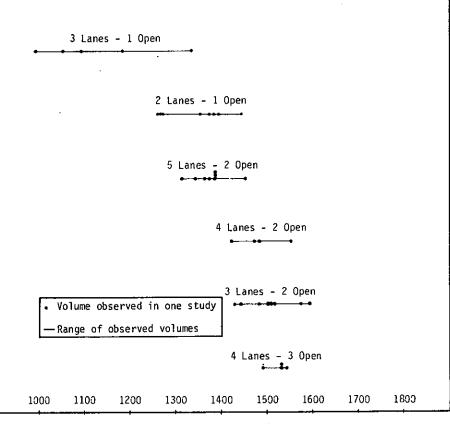
Figure 6-11 shows the range of capacities measured at several worksites in Texas, with an active work crew at the site. The observations are taken to be approximate capacities, as continuous queues of vehicles were present upstream of the sites included.

Figure 6-11. Range of observed work zone capacities—work crew at site. (Source: C.L. Dudek and S.H. Richards, "Traffic Capacity Through Urban Freeway Work Zones in Texas," Transportation Research Record 869, 1982)

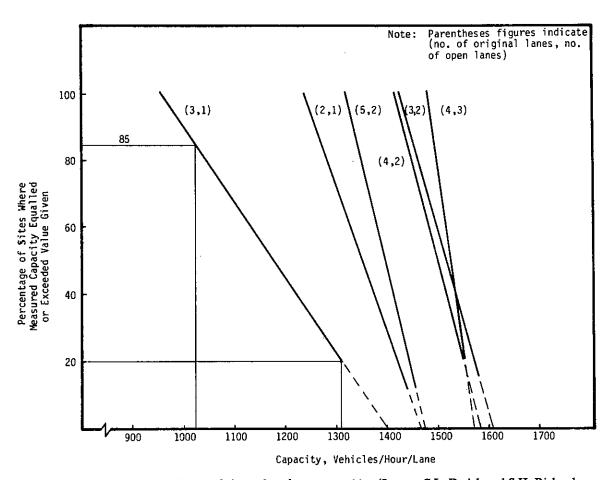
Figure 6-12. Cumulative distribution of observed work zone capacities. (Source: C.L. Dudek and S.H. Richards, "Traffic Capacity Through Urban Freeway Work Zones in Texas," Transporation Research Record 869, 1982)

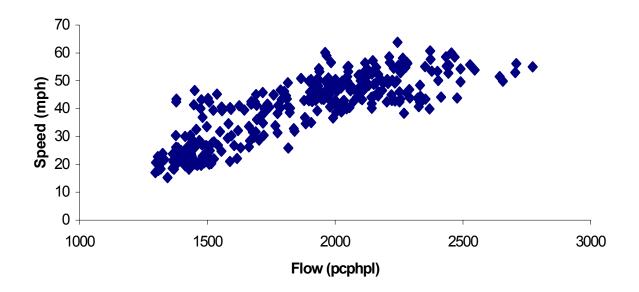
Figure 8.1 Flow Vs Speed for Maximum Flow Conditions

This equation was used to establish the lower part (congested part) of the speed-flow curve. Thus, it is used in determining capacity values and flow rates when speed is below the optimal speed (speed at capacity). The free flow part of the curve (when speed is higher than the optimal speed) is based on information from HCM 2000, ideal capacity values from the field data as shown in Table 8.1, and knowledge of the authors. A speed range of 65 mph to 40 mph was used to establish the speed-flow curves. The capacity for each speed level was decided considering all of the above mentioned factors. It was also decided that the flow at which the free flow speed begins to drops is at 1300 pcphpl. This value is based on the information in HCM2000 and knowledge of the authors. The speed drop between 1300 pcphpl and the capacity value is based on the following equation which is obtained from the above discussion:

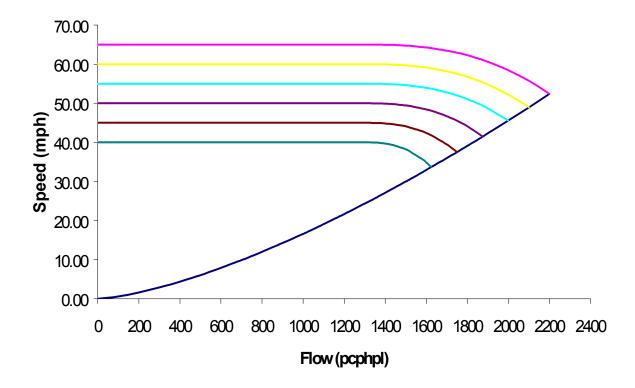
The exponent of 2.6 used in Equation 8.2 is used in HCM 2000 for comparable equations (Chapter 23 - Basic Freeway Sections). Putting the upper and lower parts of the speed-flow curves resulted in a series of speed-flow curve as shown in Figure 8.2. Figure 8.2 is developed in this study and there is no specific reference for this curve in the literature. It is based on the findings from the field data, knowledge of authors about capacity and traffic flow and information that is available in HCM.

Figure 8.2 Speed-Flow Curves for Work Zones

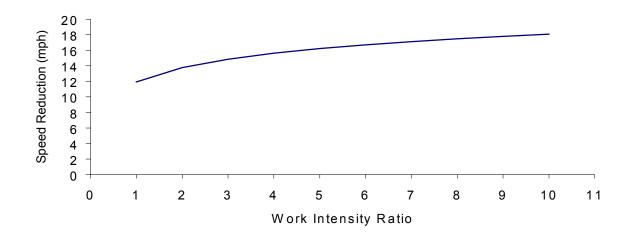
Figure 8.3 Work Intensity Ratio Vs Speed reduction- Short Term

The data used for arriving at this relationship had wide variation in speed reduction because different drivers react differently. We could average the data and could get higher R^2 values but that will conceal the variation in data that will give a wrong impression. So we took the actual values.

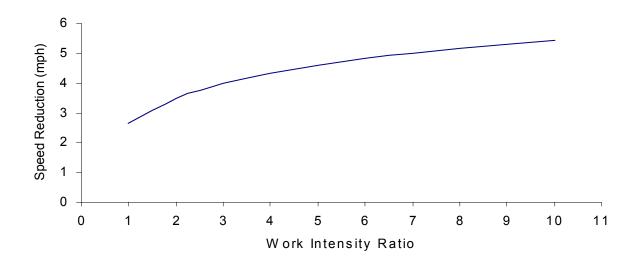
Figure 8.4 Work Intensity Vs Speed Reduction - Long Term

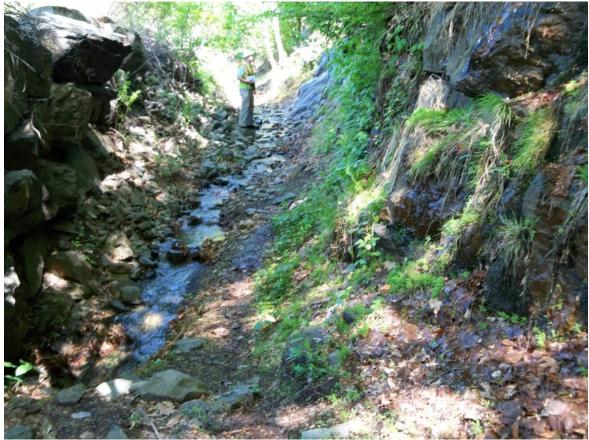
Photo 1 – Existing Drainage Ditch With Stacked Stone Wall to the Left

In the eastern half of Area A between approximately M.P. 1.11 and M.P. 1.15, a 4-foot wide concrete drainage ditch runs parallel to the roadway directly behind the stone wall. The drainage ditch ends at a corrugated metal pipe, approximately 18 inches in diameter, which crosses under Route I-80 and discharges into the Delaware River. It appears that the ditch was constructed as a concrete channel to capture water seepage from the rock face. Recent field investigation indicates that the concrete lining is broken or covered with soil in many areas; however, portions of the concrete channel remain intact. Palustrine forested wetlands exist along the ditch. The photographs in Appendix E show the drainage ditch, corrugated metal pipe, and some recent rockfall illustrated by the newly broken tree trunks.

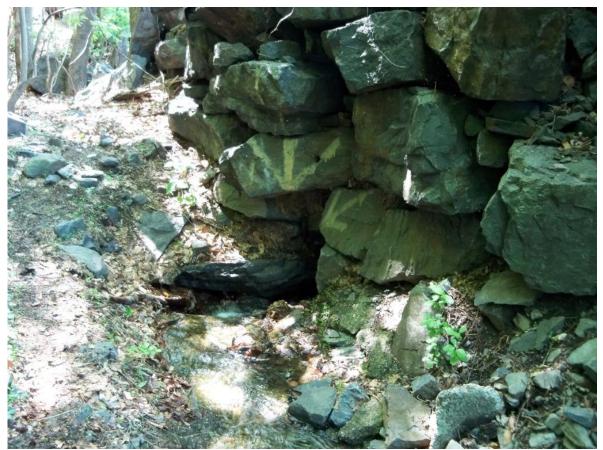
Photo 2 – Back of Stacked Stone Wall

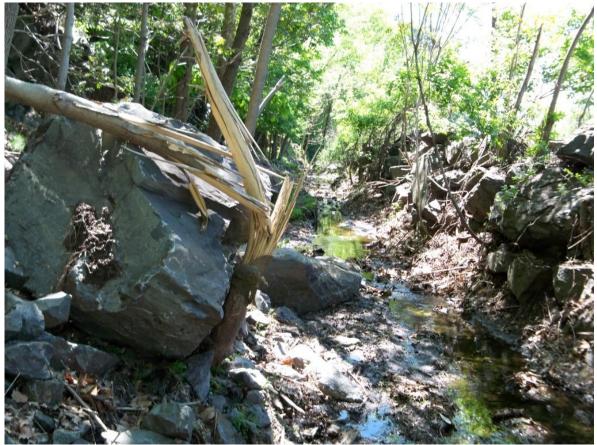
Photo 3 – Broken Tree Trunk, Evidence of Recent Rockfall

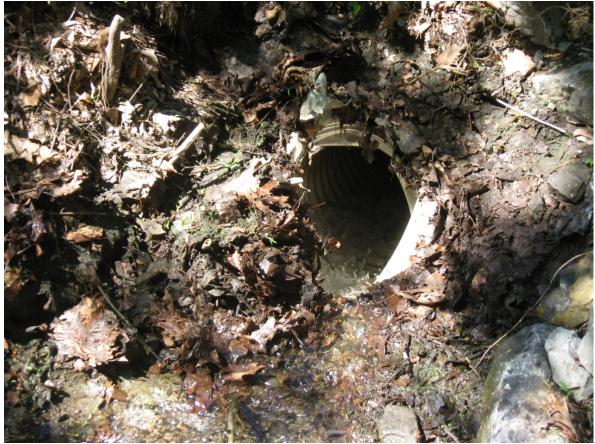
Photo 4 – 18"± Corrugated Metal Pipe Across Route I-80

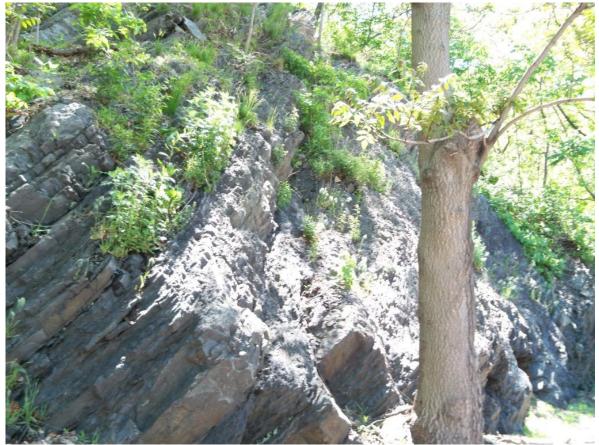
Photo 5 – Typical Rock of Area B

The 2009 rockfall hazard rating for this area is 630 out of 1000. The rock discontinuity and bedding orientations were considered generally favorable because they are sloped away from the face into the rock mass. The height and inclination of the slope in this area ranges from approximately 900 to 1,100 feet and 1H:1V to 2H:1V, respectively. Rock at this location is primarily siltstone and quartzite with some shale. Fracture spacing is generally one (1) to six (6) feet, with a fracture thickness of roughly one-quarter (0.25) inch to two (2) inches. Joint weathering varies from slight to moderate with no apparent infilling or slickensides. Generally, the rock is slightly weathered.

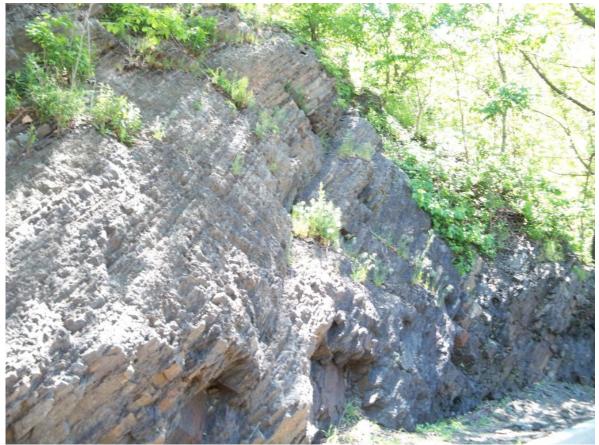
Photo 6 – Typical Rock of Area B

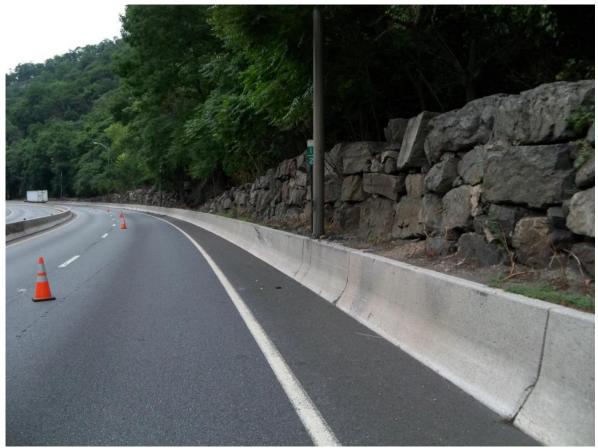
Photo 7 – General view of Westbound Route I-80, Looking West

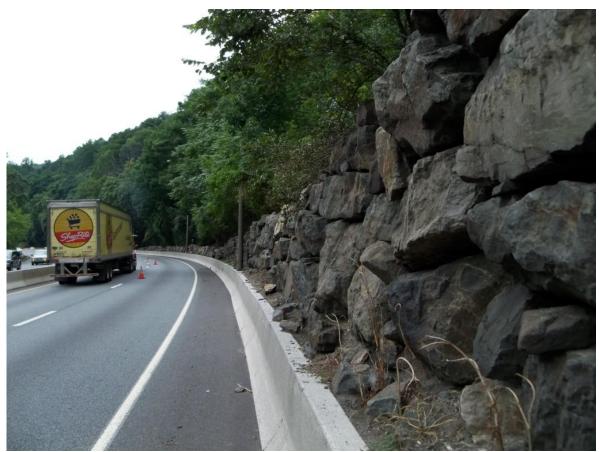
Photo 8 - Close-up View of Stacked Stone Wall on top of Barrier Curb

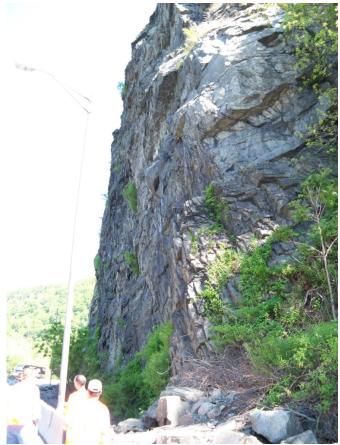
Photo 9 – Large Rock Face in Area C

The 2009 rockfall hazard rating for this area is 662 out of 1000. Rock discontinuities and bedding orientation were considered generally favorable because they are sloped away from the face, but only dip into the face slightly as they are near horizontal. The height and inclination of the slope in this area ranges from approximately 1,000 to 1,200 feet and 1H:10V to 2H:1V, respectively. Rock at this location is principally siltstone. Fracture spacing is generally two (2) to twenty-four (24) inches, with a fracture thickness of roughly one-tenth (0.1) to one (1) inch. Joint weathering varied from slight to moderate

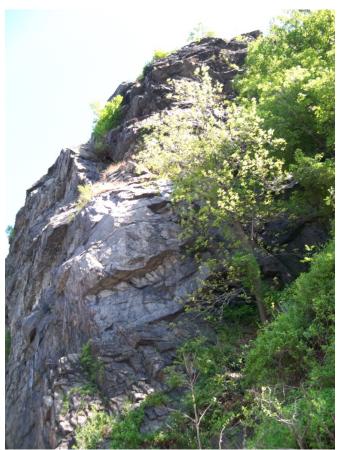
Photo 10 – Overhang near Top of Large Rock Face in Area C

with no apparent infilling or slickensides. Generally, the rock is slightly weathered. An overhanging knob of rock is present roughly two-thirds of the way up the lower slope, and is considered to be a hazard by NJDOT. Further investigation is required during the Preliminary Engineering phase to verify if this entire height is part of the source contributing to rockfall and if the rockfall is capable of reaching the roadway.

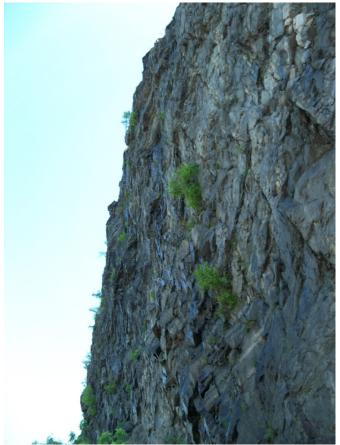
Photo 11 – Close-up view of Top of Large Rock Face in Area C

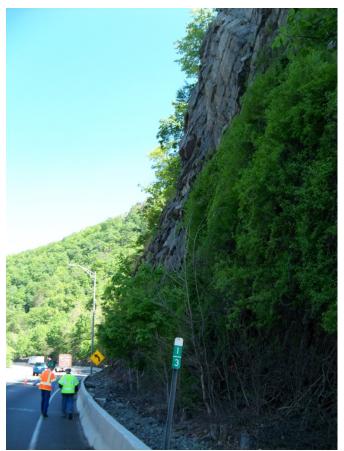
Photo 12 – East end of the Large Rock Face in Area C

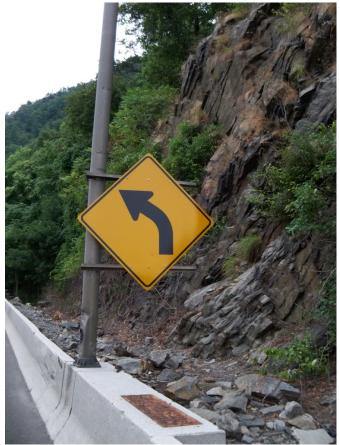
Photo 13 - Loose Rock Accumulated at bottom of Rock Cut

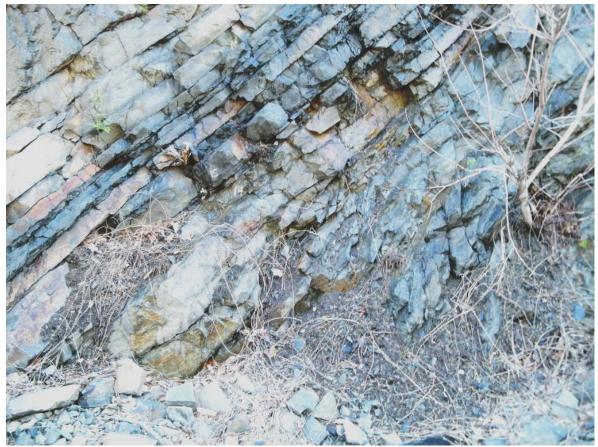
Photo 14 – View of Typical Rock in Area C

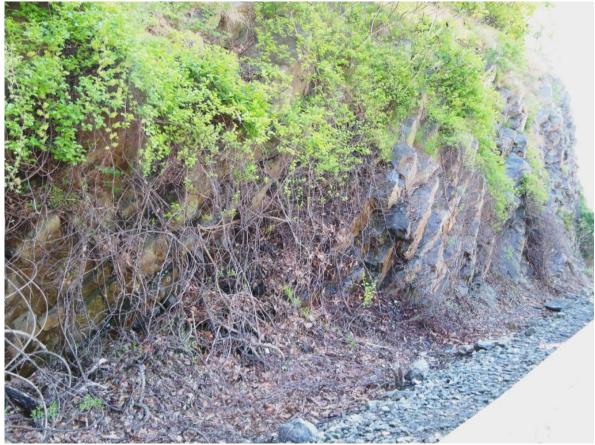
Photo 15 – Typical Catchment Area in East side of Area C

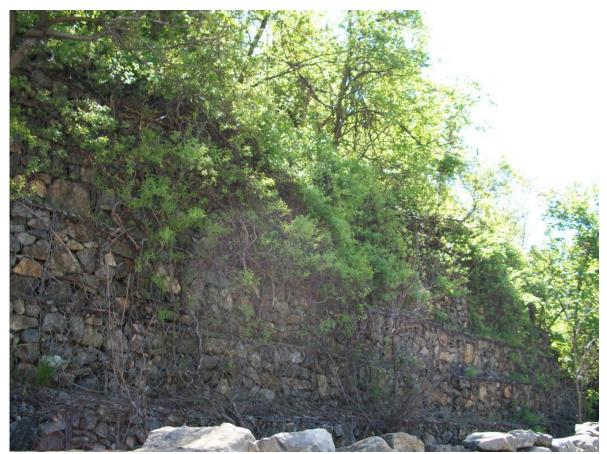
Photo 16 – Existing Gabion Wall

The eastern portion of Area C has an existing gabion wall roughly 18 feet high and 85 feet long. Based on a review of as-built drawings and observed site conditions, the wall is inferred to be approximately nine (9) feet wide and founded roughly one (1) foot below the ground surface. According to NJDOT maintenance, this gabion wall was built in approximately 2007 or 2008 after a small landslide. It appears to be in satisfactory condition and is effectively mitigating some degree of rockfall. The vertical rock face in this area is setback further from the roadway while the gabion wall is at a similar offset to the vertical face in the western portion of Area C.

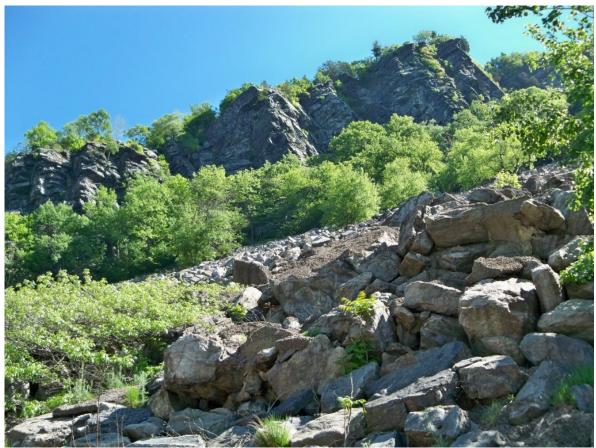
Photo 17 – Talus Slope in Area D

The 2009 rockfall hazard rating for this area is 422 out of 1000. The talus slope was formed by rock falling from the overhead source area to a marginally stable slope. The surface of the talus slope is likely comprised of Shawangunk Formation rocks including sandstone, siltstone, shale, quartzite, and conglomerate. The talus appears to be stable, with no distress or instability noticed in the slope or roadway. A few trees are growing on the slope. The age or source activity of the talus slope is unknown. Based on the literature search, the source area is believed to be from the Shawangunk Formation, likely quartzite and conglomerate.

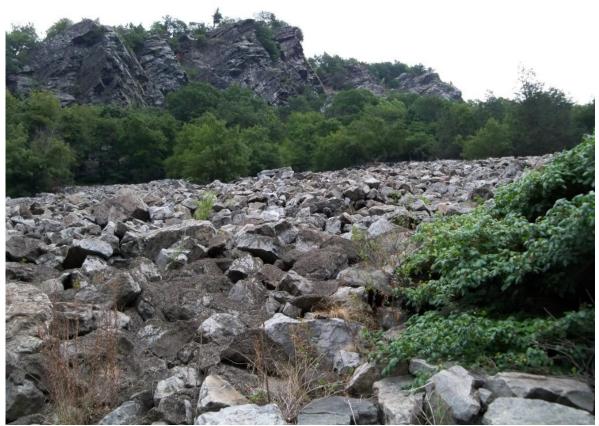
Photo 18 – General View of Talus Slope in Area D

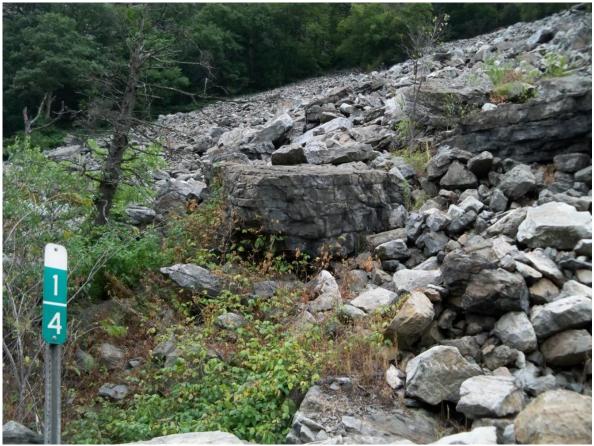
Photo 19 – Large Boulders near the Bottom of the Talus Slope

The literature search revealed that the bedrock below the talus slope is from the Martinsburg Formation and is likely of less strength and more susceptible to weathering. The largest rock on the talus slope appears to be about ten (10) feet by ten (10) feet by five (5) feet, estimated to weigh roughly 37 tons. At the toe of slope, individual rocks roughly two (2) to three (3) feet in diameter were previously placed. This is evident by the holes drilled in the rock for lifting purposes and the grout found in the open spaces.

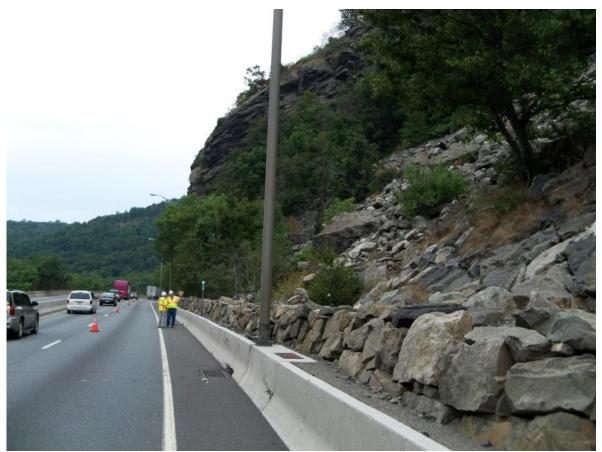
Photo 20 - General View of Westbound Route I-80 with Talus Slope

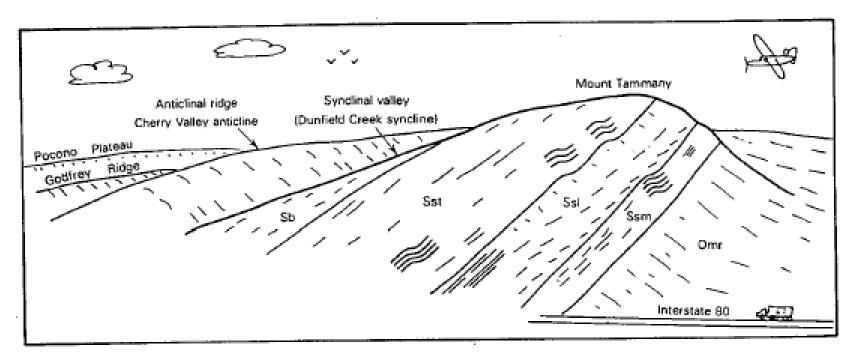
Figure 11.

Sketch from photograph looking northeastward into New Jersey from Stop 4 showing the geology at Delaware Water Gap. A few satellitic folds in the Shawangunk Formation are indicated. Relief between the Delaware River and Mt. Tammany is 1260 feet (384 m). Sb, Bloomsburg Red Beds; Sst, Ssl, and Ssm, Tammany, Lizard Creek, and Minsi Members of the Shawangunk Formation; Omr, Ramseyburg Member of the Martinsburg Formation, which is talus covered in the area of the sketch.

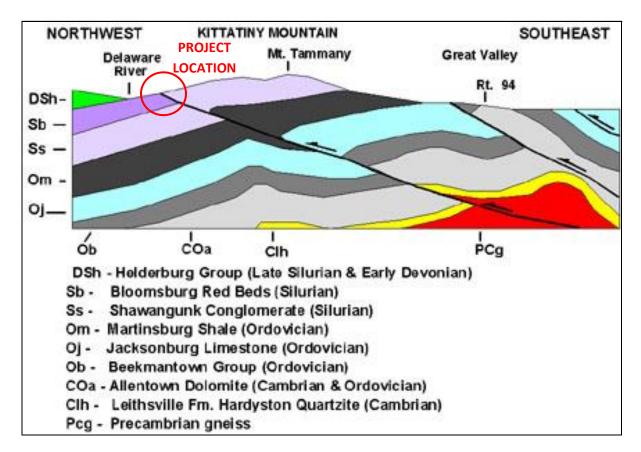
Figure 2 –Generalized Geologic Cross Section of Kittatinny Mountain at the Delaware Water Gap Area (after Lyttle & Epstein, 1987)

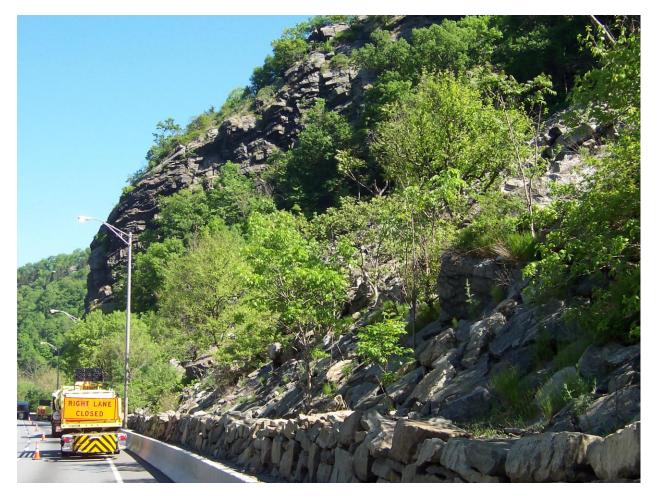
Area D observations; in this area, a large rock face is set some distance back from the roadway making the mobilization of equipment difficult. A large area of broken rock slopes down toward the roadway and ends at a 2'-3' stacked stone wall that sits approximately 1' behind the barrier face. This area may be a candidate for a catchment fence.

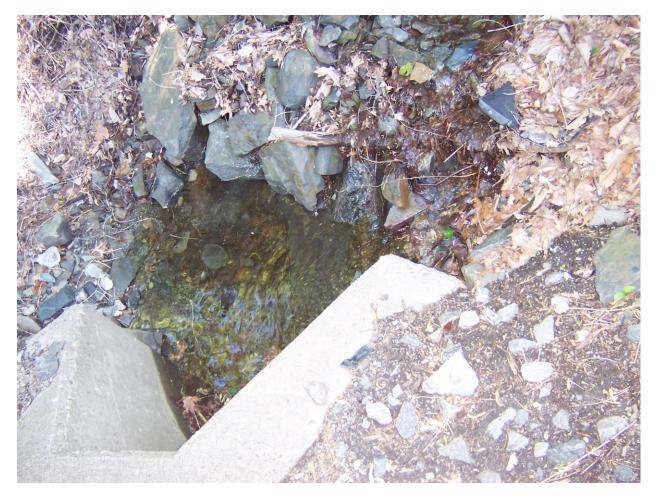
Area B observations; there is a drainage crossing located in this area. There is a very large vertical face set a far distance back from the roadway however, this face will not be directly addressed. There is stacked stone set at the height of the barrier curb which extends 3'-4' high. The area is a possible candidate for catchment fencing however, special treatment in the area of the drainage crossing will need to be addressed.

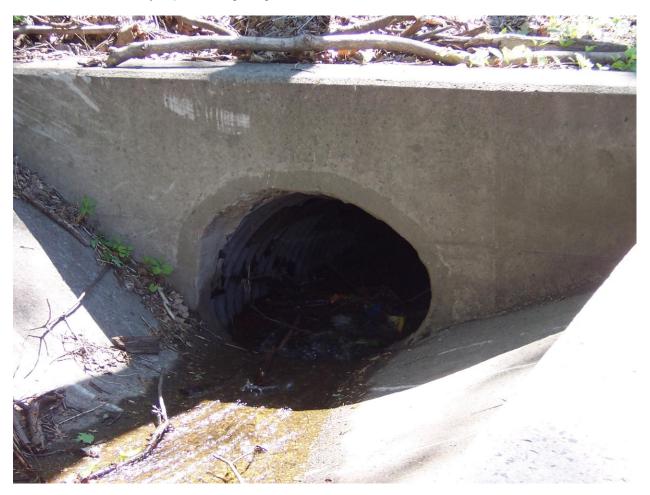
Area A observations; there is a drainage ditch which runs parallel to the roadway and approximately 8' – 10' behind the barrier curb for most of area A. The ditch ends at an approximately 18" CM pipe which is believed to cross under I-80. Further investigation of this crossing is required as the 18" pipe appears to run along westbound I-80 and uphill rather than along the roadway, and surface indications in the area were lacking. Scott Sheldon indicated that Maintenance forces would need future access to this area in order to keep the ditch cleaned of debris. Several team members expressed concern about triggering environmental issues by implementing mitigation measures in this area.

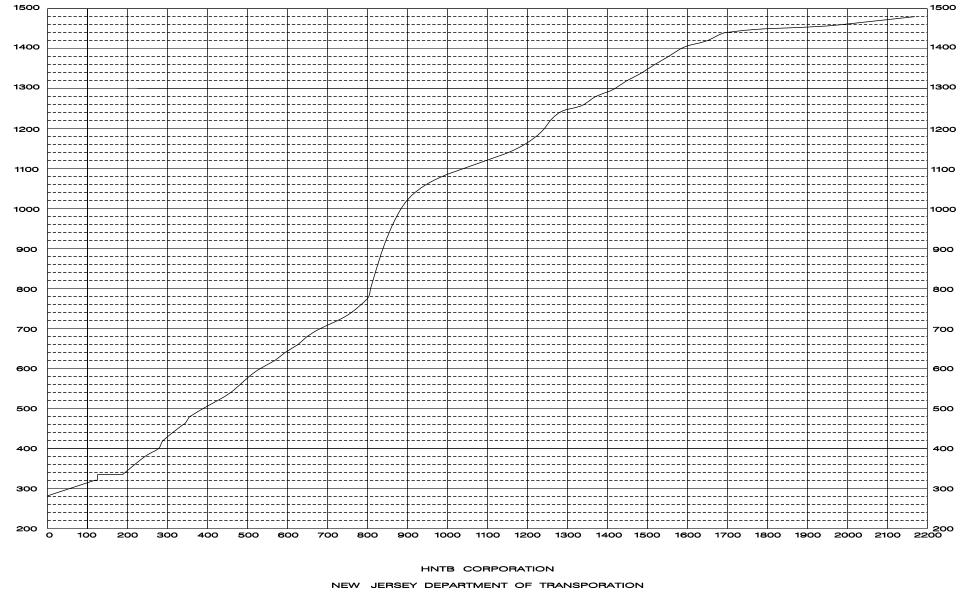
PRELIMINARY ASSUMED CROSS SECTION OF AREA D

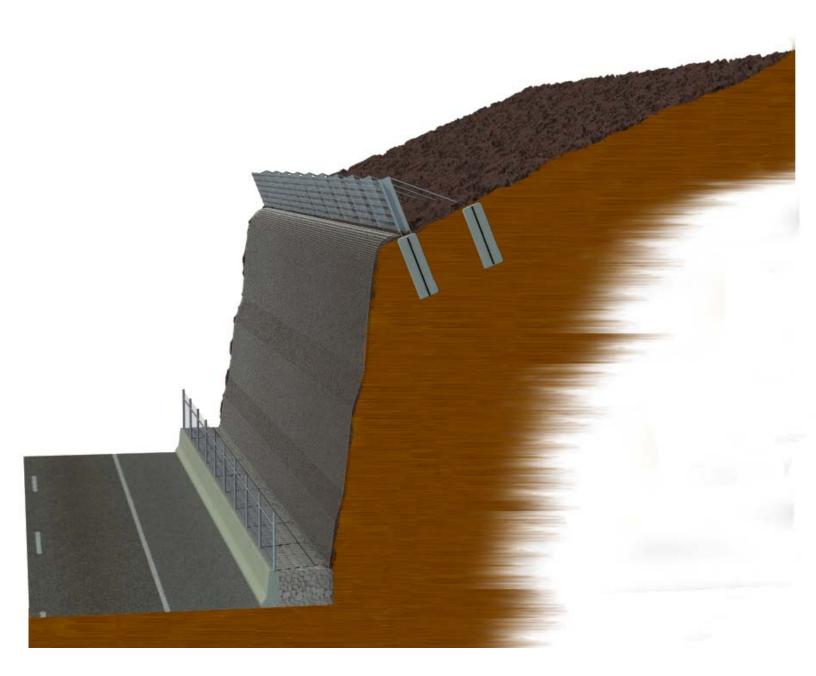
FIGURE 1

AREA C (MP 1.25 - 1.35) CONCEPTUAL SKETCH SHOWING PROPOSED HYBRID ROCKFALL PROTECTION SYSTEM AND CATCHMENT FENCE

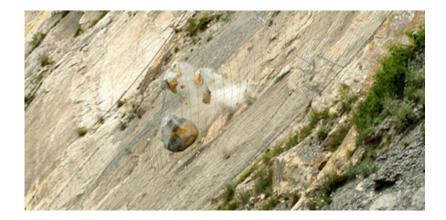
Hybrid rockfall protection barriers and catch fences

Hybrid rockfall protection barriers (attenuators) are a combination of rockfall protection drapes and flexible rockfall protection barriers without bottom supporting ropes. They are used as passive protection measures: The barrier brakes the falling rocks and the drape enables them to roll under control into the catch zone. Several hybrid barriers can be installed in succession.

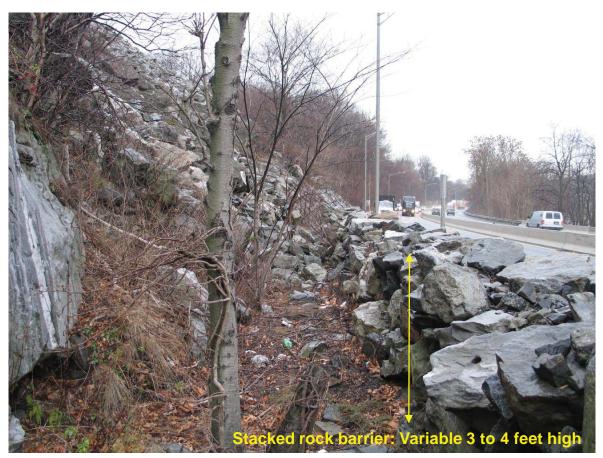
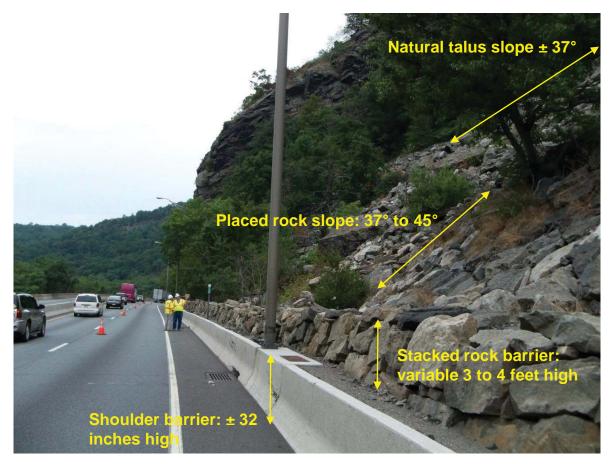
Figure 1 Area "D" – Existing Ditch Catchment

View eastbound, November 30, 2010

View westbound, July 20, 2010

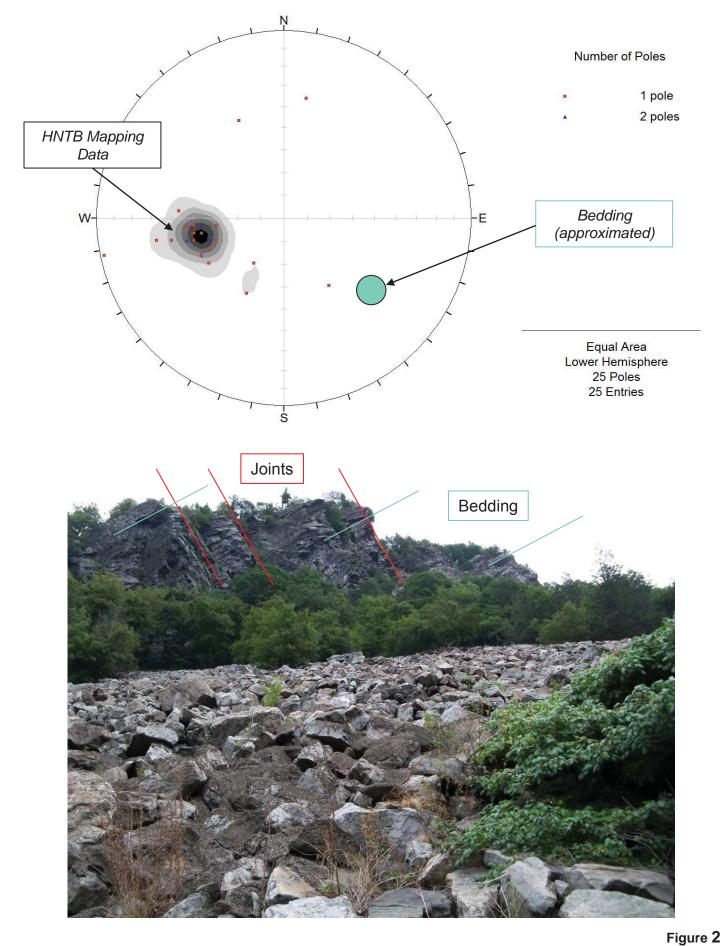
View upslope vicinity M.P. 1.42

Area "D" Structural Geology

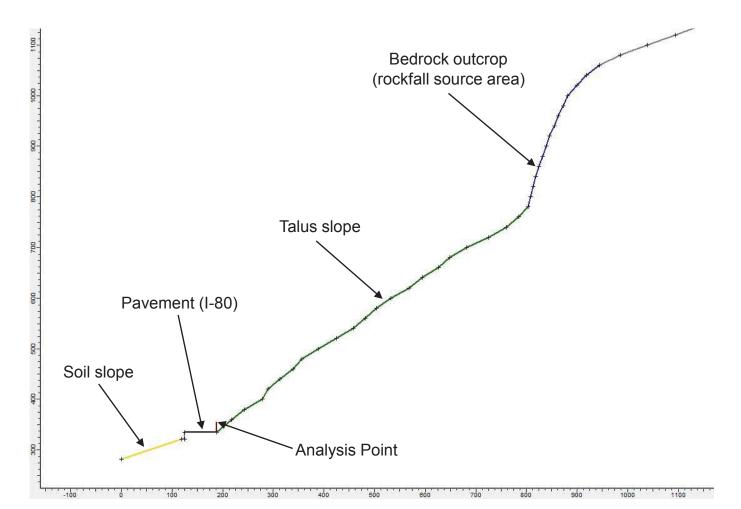
Figure 4

MATERIAL PROPERTIES (Design boulder = 4-foot diameter, 2¹/₂ tons)

R _n	R _n	R _t	R _t	φ	φ	Rough
Material	Mean	Std Dev	Mean	Std Dev	Mean	Std Dev	
Bedrock outcrop	0.35	0.04	0.85	0.04	35	3	5
Talus slope	0.32	0.04	0.82	0.04	35	2	4
Soil slope	0.3	0.04	0.8	0.04	30	2	0
Pavement	0.4	0.04	0.9	0.04	30	2	0

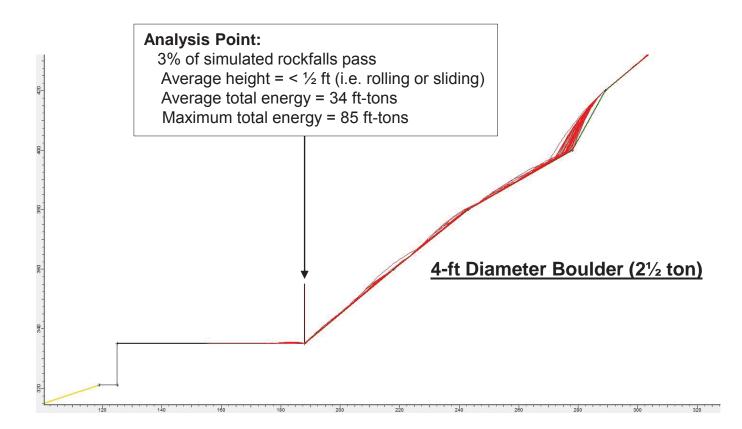
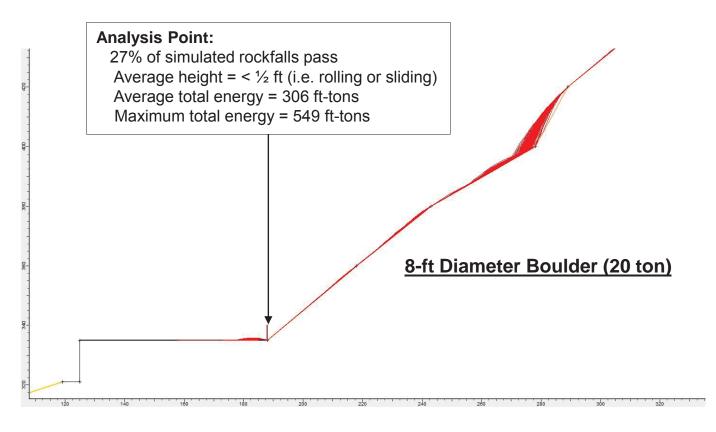
Figure 5 Rockfall Simulation Results

Rockfall simulations performed using Rocscience software "RocFall" Ver 4.054
 Simulations for concept development only; not suitable for design.
