Stream Morphology and Water Quality Based Restoration Plan for the Paradise Creek Watershed

Phase I Technical Report for the Paradise Creek Watershed Assessment

Prepared by Robert Limbeck, Watershed Scientist Delaware River Basin Commission, West Trenton, NJ For the Brodhead Watershed Association, Henryville, PA

February 2005

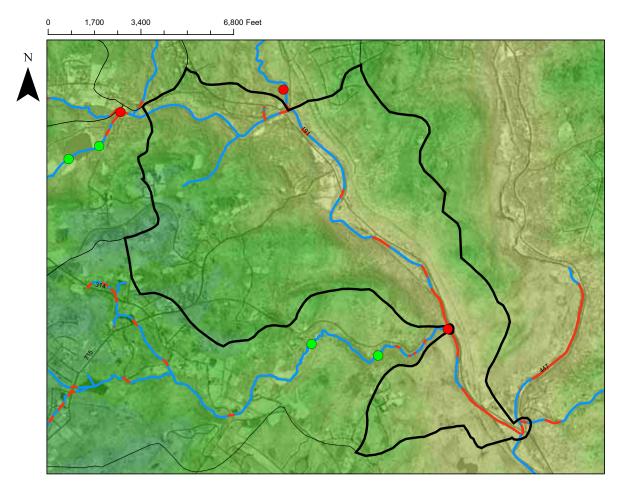
Lower Paradise Creek Sub-Watershed Potential Restoration Sites

Figure 4 – Potential restoration sites in the Lower Paradise sub-watershed. Sites were identified by means of topographic map examination; stream proximity within 150 feet of roads, bridges and culverts; aerial photo examination and field verification.

Road (1 red) Observation 1. Paradise Creek along Route 191 (4 segments): extensive channelization. Improve habitat within incised channel.

Install habitat improvement structures.

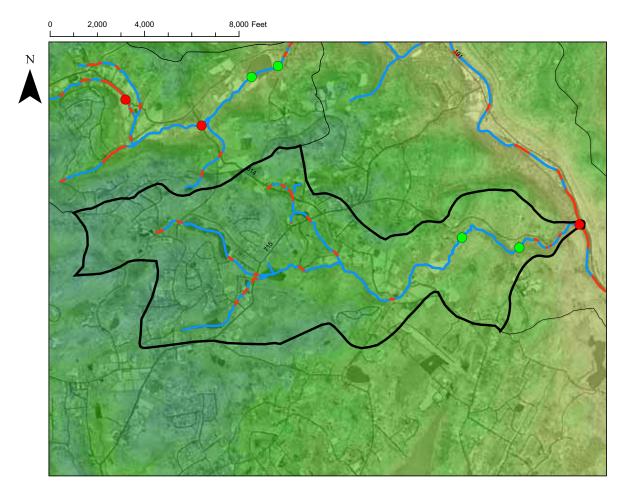
Butz Run Sub-Watershed Potential Restoration Sites

Figure 5 – Potential restoration sites in the Butz Run sub-watershed. Sites were identified by means of topographic map examination; stream proximity within 150 feet of roads, bridges and culverts; aerial photo examination and field verification.

Other (1 green) Observation 1. Butz Run in Parcel 3571 just upstream of forest and abrupt gradient change entering hemlock valley.

Document reference reach morphology of E channel.

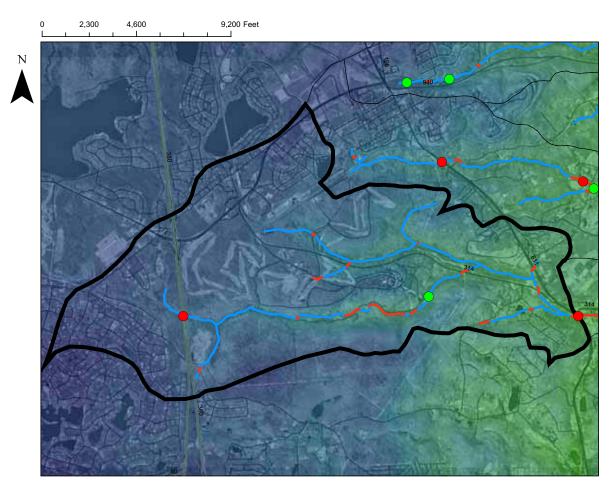
Upper Swiftwater Creek Sub-Watershed Potential Restoration Sites

Figure 15 – Potential restoration sites in the Upper Swiftwater Creek sub-watershed. Sites were identified by means of topographic map examination; stream proximity within 150 feet of roads, bridges and culverts; aerial photo examination and field verification.

Other (1 green) Observation 2. Swiftwater Creek at Ireland Hotels property – repair old dam effects. Action Install BMPs to capture road runoff.

Old dams on property, 1 breached and 1 filled with sediment. Investigate old diversion structure. Possible project: remove small dam and improve local habitat.

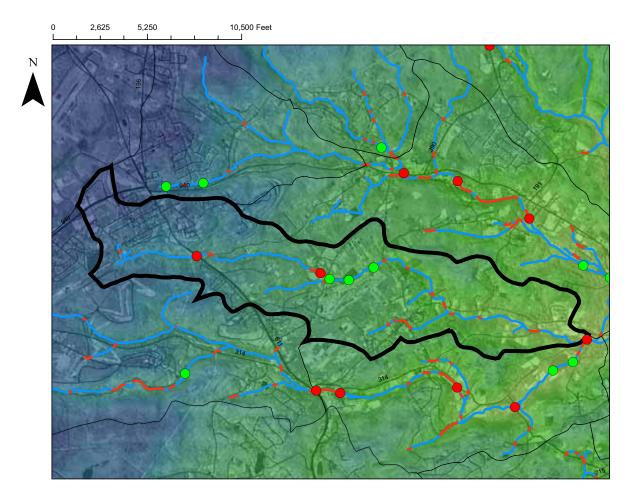
Forest Hills Run Sub-Watershed Potential Restoration Sites

Figure 16 – Potential restoration sites in the Forest Hills Run sub-watershed. Sites were identified by means of topographic map examination; stream proximity within 150 feet of roads, bridges and culverts; aerial photo examination and field verification.

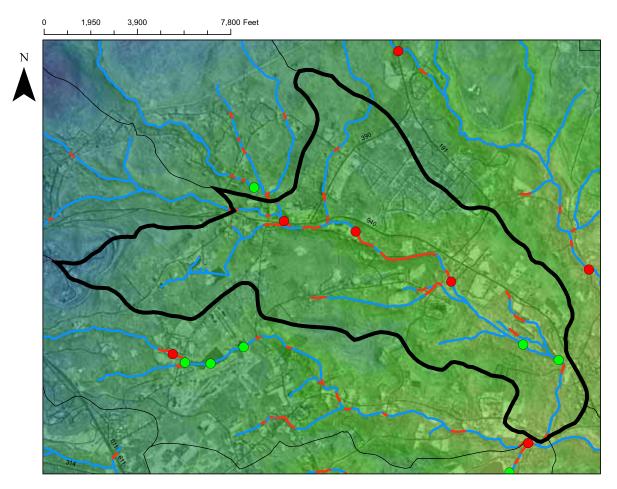
Upper Paradise Creek Sub-Watershed Potential Restoration Sites

Figure 18 – Potential restoration sites in the Upper Paradise Creek sub-watershed. Sites were identified by means of topographic map examination; stream proximity within 150 feet of roads, bridges and culverts; aerial photo examination and field verification.

Install fish passage structure. Implement lake management recommendations. Install sediment capture forebay, maintain regularly. Possible large restoration project to ½ mile upstream of lake.

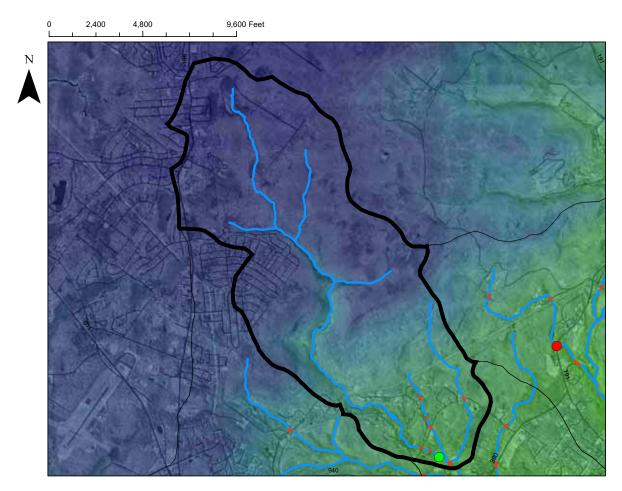
Devils Hole Creek Sub-Watershed Potential Restoration Sites

Figure 22 – Potential restoration sites in the Devils Hole Creek sub-watershed. Sites were identified by means of topographic map examination; stream proximity within 150 feet of roads, bridges and culverts; aerial photo examination and field-verification.

Major restoration and stabilization project. Recommend dam removal at lower end of reach.

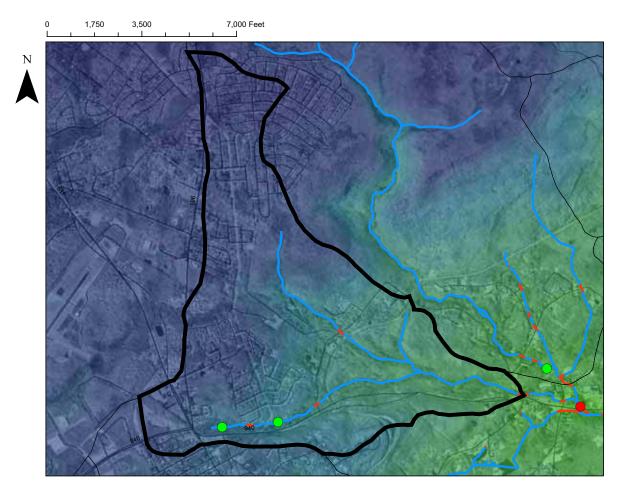
Tank Creek/Yankee Run Sub-Watershed Potential Restoration Sites

Figure 25 – Potential restoration sites in the Tank Creek and Yankee Run sub-watershed. Sites were identified by means of topographic map examination; stream proximity within 150 feet of roads, bridges and culverts; aerial photo examination and field-verification.
