# Mile Run - FIBI015

## SUMMARY OF RESULTS – FIBI015

**FIBI015  
MILE RUN  
EASTON AVENUE  
NEW BRUNSWICK, MIDDLESEX COUNTY**

**FIBI015-Mile Run @ Easton Ave**  
**Date Sampled - 7/13/2005**

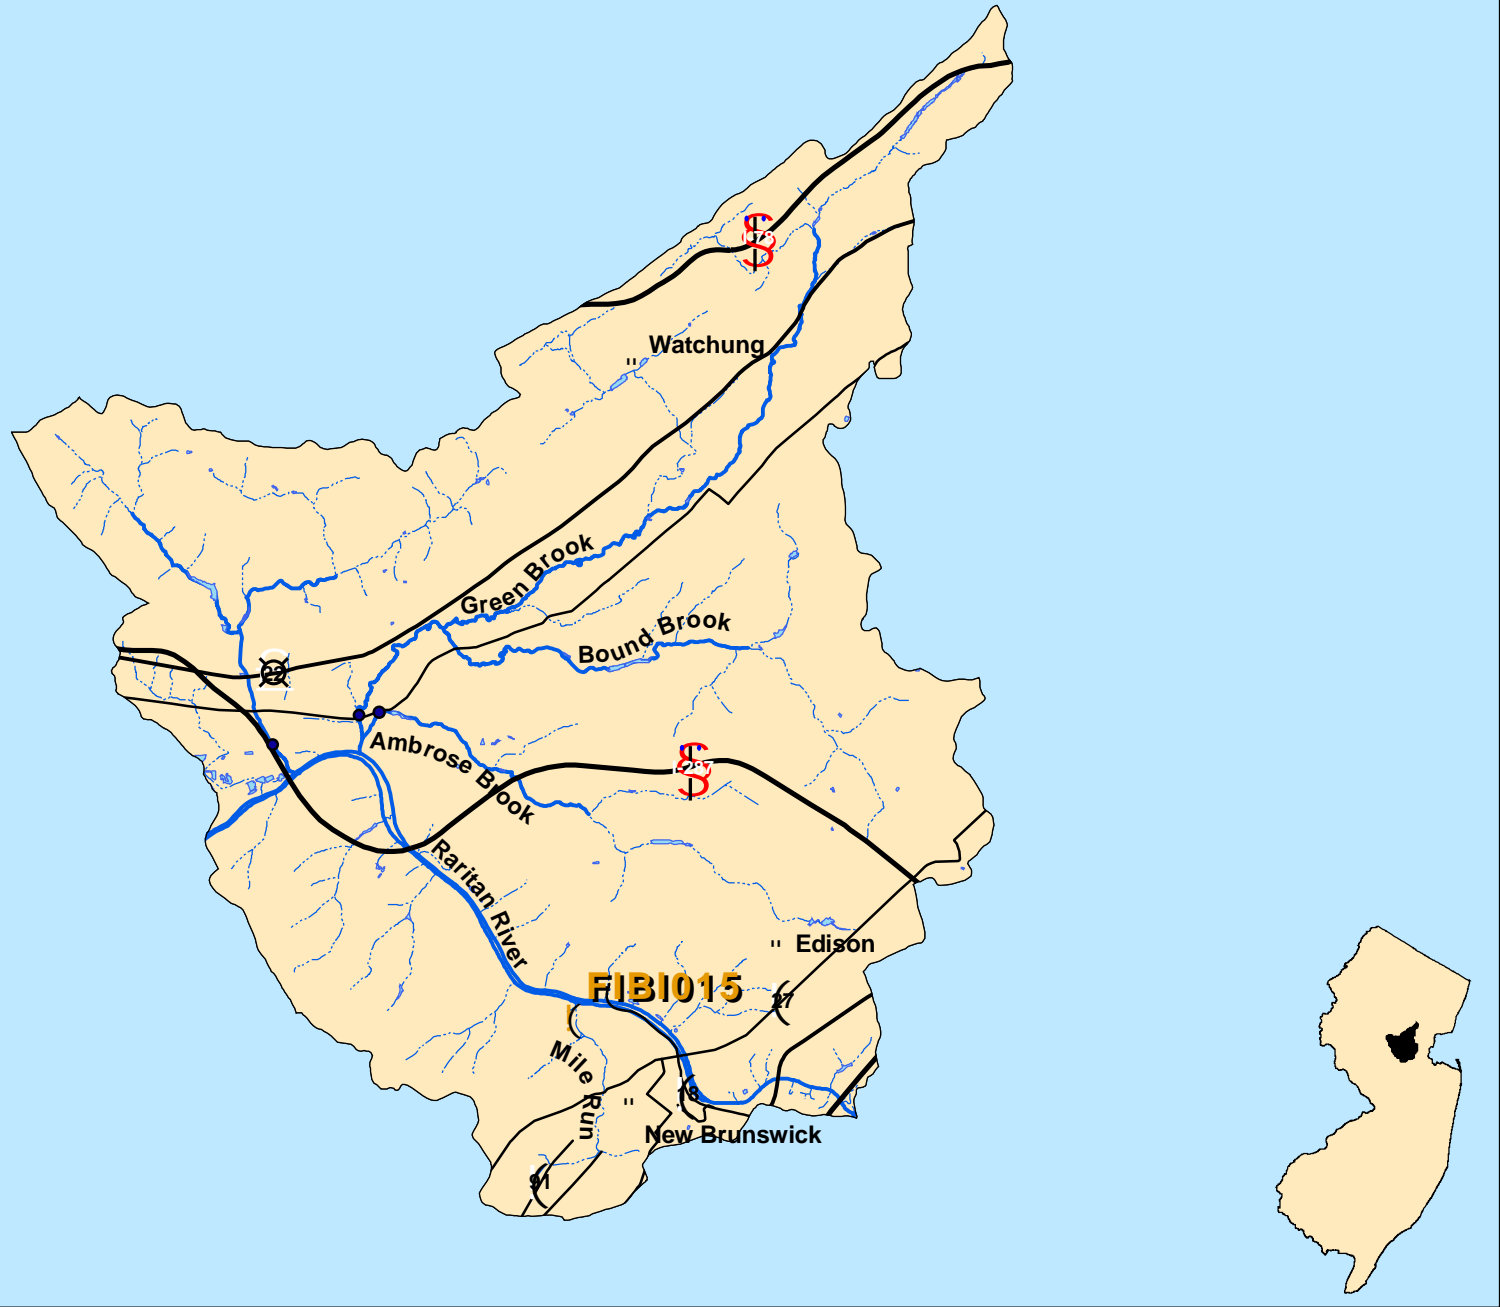
FIBI Sampling Location
-

Small Streams (1st and 2nd Order)
-

Large Streams (3rd Order and Larger)

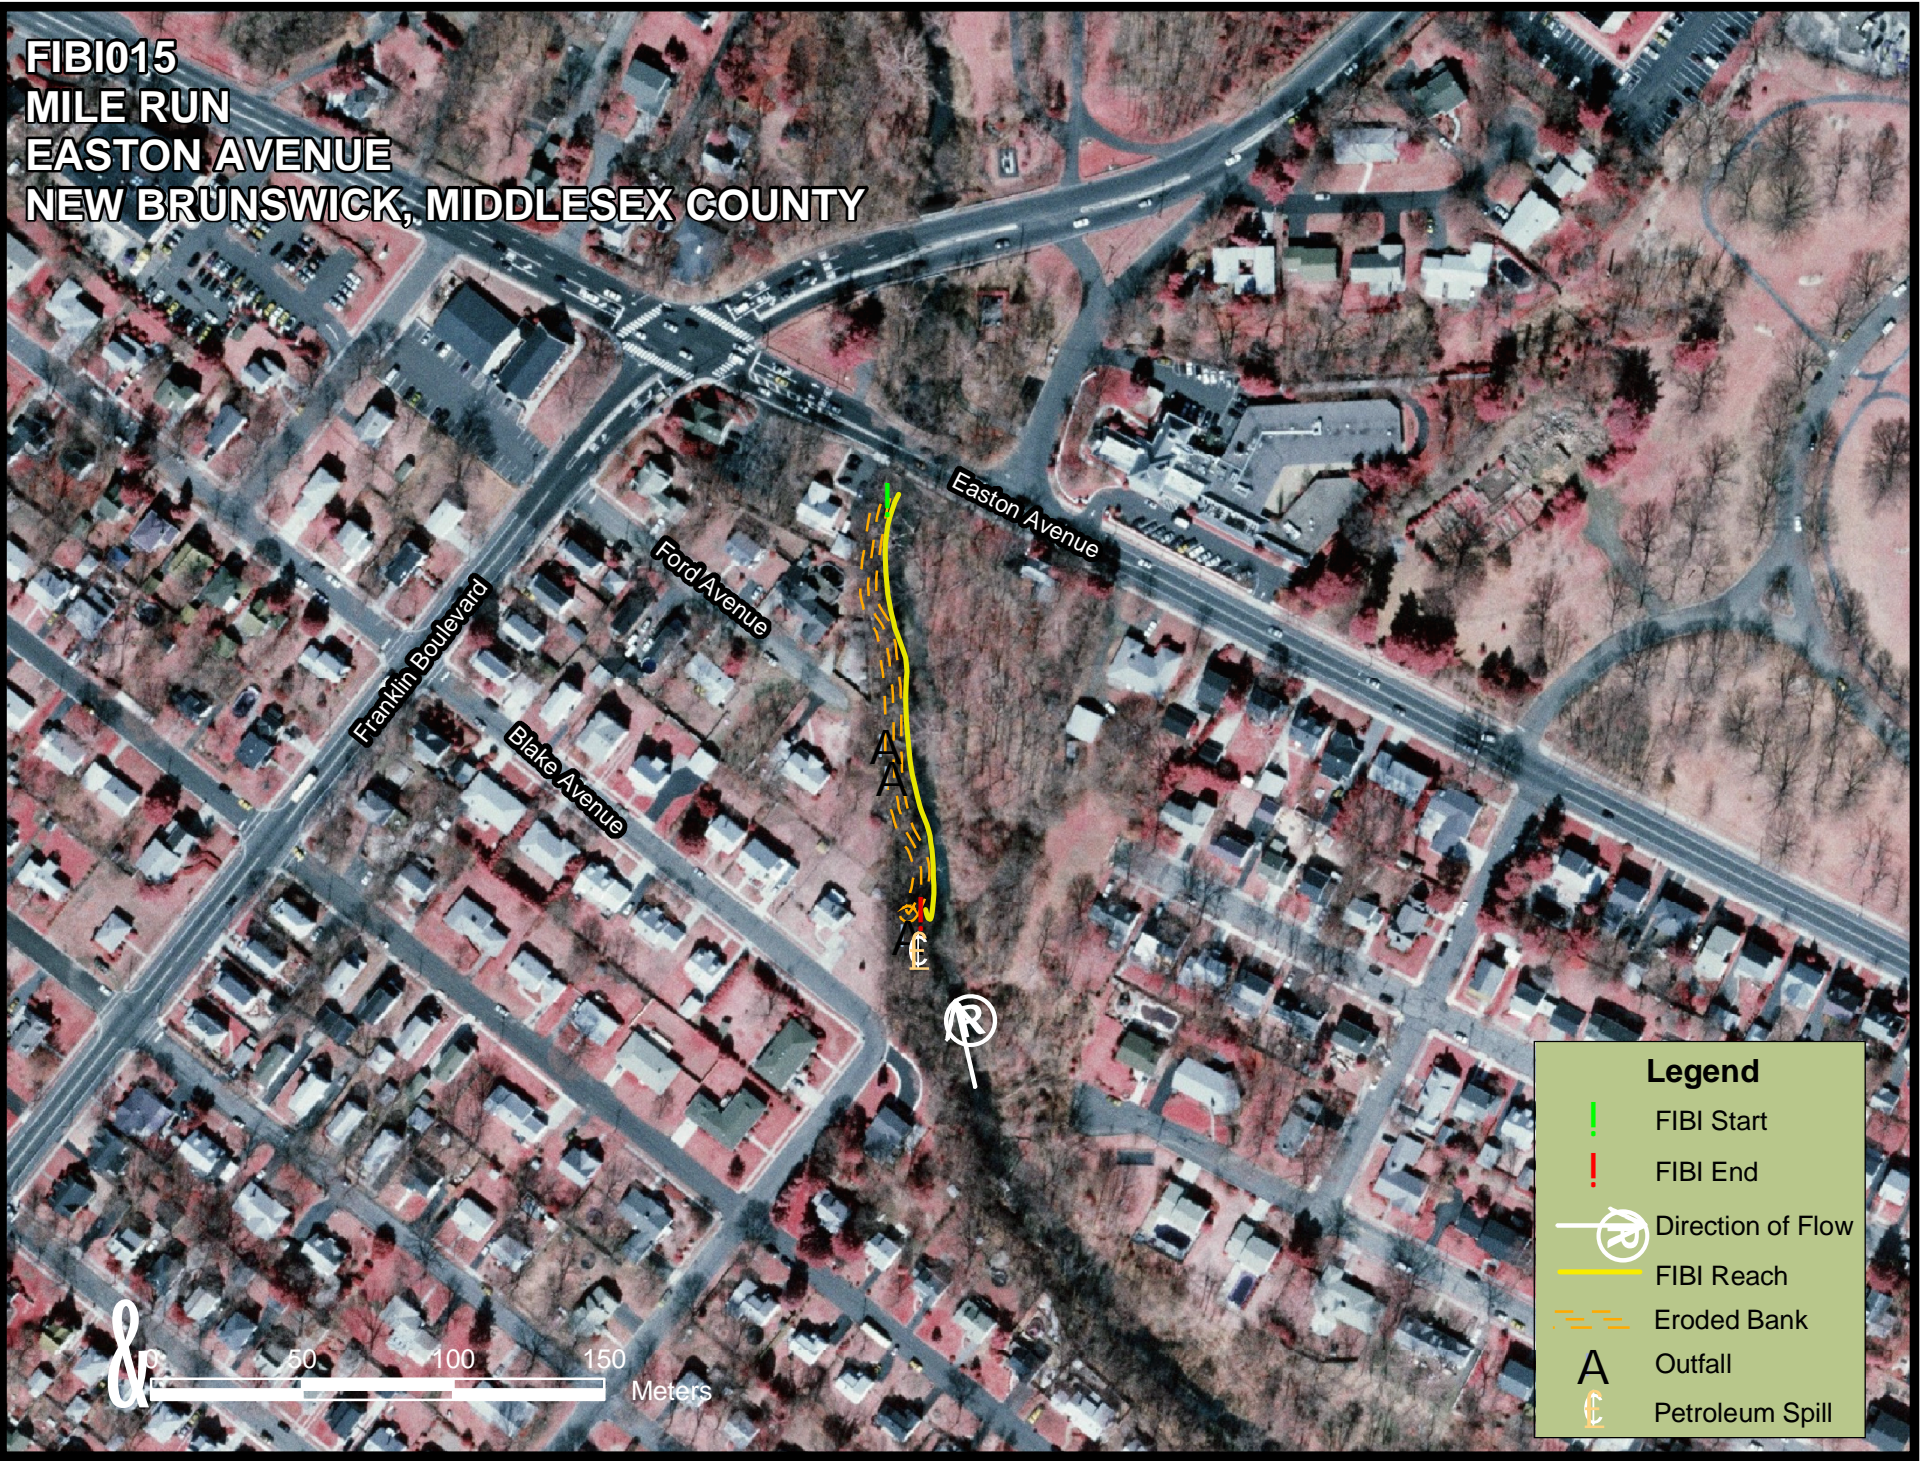
- ! FIBI Start
- ! FIBI End
- ↻ Direction of Flow
- FIBI Reach
- - - Eroded Bank
- A Outfall
- E Petroleum Spill
