SUMMARY OF RESULTS – FIBI016

FIBI016-R3

PIKE RUN
HARLINGEN ROAD
MONTGOMERY TWP.
SOMERSET

FIBI016- Pike Run @ Mill Pond Road
Date Sampled - 8/2/2010

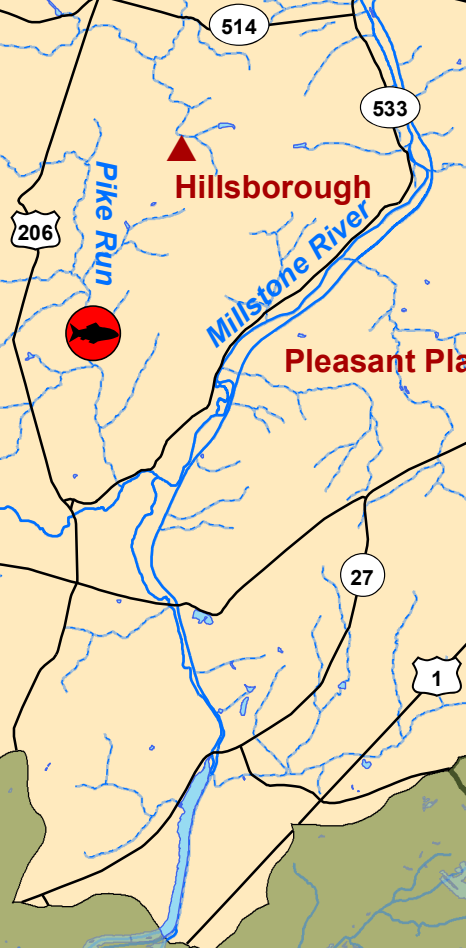
FIBI Rating

- Excellent (Green circle with black fish icon)
- Good (Yellow circle with black fish icon)
- Fair (Orange circle with black fish icon)
- Poor (Red circle with black fish icon)

Stream Order

- 1st, 2nd and 3rd Order (Thin blue line)
- 4th Order and Higher (Thick blue line)
