Subject: NEUP NJ Loop 325 Highlands Region Year 1 Post-Construction Monitoring Report

YEAR 1 POST-CONSTRUCTION MONITORING
Tennessee Gas Pipeline Company, L.L.C.
NEUP PROJECT - LOOP 325
HIGHLANDS REGION
Passaic and Bergen Counties, New Jersey

Prepared for: Tennessee Gas Pipeline Company, L.L.C.
Prepared by: AK Environmental, LLC an NV5 Company
December 29, 2014

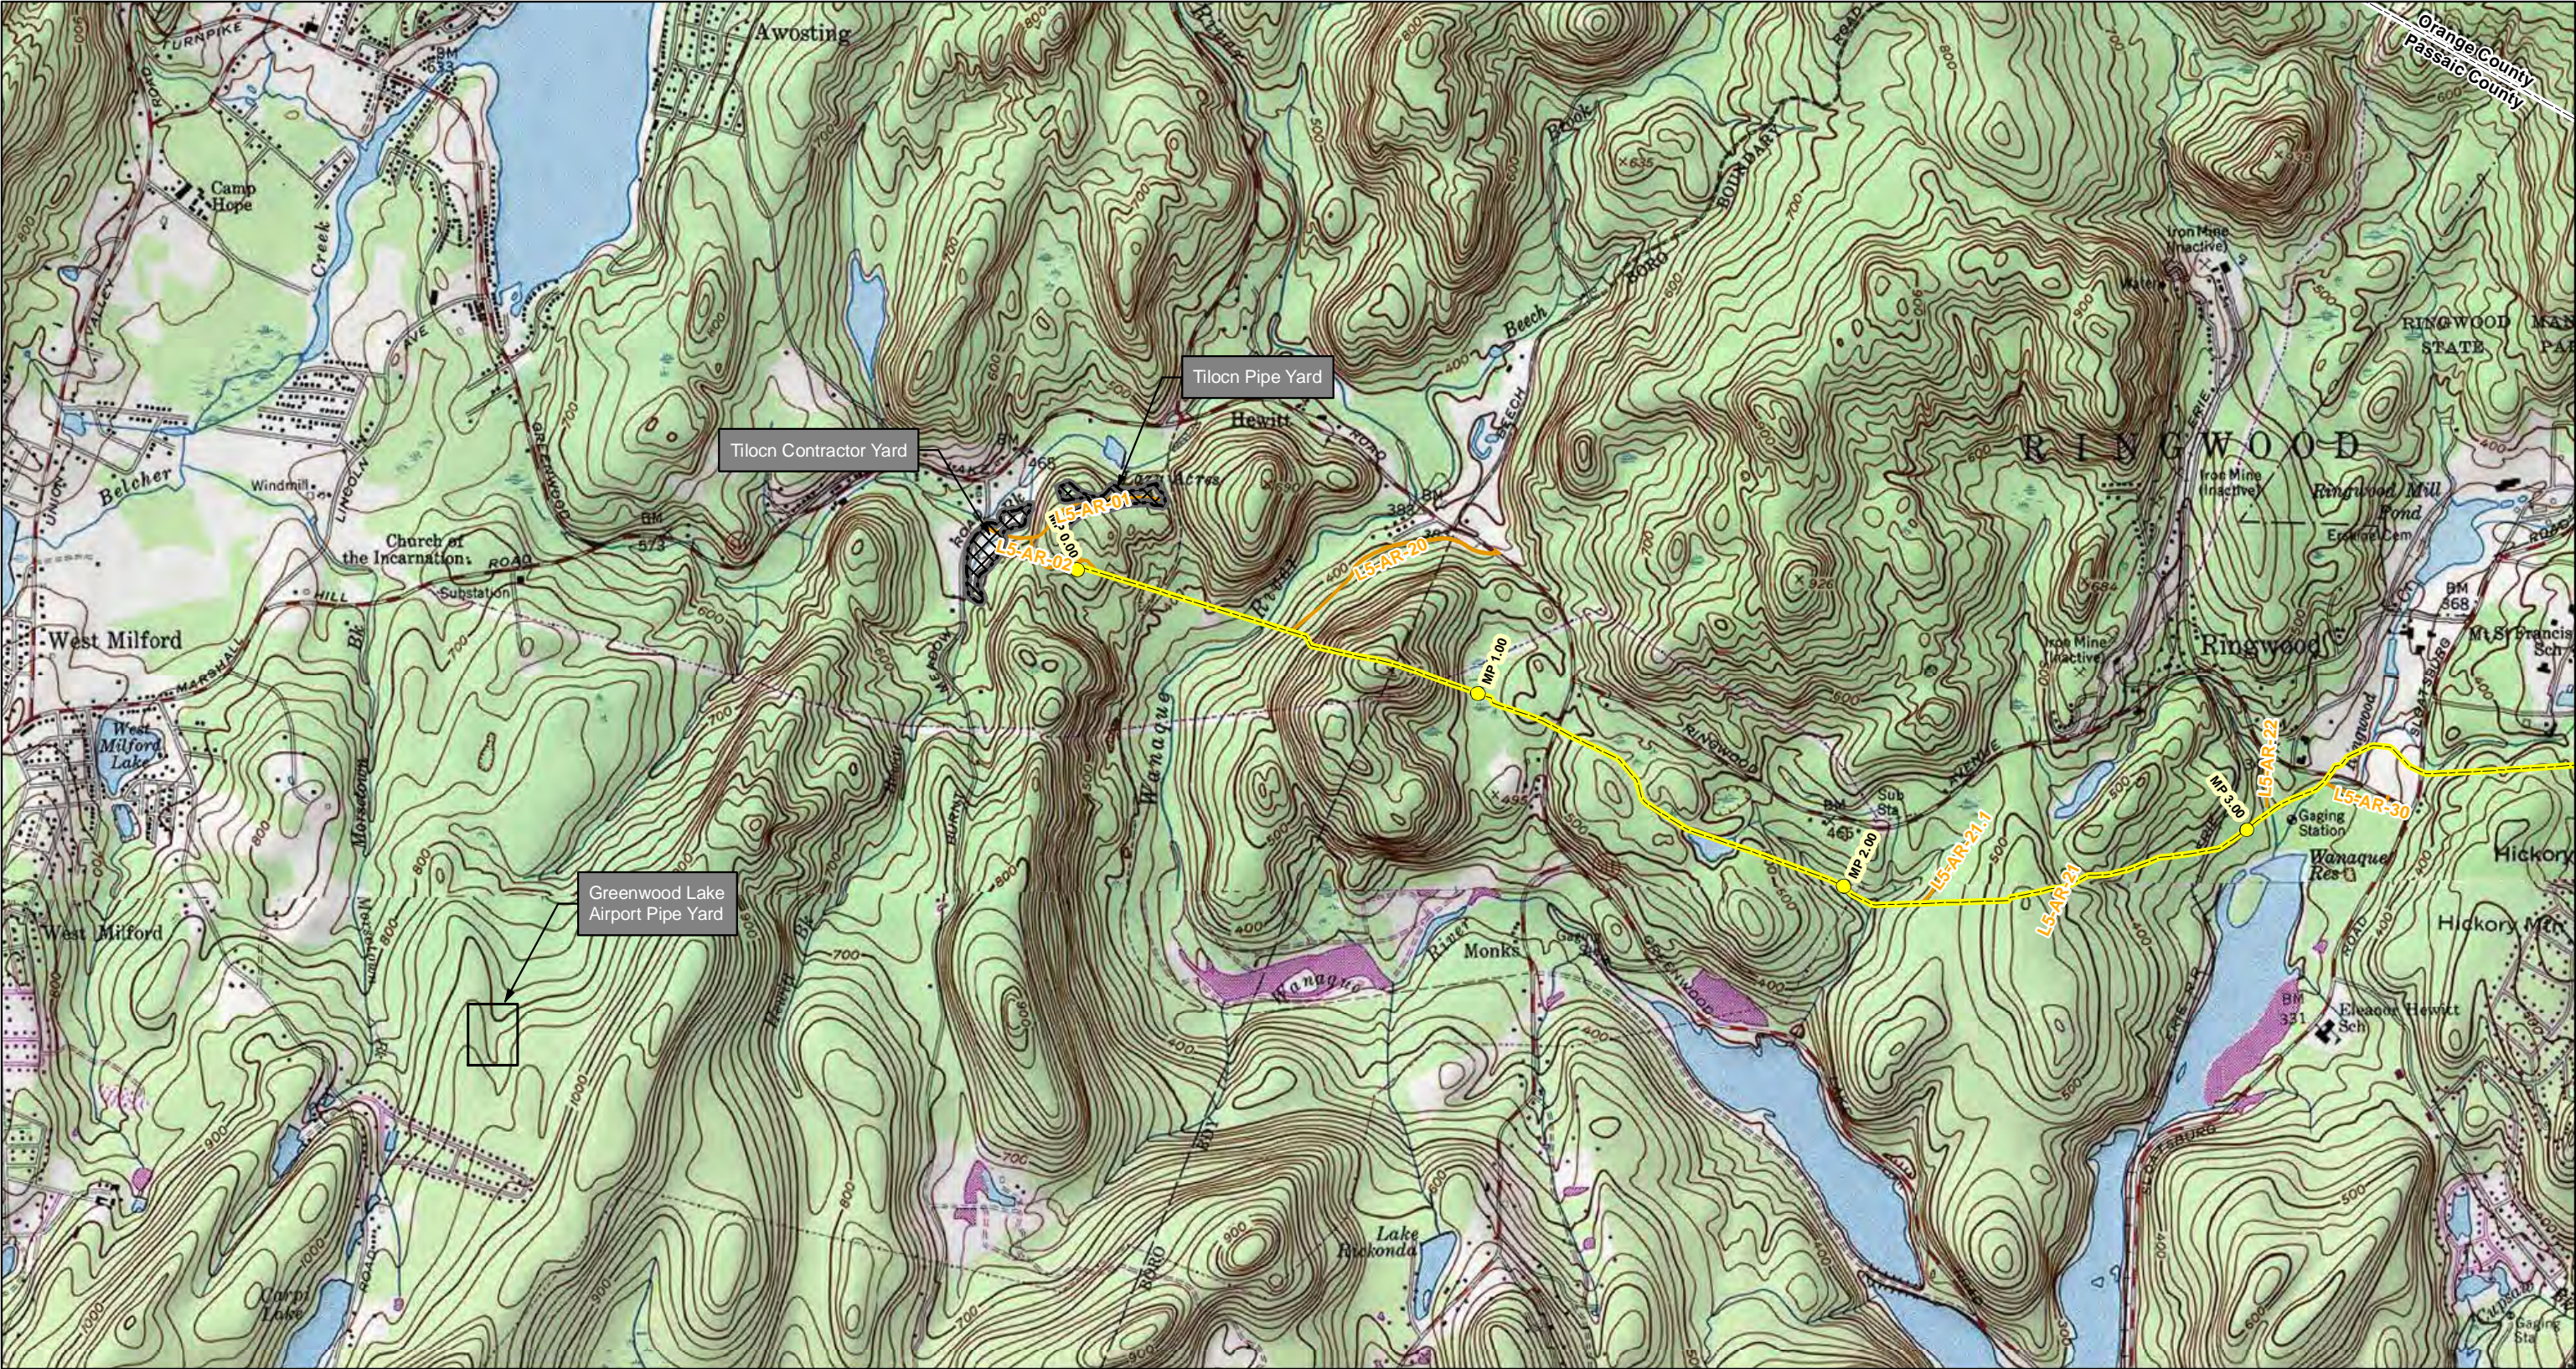
Map Location 	Map Index 	Legend <ul style="list-style-type: none">NEUP CenterlinesCompressor StationCounty BoundaryPipe YardsAccess Roads <p>Data Source: USGS, PASDA, NJDEP Map Projection: NAD 1983 UTM Zone 18N Foot US USGS Quad: Greenwood Lake, Slootsburg</p> <p>0 250 500 1,000 1,500 2,000 Feet</p> <p>1:24,000 1 inch = 2,000 feet</p>	<p>Tennessee Gas Pipe Line Company USGS Site Location Northeast Upgrade Project - Loop 325</p> <p>Passaic County, NJ</p> <p>Sheet 1 of 2</p>	<div></div> <p>Figure 1-1</p> <p>Date: April 2011</p> <p>Project #: 60136976 300</p>
-------------------------	----------------------	--	---	--

Figure 1-1. Loop 325 Project Area
