Neshanic River - FIBI023

SUMMARY OF RESULTS – FIBI023

**FIBI023
NESHANIC RIVER
ALONG KUHL ROAD
RARITAN TWP., HUNTERDON COUNTY**

HABITAT ASSESSMENT FOR HIGH GRADIENT STREAMS Neshanic River (FIBI023) – 7/13/06

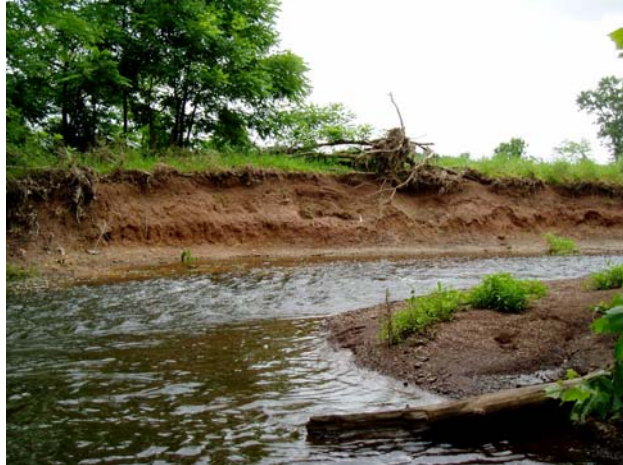
1. Stream Name:	Neshanic River
2. Sampling Date:	7/13/2006
3. Sampling Location:	Along Kuhl Road
4. Municipality:	Raritan Twp.
5. County:	Hunterdon
6. Watershed Management Area:	8
