Lamington River - FIBI032

SUMMARY OF RESULTS – FIBI032

FIBI032
LAMINGTON RIVER
BLACK RIVER ROAD
BEDMINSTER TWP., HUNTERDON COUNTY

HABITAT ASSESSMENT FOR HIGH GRADIENT STREAMS Lamington River(FIBI032) – 7/11/06

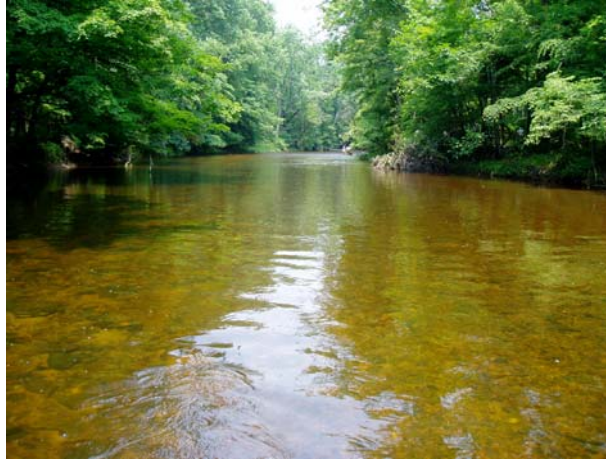
1. Stream Name:	Lamington River
2. Sampling Date:	7/11/2006
3. Sampling Location:	Black River Road
4. Municipality:	Bedminster Twp.
5. County:	Somerset/ Hunterdon

6. Watershed Management Area:	8
7. Contributing Drainage Area (Sq. Mi.):	46.2
8. Electrofishing Gear:	Barge
9. FIBI Score and Rating:	Round 1* Good (44); Round 2 Good (40)

10. Habitat Score and Rating:	Round 1 Optimal (161); Round 2 Sub-Optimal (148)
11. Fishable Species Present:	Yes
12. Relevant AMNET ¹ Station Data:	
Proximity of FIBI station to AMNET station:	1.2mi upstream AN0363
AMNET Rating:	1994 – Non-impaired; 1999 – Non-impaired; 2004 – Non-impaired

13. Stream Chemistries:	
Dissolved Oxygen (mg/l)	9.17
Temperature °C.	20.71
pH	6.96
Conductivity (µmhos/cm)	285
14. Length of Stream Sampled:	150m
15. Water Clarity:	Clear

16. Average Open Forest Canopy:	64%
17. Discharge:	46.7 cfs
18. Substrate:	40% Gravel/Sand, 35% Cobble, 5% Boulder, 10% Mud, 10% Silt,
19. Habitat:	70% Riffle, 30% Run

20. Snags:	Yes
21. Periphyton:	Slight
22. Submerged Aquatic Vegetation:	Yes
23. Outfalls:	1
24. Number of Fish Species Identified:	23
25. Total Number of Fish Collected:	410

26. Number of Fish With Anomalies:	9
27. Other Observations:	Substrate relatively clean; little habitat for piscivores
