Pohatcong Creek - FIBI033

SUMMARY OF RESULTS – FIBI033

FIBI033
POHATCONG CREEK
ROUTE 31
WASHINGTON TWP., WARREN COUNTY

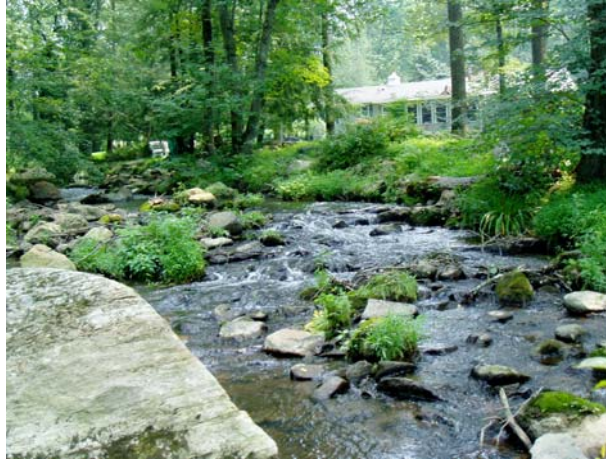
1. Stream Name:	Pohatcong Creek
2. Sampling Date:	8/2/2006
3. Sampling Location:	Route 31
4. Municipality:	Washington Twp.
5. County:	Warren
6. Watershed Management Area:	1

7. Contributing Drainage Area (Sq. Mi.):	9.8
8. Electrofishing Gear:	2 Backpacks
9. FIBI Score and Rating:	Round 1* Good (44); Round 2 Good (44)
10. Habitat Score and Rating:	Round 1 Sub-Optimal (145); Round 2 Optimal (175)

13. Stream Chemistries:	
Dissolved Oxygen (mg/l)	7.43
Temperature °C.	25.18
pH	6.44
Conductivity (µmhos/cm)	159
14. Length of Stream Sampled:	150m
15. Water Clarity:	Clear

16. Average Open Forest Canopy:	12%
17. Discharge:	6.0 cfs
18. Substrate:	50% Gravel/Sand, 30% Cobble, 10% Boulder, 5% Mud, 5% Silt,
19. Habitat:	30% Riffle, 50% Run, 20% Pool

20. Snags:	Yes
21. Periphyton:	Slight
22. Submerged Aquatic Vegetation:	Yes
23. Outfalls:	0
24. Number of Fish Species Identified:	18
25. Total Number of Fish Collected:	664

26. Number of Fish With Anomalies:	9
27. Other Observations:	Wild brown and rainbow trout were collected.

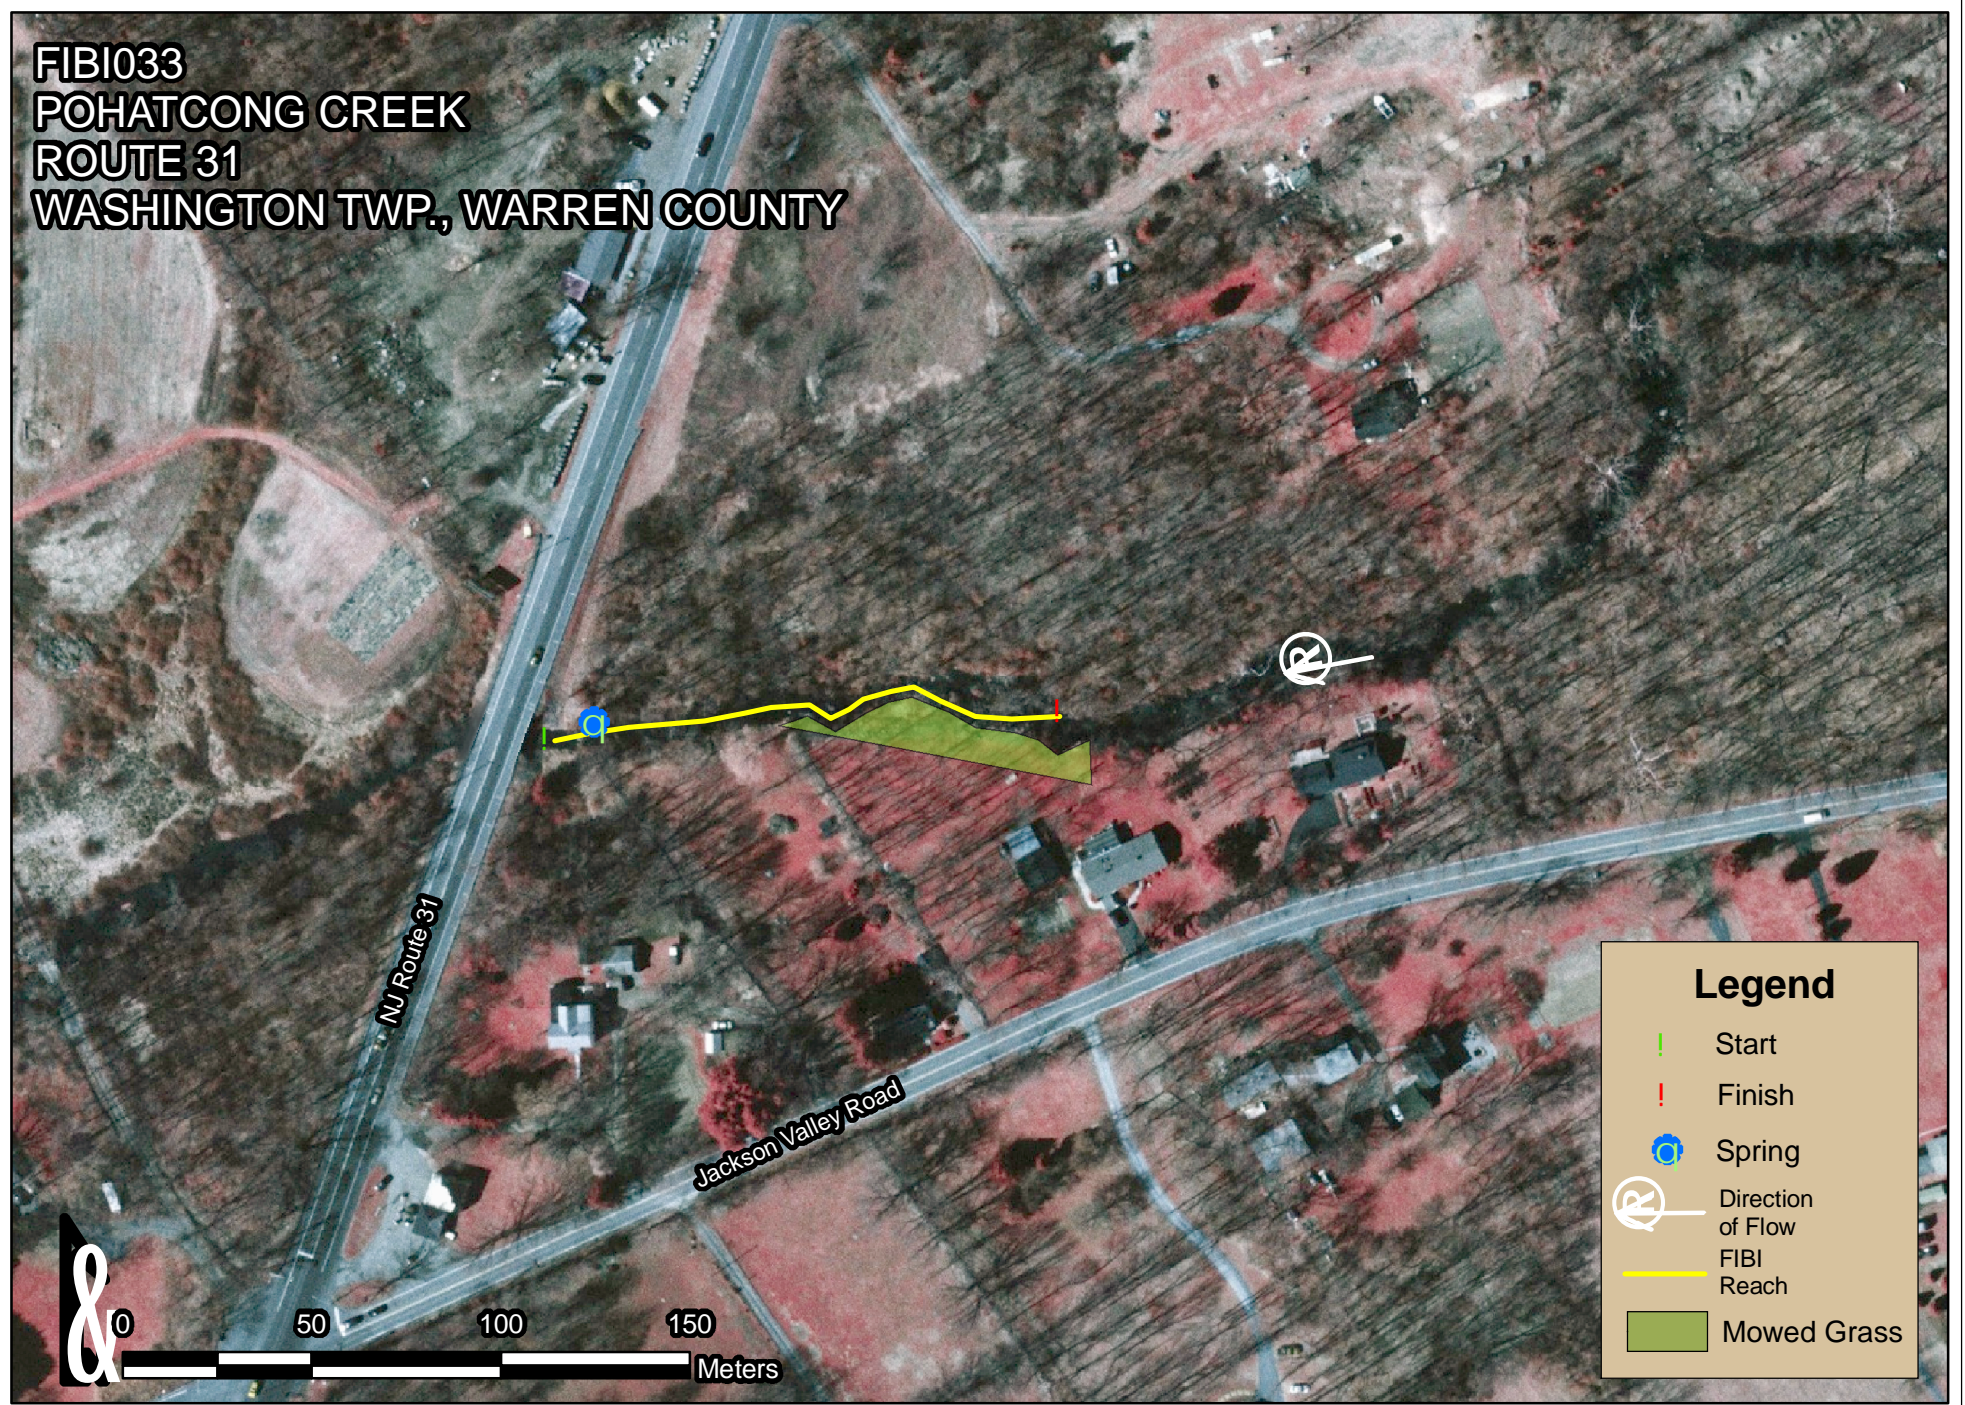
- Start
- Finish
- Spring
- Direction of Flow
- FIBI Reach
- Mowed Grass
