# ***NEW JERSEY DIVISION OF FIRE SAFETY***

## ***Firefighter Fatality and Serious Injury Report Series***

### **Firefighter Issues “Mayday” and Runs Out of Air While Operating at a Structure Fire**

**Perth Amboy, New Jersey  
March 26, 2013**

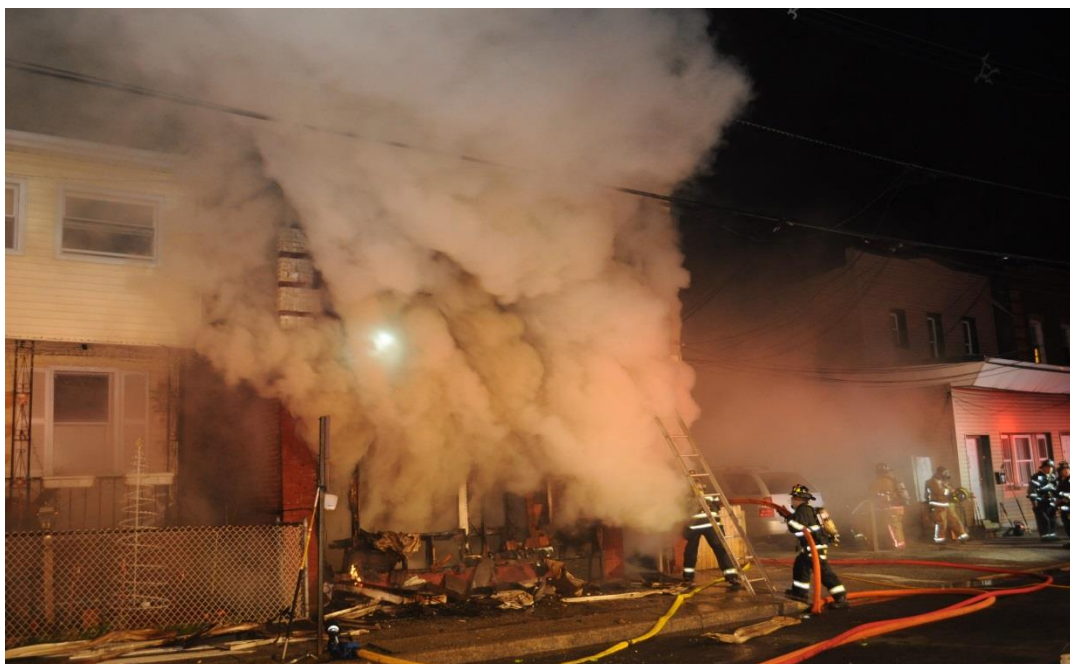
***Photo 1: Heavy smoke still pushes from the structure, after multiple attempts to extinguish it from the exterior and interior. This photo is approximately an hour after arrival on scene, shortly before BC Simon's "Mayday".***

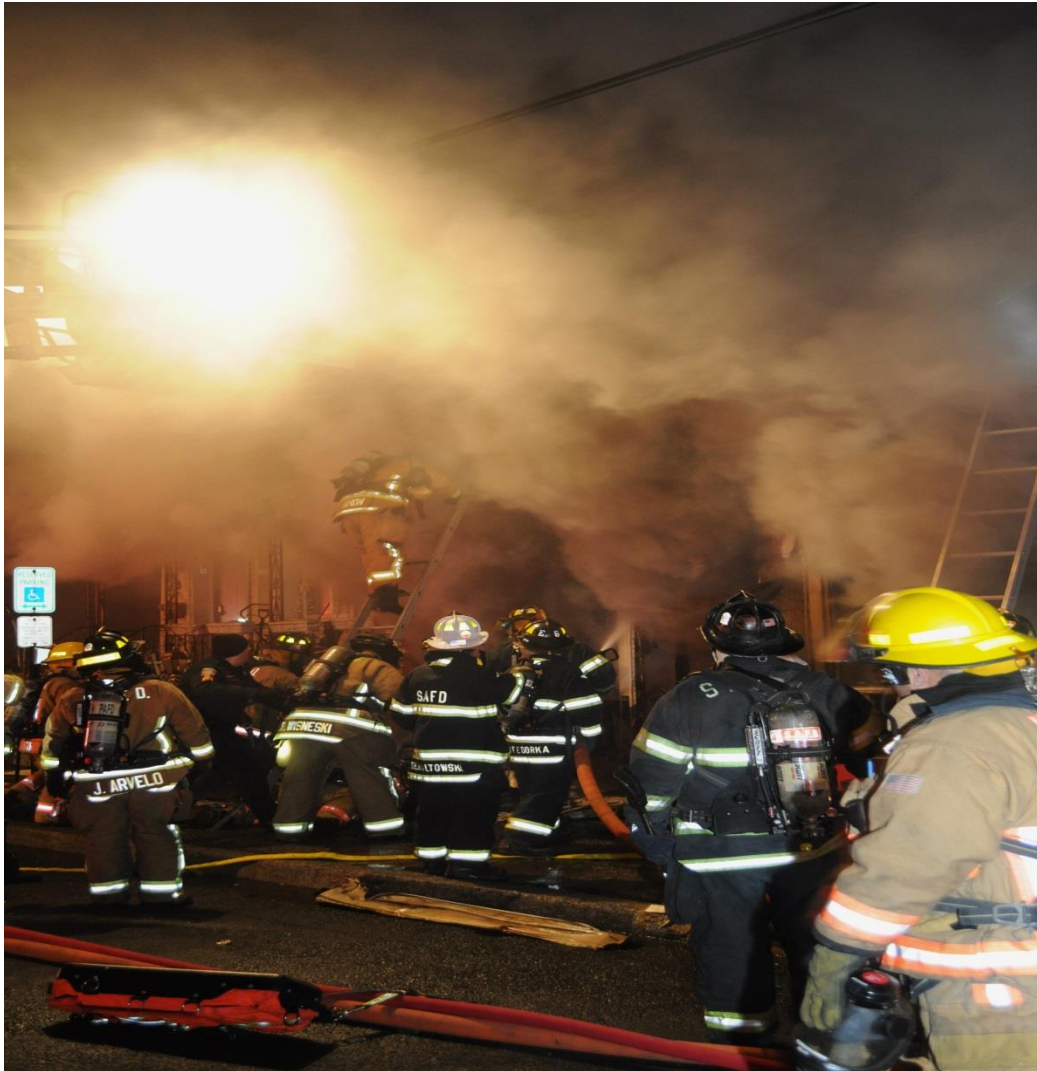
***Photo 2: Following his “Mayday”, BC Simon exits through the 2<sup>nd</sup> floor Div. A window, and descends down the ladder immediately after the assisting FF (Macri) fell to the sidewalk below. Note the heavy smoke condition throughout, over an hour after arrival on scene.***
